TURBINE AND COMPRESSOR VIBRATIONS  
ENCOUNTERED AT STARTUP OF A METHANOL PLANT

J.C. Wachel  
Manager of Engineering  
Engineering Dynamics Inc.  
San Antonio, TX

Adapted from Paper 52B presented at

American Institute of Chemical Engineers  
Ammonia and Related Plants Safety Symposium  
Minneapolis, Minnesota

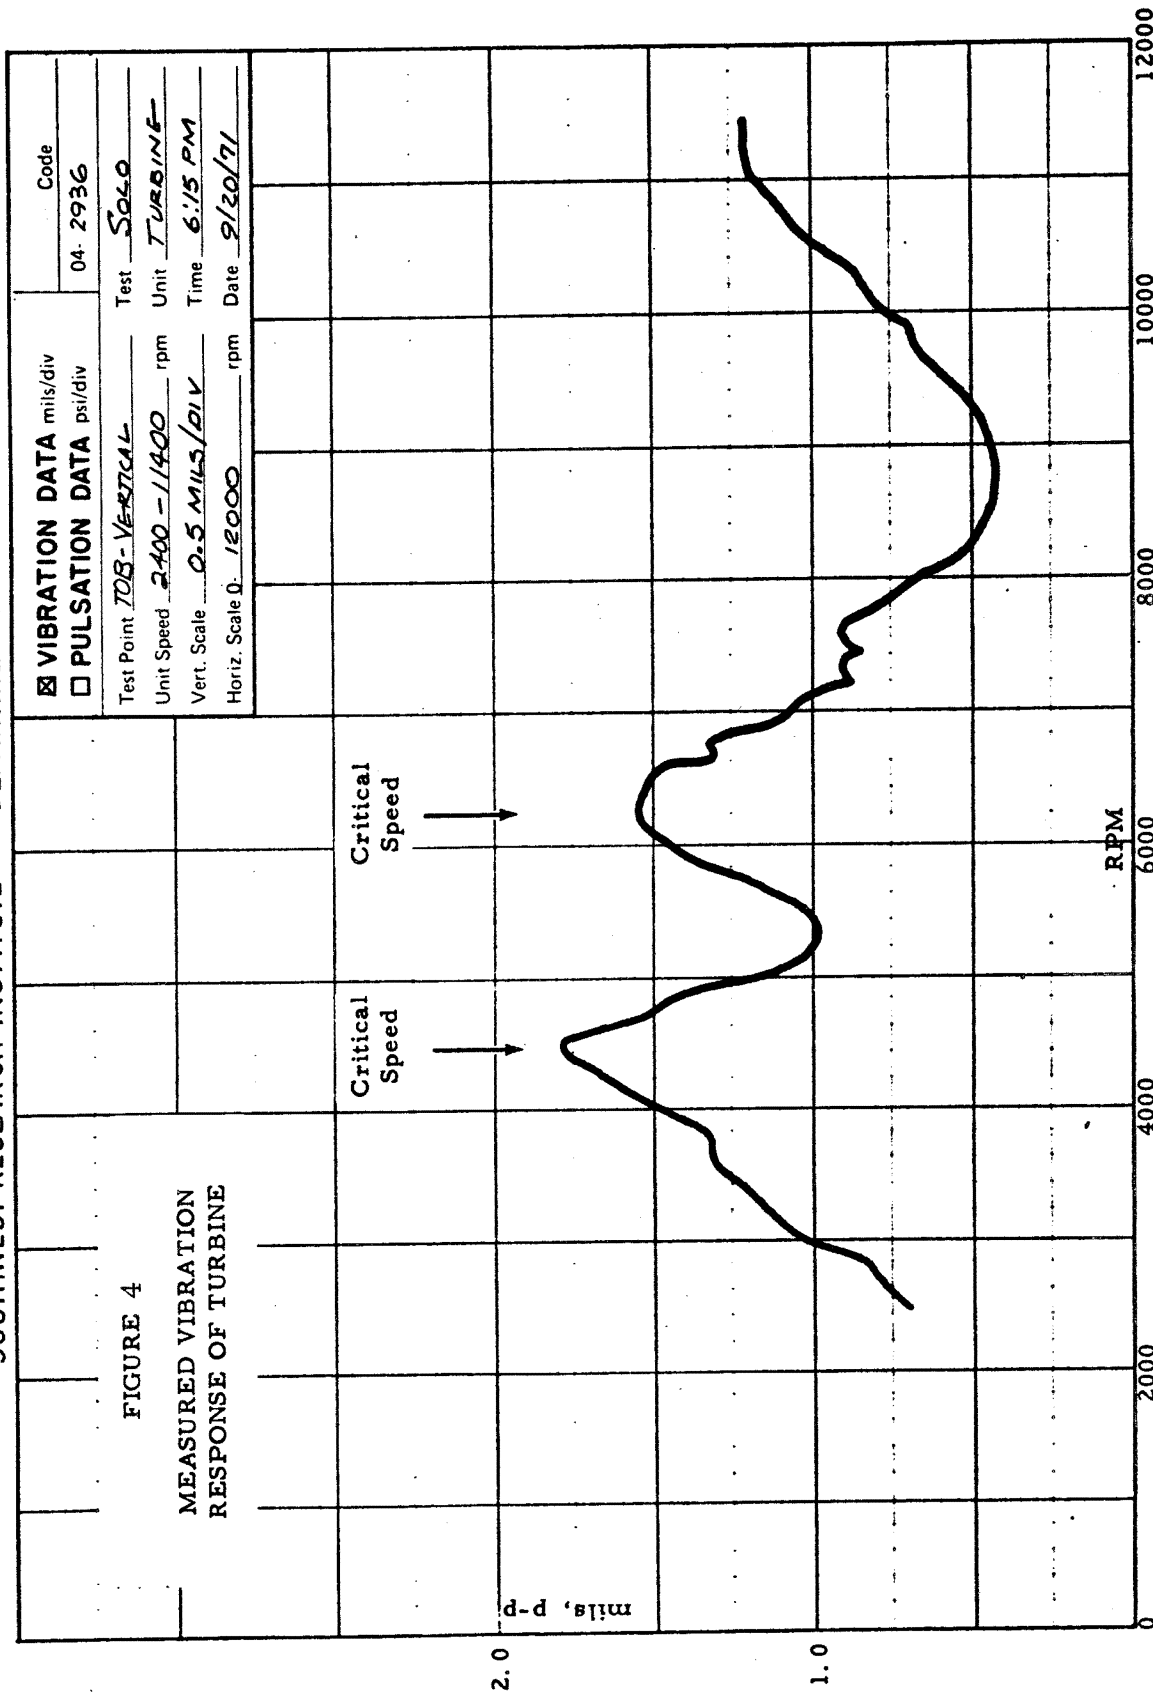
The retainer ring on the thrust bearing on the turbine was incorrectly installed and axial movement of the shaft caused sufficient damage that the spare rotor had to be installed. New bearings were used when the spare rotor was installed. Figure 4 gives a composite peak amplitude-frequency plot using a real time analyzer for the turbine outboard vertical vibration as the turbine speed was gradually increased to 11,200 rpm. This curve gives a complete response plot which defines the critical speeds. One was at 4320 rpm and another at 6200 rpm. This is similar to the response predicted in Figure 1, Curve 2.

When the turbine speed reached 11,580 rpm, a vibration component of 1.5 mils at exactly half speed was excited which was larger than the running speed component. The bearings were found to be approximately 1.5 mils out of round. A new set of bearings was checked and installed. After balancing the new rotor, the half speed components were nearly zero. This illustrates that for this machine, even small out-of-roundness or changes in the bearing properties could cause instabilities to occur in the pressure pad bearings.

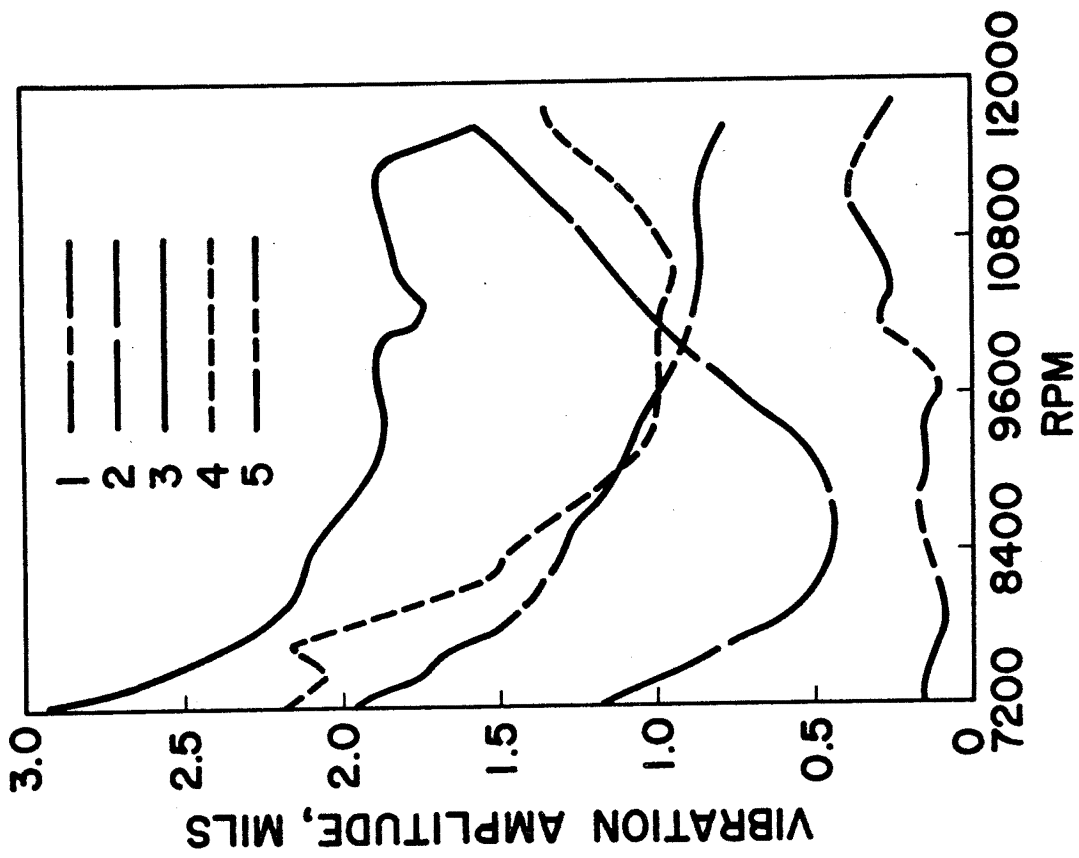
FIG. 5 NON REPEATABLE VIBRATIONS  
OF TURBINE

After several balancing tries on the new rotor, the vibration amplitudes were reduced to less than 1.5 mils at all four data points. The data taken at the outboard end of the turbine in the vertical direction is given in Figure 5, Curve 1. When an attempt was made to repeat this data, Curve

2 was obtained. Note that the shapes of the curves are different. This indicates that the balance condition changed. To check out the nonrepeatable data, the unit was slowly cycled from 3000 to 11,000 rpm six times and the data obtained again. Curve 3 shows that the amplitudes had increased by a factor of nearly 2:1. When the unit was brought back up, Curve 4 resulted showing that the amplitudes were not repeatable.

This evidence was sufficient to prove that the sleeves on the rotor shaft were shifting and causing the unbalance of the rotor to change. This design feature was later changed to eliminate this undesirable characteristic.

When the sleeve design was changed, the vertical vibration amplitudes at the outboard bearing were less than 0.5 mil (Curve 5) and repeatable after many speed cycles.

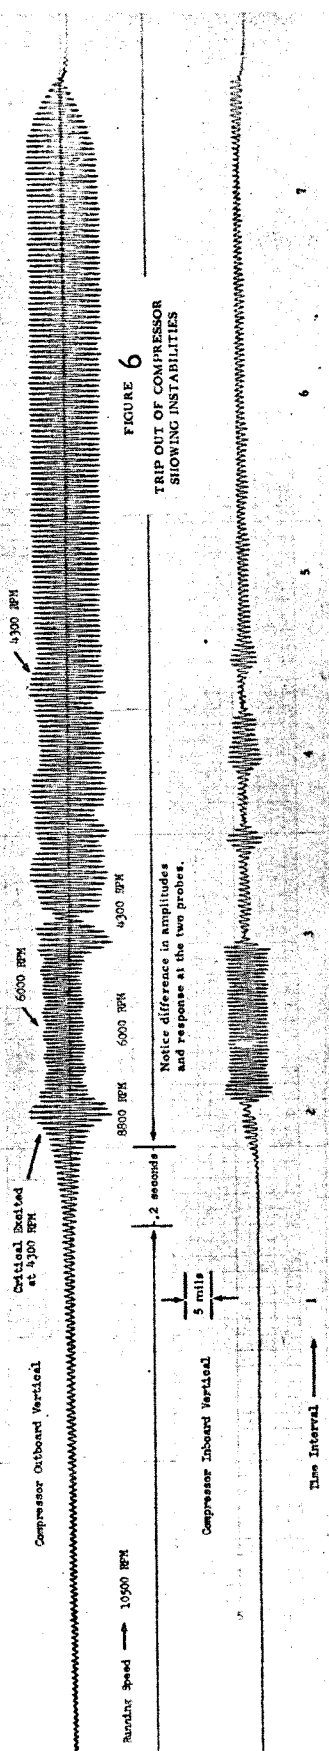
FIGURE 6

After installing additional knockout drums and other safety devices, a second failure was experienced. This time, the seal oil pressure dropped suddenly and the speed dropped to 4500 rpm, which was the compressor first critical, and remained there for an undetermined length of time. It was thought that this caused the second failure. A month after the compressor was rebuilt, it vibrated severely when the system tripped out. The seals and labyrinths were again wiped. Since no spare parts were available, the unit was brought back up under partial load. Data was recorded on the next trip-out to capture the severe compressor vibrations. A strip chart recording of the trip-out is given in Figure 6. Figure 7 is a time history plot of this sequence of events. Each vertical offset of the horizontal line represents an interval of time; therefore, the overlay of the instantaneous frequency analyses from the real time analyzer shows exactly what frequencies were excited as a function of time.

An analysis of the time history shows that immediately after the trip-out occurred, the component already present in the vibrations at 4000 rpm increased in amplitude (approximately 16 mils) until the bearing clearances were exceeded. The rotor then vibrated primarily at 6200 cpm for approximately 0.5 second, with an amplitude of 8 mils. The speed then locked onto the first critical at 4500 rpm with an amplitude of 15 mils. The vibrations remained at this high level for several seconds. The severe instability which excited the first critical while the speed was still above 9000 rpm apparently could be initiated by system upsets such as sudden pressure changes, fast speed drop, or overspeed trip-outs. This type of vibration

TRIP OUT OF COMPRESSOR  
SHOWING INSTABILITIES

Critical Excited  
at 4300 RPM

Notice difference in amplitudes  
and response at the two probes.

For this system several steps were taken to reduce those elements which promote this type of instability. The wheels were undercut to reduce the frictional effects at the mating surfaces. Also, the clearances in the labyrinths and seals were increased. The five shoe tilted pad bearings were also modified by reducing the pad areas on the side and by increasing the radial clearance to force the rotor to vibrate in a horizontal elliptical orbit, which helps prevent the pure circular orbit of the first critical. The theory explaining why these changes were made is beyond the scope of this paper; however, the author and his colleagues plan to deal with this one subject in a later paper utilizing this data and similar data measured at other installations.

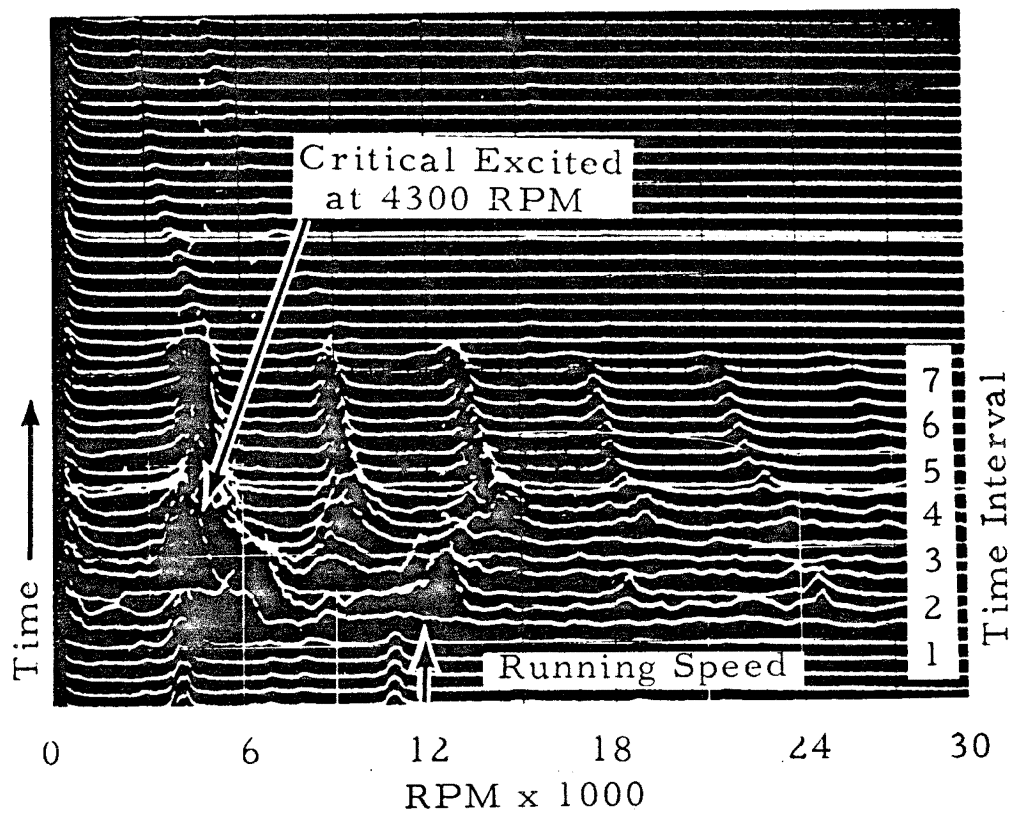
FIGURE 7

SPECTRAL TIME HISTORY OF COMPRESSOR  
TRIP-OUT SHOWING INSTABILITIES

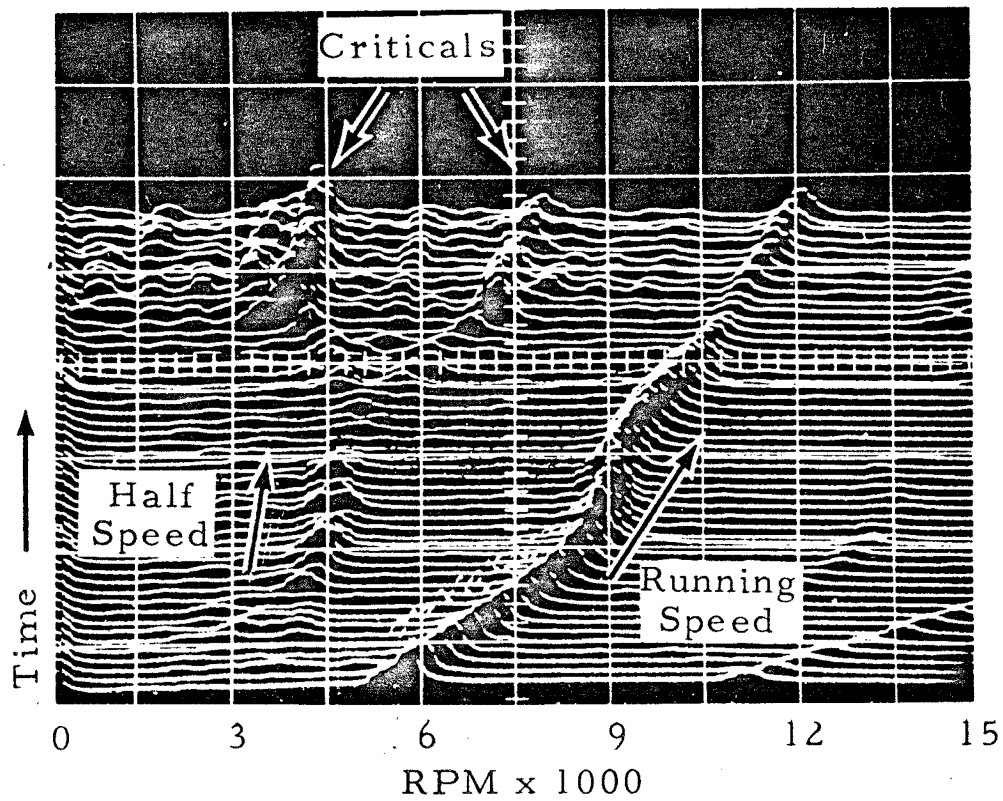
FIGURE 8

Five shoe tilted pad bearings were installed in the turbine in an attempt to eliminate the half speed problems which were discussed earlier. During the turbine startup with the new bearings, a phenomenon occurred which was recorded on tape and later replayed and analyzed. Figure 8

shows that two subharmonic criticals at 4800 and 7000 cpm and a component at approximately one-half speed were excited.

SPECTRAL TIME HISTORY OF TURBINE  
SHOWING SUBHARMONIC VIBRATIONS  
IN NORMAL SPEED RANGE

The exact causes of these subharmonic instabilities were difficult to define. Without proper analysis equipment, the entire sequence would have been virtually undefined. Several positive steps were taken which reduced the magnitude significantly. One was to strengthen the bearing retainer ring. Another was to make the seals nonrotating.

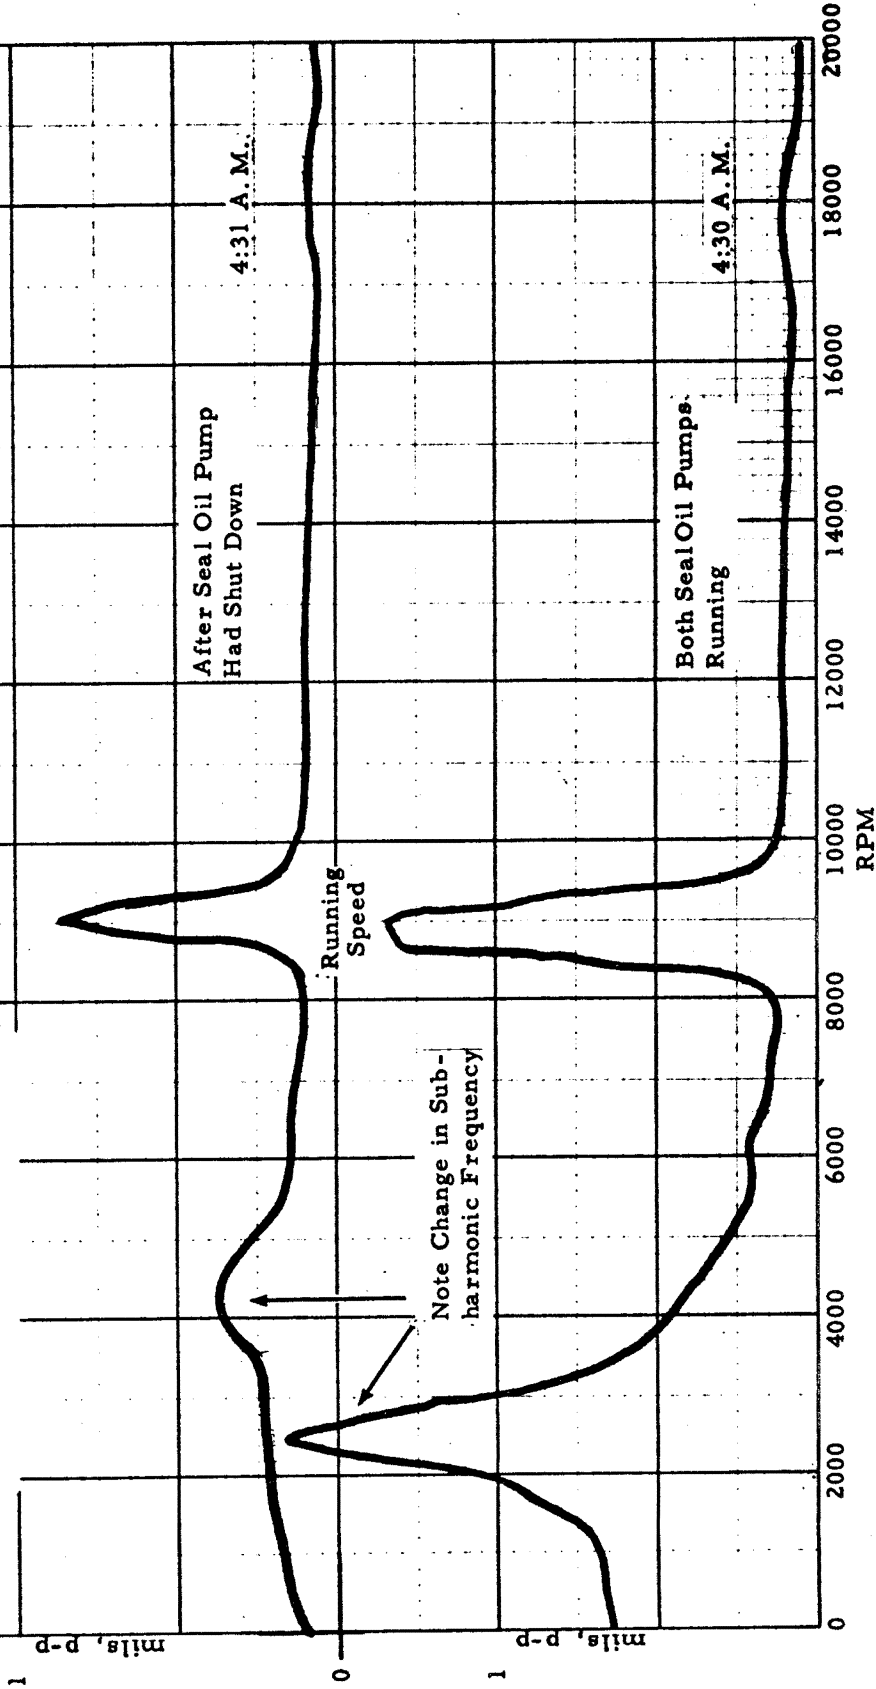
FIGURE 9  
SUBHARMONIC VIBRATIONS  
OF TURBINE

Figure 9 shows that a large amplitude component at approximately 0.3 times the running speed occurred at 2500 cpm when the speed was 9000 rpm. When the speed suddenly dropped 200 rpm, the instantaneous frequency analysis (Figure 9) shows that this moved the subharmonic component from 2500 cpm to 4400 cpm.

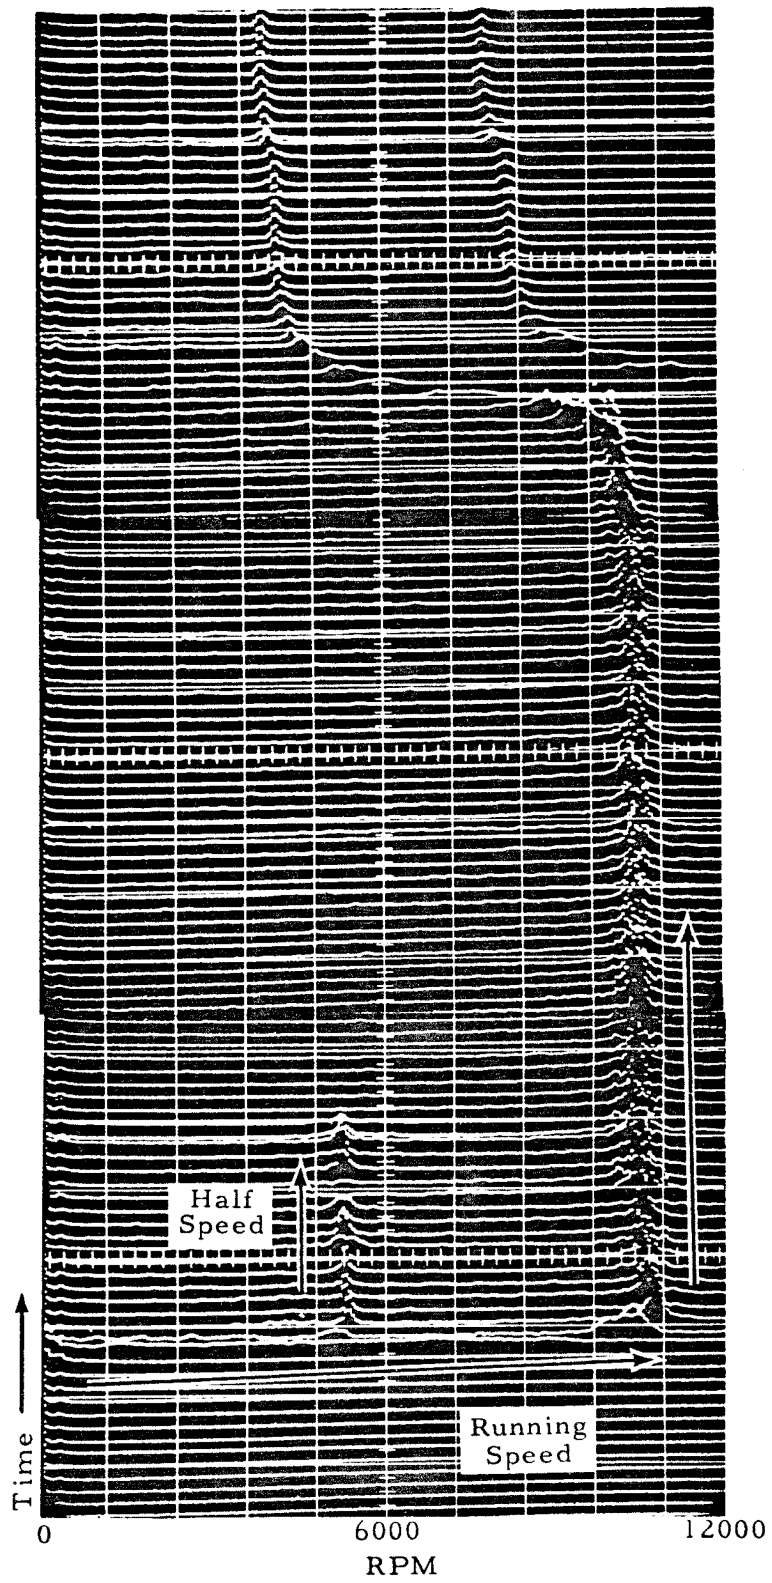
FIGURE 10

After the compressor was coupled up, measurements of the turbine and compressor vibrations showed that total amplitudes did not exceed 1 mil anywhere. The turbine tripped out suddenly while running at 10,500 rpm when seal and governor oil pressure was lost. After a short time, and without warning, the unit came back on and accelerated to 10,600 rpm in 2 seconds as shown in the time history in Figure 10. Vibrations on the turbine and compressor were in excess of 4 mils.

FAST RESTART OF COMPRESSOR  
4 mils/div, 1.28 sec/line

The turbine and compressor were uncoupled and inspected for damage. After needed adjustments were made to control circuits to prevent the valves from sticking fully open, the turbine was soloed again. Vibration amplitudes on the turbine at 10,500 rpm were less than 0.4 mil at all four probes. On the overspeed trip-check, the unit was slowly brought up to the trip speed of 12,700 rpm. Upon trip-out, the speed jumped to 19,600 rpm instantaneously and then dropped. This is documented in Figure 11. Due to the response time of the digital tachometer in the control room it did not indicate any overspeed.

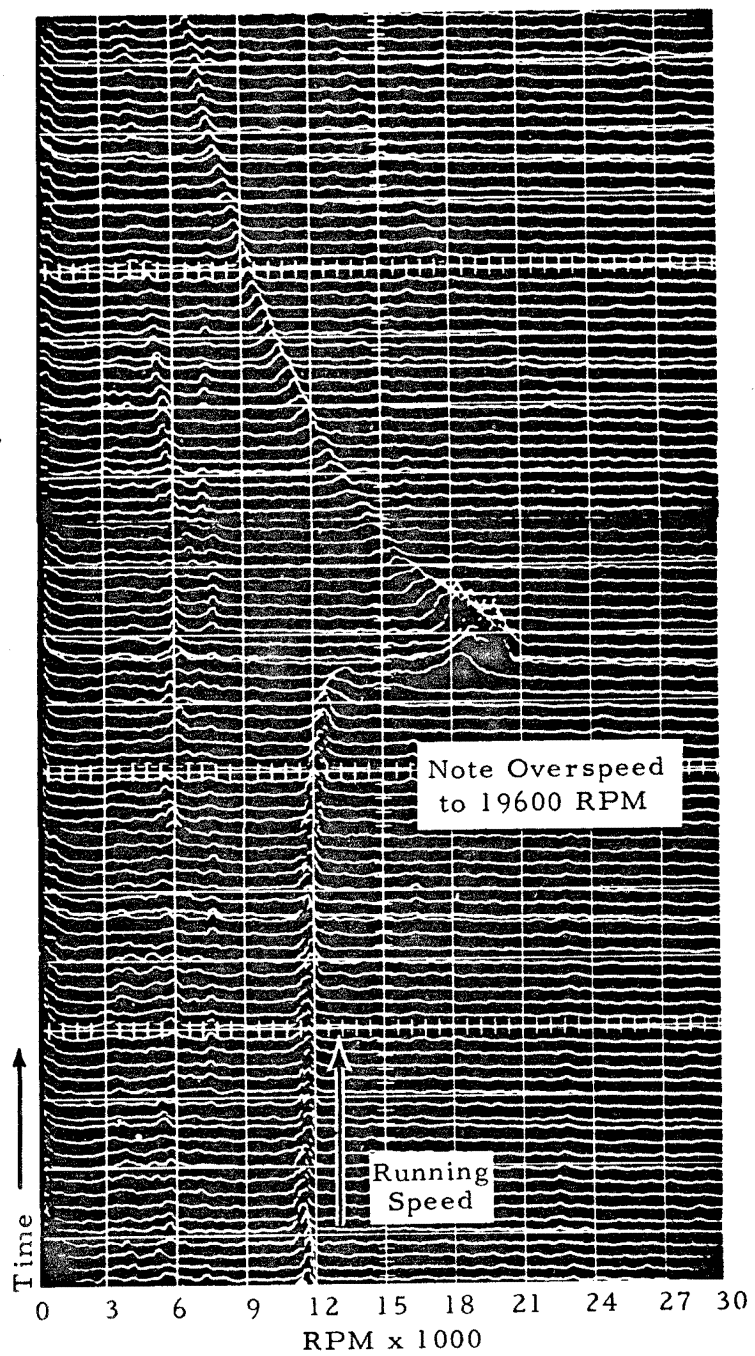
FIGURE 11

SPECTRAL TIME HISTORY OF SPEED  
OVERSHOOT ON TRIP OUT OF TURBINE

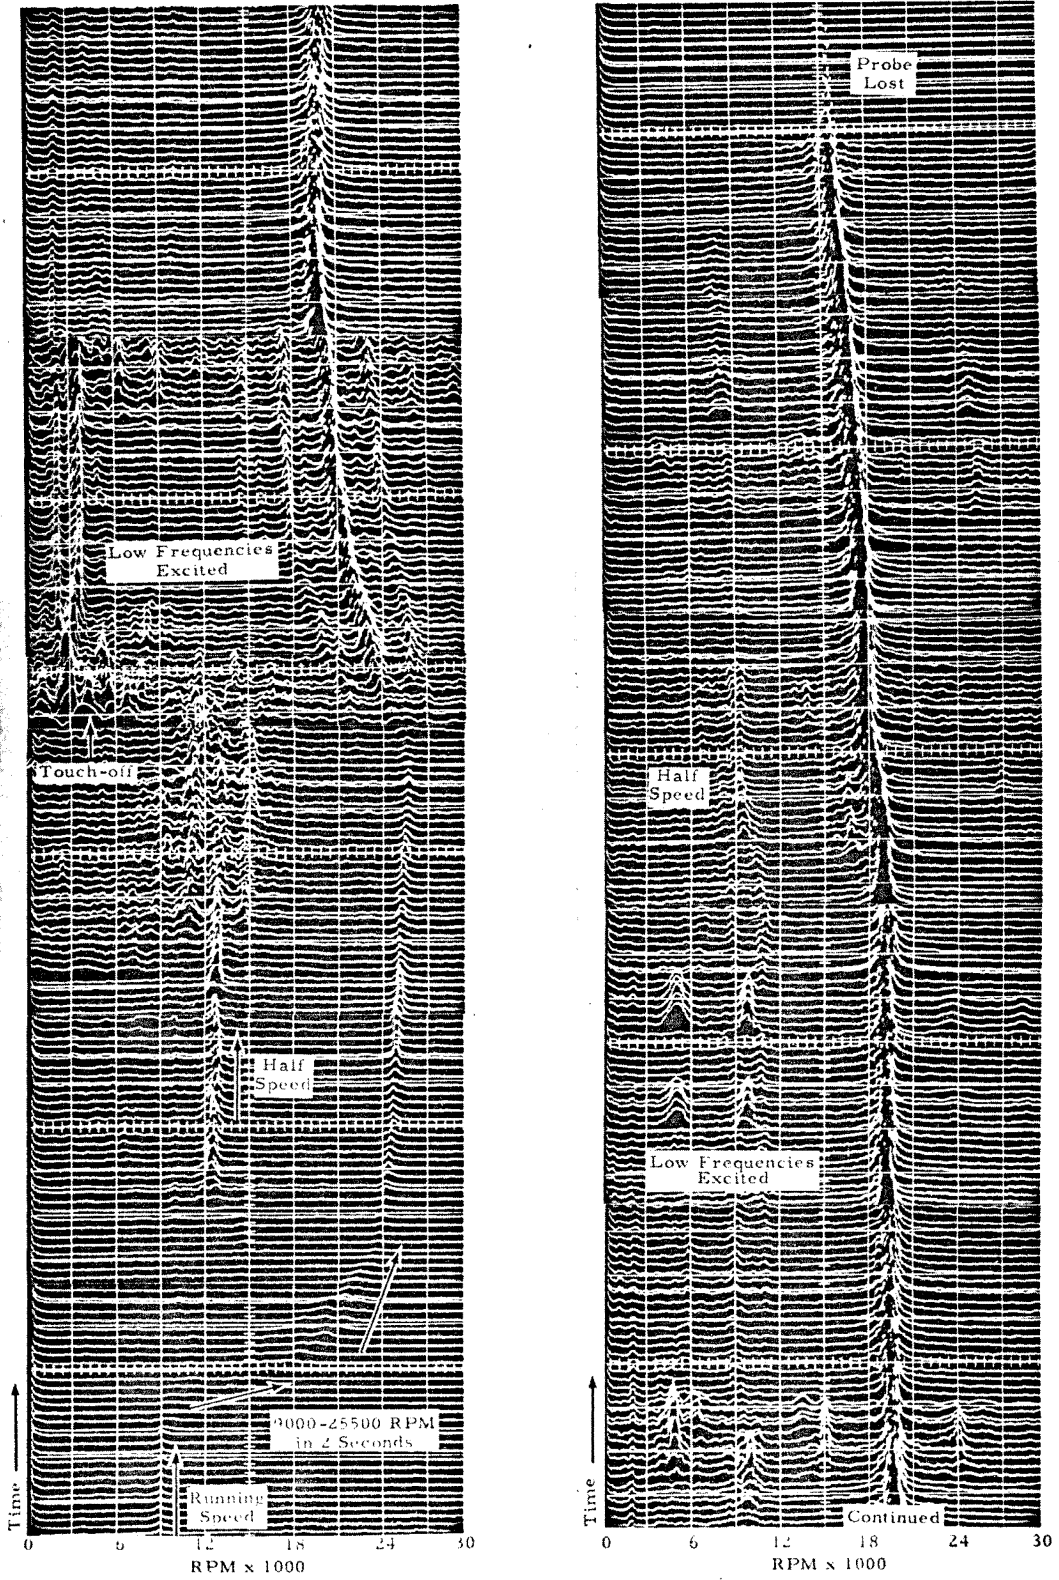
FIGURE 12

than 2 seconds. The overspeed trip did not work and efforts to shut down the machine in the control room were unsuccessful. The thrust collar finally was thrown through the bearing housing, an oil line broke, the oil ignited, and a fire resulted.

These events were being recorded and monitored at the time of the failure and the spectral time history of this failure recorded on the inboard vertical probe is given in Figure 12. Notice that the amplitudes at 25,500 rpm were less than 2 mils for about 3 seconds; however, at approximately one-half speed, 12,750 cpm, the amplitude gradually increased to nearly 4 mils. The shaft then appeared to touch off and excite several low frequencies. The shaft speed decreased to 20,000 rpm and the amplitudes were greater than 12 mils. The speed decreased to 16,000 rpm where the amplitude reached 14 mils, at which time the probe was lost. All these events took place in approximately 30 seconds.

SPECTRAL TIME HISTORY OF OVERSPEED FAILURE

The value of monitoring rotating equipment can be easily understood when one considers the fact that none of the board instruments indicated the overspeed which caused the failure. By analyzing the taped vibration data, the exact sequence of events was documented and therefore, steps could be made to correct the speed control circuitry.
