# Solving Pulsation Induced Vibration Problems in Centrifugal Pumps

BY KEN ATKINS AND JIM TISON - ENGINEERING DYNAMICS, INC.

The root cause of the failures was identified as an acoustic resonance of the pump internals excited by blade pass frequency. The solution was to change the number of impeller vanes, which was relatively simple compared to other options investigated.

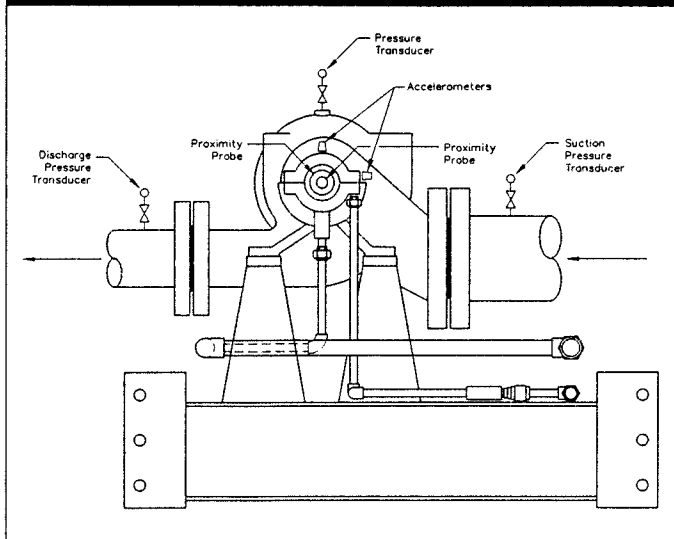
**FIGURE 1: PUMP TEST POINT LOCATIONS**

was made to identify the root cause(s) of the failures. A sketch of the pump is shown in Figure 1. Bearing housing vibration levels were measured using accelerometers, as well as shaft-relative-to-housing vibrations levels using non-contacting proximity probes. Pressure taps were installed in the suction and discharge piping as well as the pump case. Piping vibration and sound pressure level measurements were also made. All of these data were

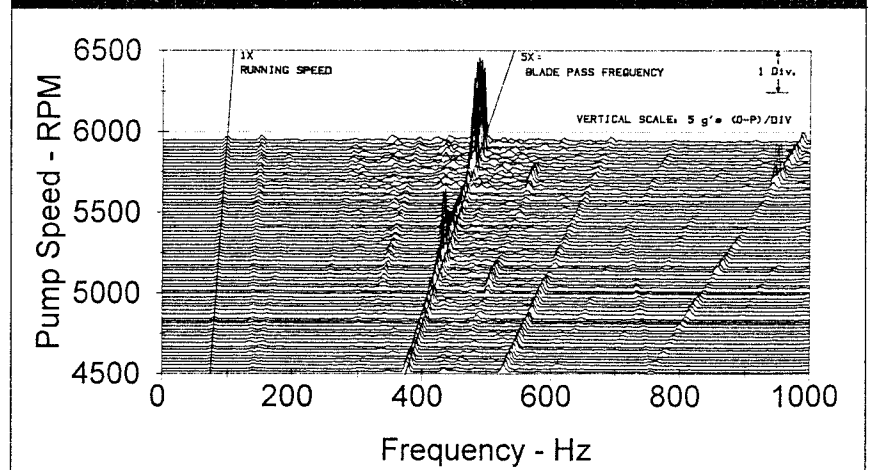
**FIGURE 2: PUMP BEARING HOUSING VIBRATION 4500-5950 RPM**

The bearing housing vibration spectra were plotted versus pump speed in a speed raster (cascade) format as shown in Figure 2. Two resonant frequencies were excited by blade pass frequency (5x running speed) as shown. The noise levels near the pump showed similar spectral content. Initially, it was not known if these frequencies were mechanical natural frequencies or acoustic natural frequencies. The discharge pulsation data indicated that these were acoustic resonances. Impact tests with the pump

shut down verified that mechanical natural frequencies of the pump components (i.e., bearing housings, shaft, etc.) were not involved.

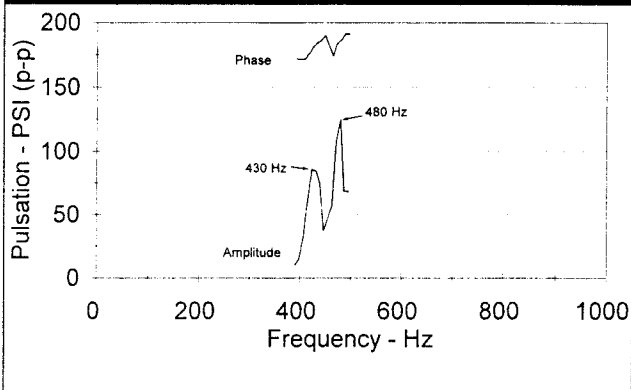
**FIGURE 3: DISCHARGE PULSATION TRACKING 5X PUMP SPEED**

The discharge pulsation data from the same speed run was also processed using a tracking filter to plot amplitude and phase of the 5x running speed vibration versus frequency (Bode plot). This data, shown in Figure 3, clearly identified two response peaks which represented the acoustic natural frequencies of the system. Note that the peak amplitudes for this pump were 90-140 psi (p-p), which was considered excessive in the 550 psig discharge piping. Similar data from other pumps showed pulsation levels in excess of 185 psi (p-p).

The acoustic natural frequencies were similar in all six pumps tested. Two modes were found within the operating speed range. Each pump seemed to have a predominant response peak near 450-480 Hz range that appeared to be independent of the attached piping. Additional resonances in the 250-410 Hz range appeared to be influenced by the attached piping, which varied slightly from pump to pump. The fact that the frequencies were different on some pumps indicated that the attached piping configuration had some influence on these modes, or that some differ-

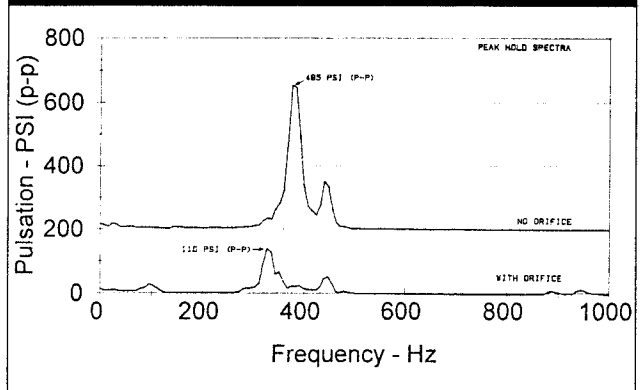
**FIGURE 4: EFFECT OF ORIFICE PLATE ON DISCHARGE PULSATION**

ameter ratio of 2:1 usually results in a noticeable change. A comparison of the discharge pulsation with and without the orifice is shown in Figure 4. The two spectra plotted in Figure 4 are "peak-hold" spectra. This means that the maximum amplitude at each frequency is stored during the chosen sample time. For this plot, the analyzer was

allowed to sample the pulsation data as the speed was varied from 4000-5850 rpm. The data was then repeated with the orifice installed. During the speed range of 4000-5850 rpm (67 to 98% speed), the BPF ranges from 333-488 Hz as noted on Figure 4. The effect of the orifice was to lower the first mode from approximately 380 Hz to 340 Hz and attenuate the amplitude of the 450 Hz mode from 140 psi (p-p) to 50 psi (p-p).

This was a significant improvement in the blade pass frequency pulsation and related vibration. Unfortunately, the restriction in the discharge line caused excessive pressure drop which could not be tolerated for long-term operation. Therefore, it was recommended that the orifice be removed.

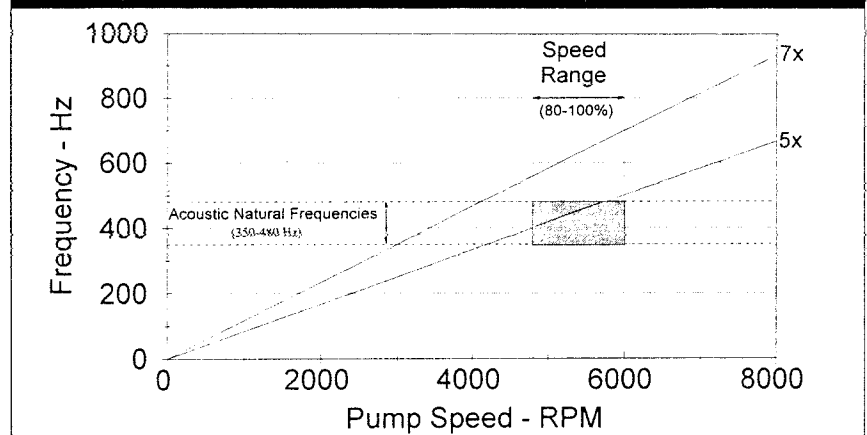
**FIGURE 5: INTERFERENCE DIAGRAM MAIN OIL LINE PUMPS**

An interference diagram was constructed as shown in Figure 5 to evaluate the acoustic resonances. This shows the relationship between the excitation frequencies and the acoustic natural frequencies. The range of acoustic natural frequencies measured was 350 Hz

to 480 Hz and is represented by the horizontal lines in the figure. The desired operating speed from the pumps was 4800 to 6000 rpm and is represented by the vertical lines as noted. The intersections of the horizontal and vertical lines develop the cross-hatched rectangle, which is the area that should be

avoided by any system excitation frequency. The blade pass frequency (5x running speed) excitation is represented by the upward sloping diagonal line in Figure 5. It intersects the cross-hatched area. The blade pass frequency excitation line for a seven-vane impeller (7x running speed) is also shown in

Figure 5. This line does not intersect the cross-hatched area, which indicates that the acoustic natural frequencies would not be excited within the desired operating speed range, if a seven-vane impeller were used.

The pump manufacturer was able to supply seven-vane impellers for the pumps, which resulted in significant reductions in overall vibration and noise levels. The detailed pulsation and vibration tests were not repeated after the seven-vane impellers were in-
