# PUMPS AND SYSTEMS

# Torsional Vibration Linked to Water Pumping System Failure

By Troy Feese

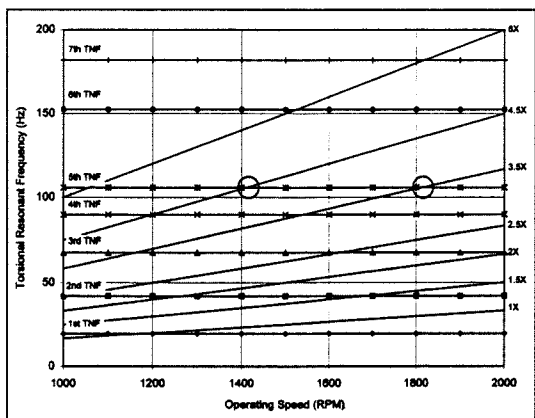
Figure 1. Interference diagram

The torsional analysis indicated that the engine produces significant dynamic torque at 2.5x, 3.5x, 4.5x and 6x running speed. The interference diagram in Figure 1 show the calculated torsional natural frequencies and harmonic speed lines associated with the engine. The intersection points indicate torsional critical speeds. The two circled points in Figure 1 show where the 4.5x and 3.5x engine harmonics intersect the fifth torsional mode - at approximately 1400 and 1800 rpm respectively. The fifth torsional mode was of concern since the shape showed twisting in the input

gear shaft and oscillation at the cooling fan. Also, the engine damper is not as effective for this mode. Steady-state forced calculations were performed to predict the level of torsional vibration versus engine speed. The alternating shear shaft were above the endurance limit of the shaft material. The force analysis also showed that the cooling fan would experience high torsional oscillation.

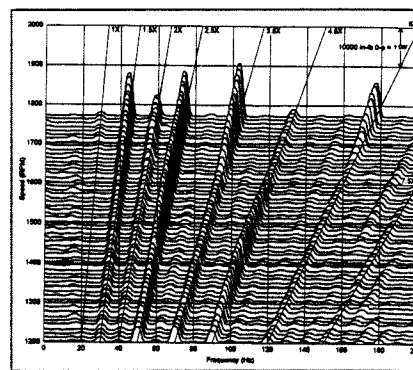
The vibration data were gathered over a two minute period as the engine speed was increased from 1200 to 1800 rpm. During the tests the pump was operated with recirculated water. Speed rasters of the dynamic torque measured in the drive shaft for both configurations are shown in Figures 2a and 2b. The most significant engine harmonics from the speed rasters and the overall dynamic torque (all harmonics combined) are plotted versus engine speed in Figures 3a and 3b. For the original system, the overall dynamic torque in the drive shaft was as much as 56% of the transmitted torque. However, with the rubber coupling installed the overall dynamic torque was reduced to 16% of the transmitted torque. The measured torque data compared favorably with the predicted results from the computer analyses. For example, in Figure 2a the 4.5x engine harmonic passed through a resonance near 1400 rpm, and the amplitude of the 3.5x harmonic increased as the engine speed approached 1800 rpm. The stress levels in the input gear shaft would be reduced by approximately the same amount as the dynamic torque in the drive shaft. The torsional oscillation at the cooling fan was also reduced. Based on the test results, the rubber coupling was recommended as a permanent solution. No failures have been reported since the coupling was installed. ■

Figure 2a. Original system - dynamic torque in drive shaft

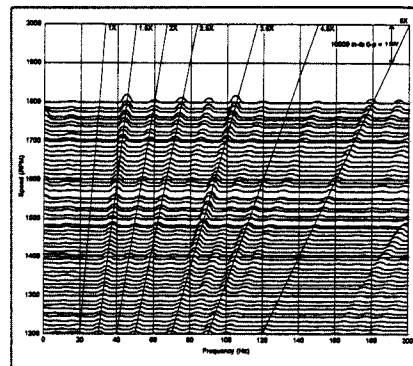
Figure 2b. Modified system with rubber coupling - dynamic torque in drive shaft

Based on the torsional analysis results, the system needed to be modified to reduce the excessive torsional vibration and stress levels. A parametric study was performed. This showed that using a "torsionally soft" coupling between the engine and gearbox would help isolate the engine harmonics from the rest of the system. A coupling with a rubber element in shear was selected that would have a low torsional stiffness (less than 300,000 in-lb/rad) and provide additional damping to the system. Since this coupling bolts directly to the engine flywheel and supports the drive shaft, the system could be easily retrofitted in the field. The analysis indicated that with the rubber coupling the torsional vibration and stress levels in the gear and pump would be significantly reduced compared to the original system.

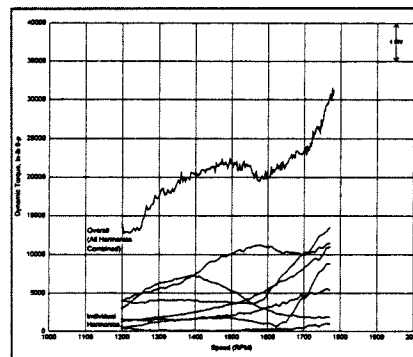
Figure 3a. Original system - dynamic torque in drive shaft

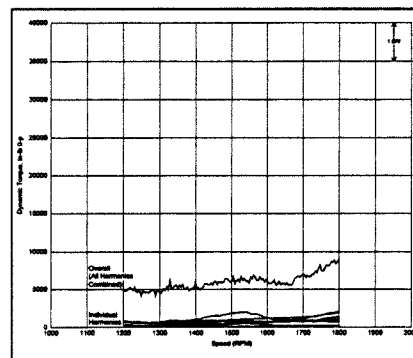
Figure 3b. Modified system with rubber coupling - dynamic torque in drive shaft
