Failure analysis of an MVR (mechanical vapor recompressor) Impeller

ABSTRACT

This article describes the root cause failure analysis of a mechanical vapor recompressor (MVR) impeller used in a dairy processing plant. An impeller blade was thrown during commissioning after approximately 150 h of service. Visual examination of the blade's fracture surface indicated that the crack growth mechanism was fatigue and this was confirmed by scanning electron microscope (SEM) examinations. A detailed investigation was commissioned to determine the source of the oscillatory stresses that must have been present to cause fatigue. A vibration analysis indicated large torsional oscillatory stresses, leading to fatigue, were induced by excitation of the 1st and 2nd torsional vibration modes of the MVR impeller and motor system. The excitation was induced by the control system for the motor variable speed drive (VSD).

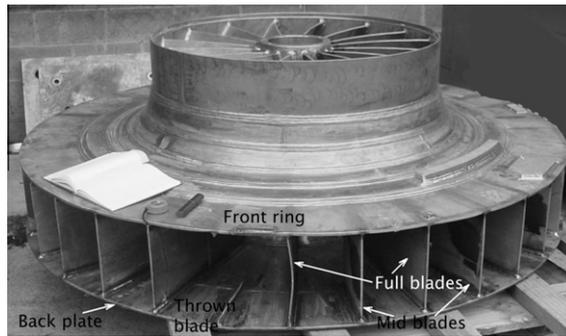
Just prior to failure, the recorded speed was approximately 1950 rpm, or 91% of the maximum speed of 2150 rpm. Catastrophic failure occurred when the impeller threw a mid-blade during commissioning mode, having run for approximately 150 h. A significant imbalance to the impeller resulted in vibrations that induced the impeller to be shut down. Figs. 2 and 3 show the damaged impeller and thrown blade, respectively.

Fig. 2. Failed impeller.

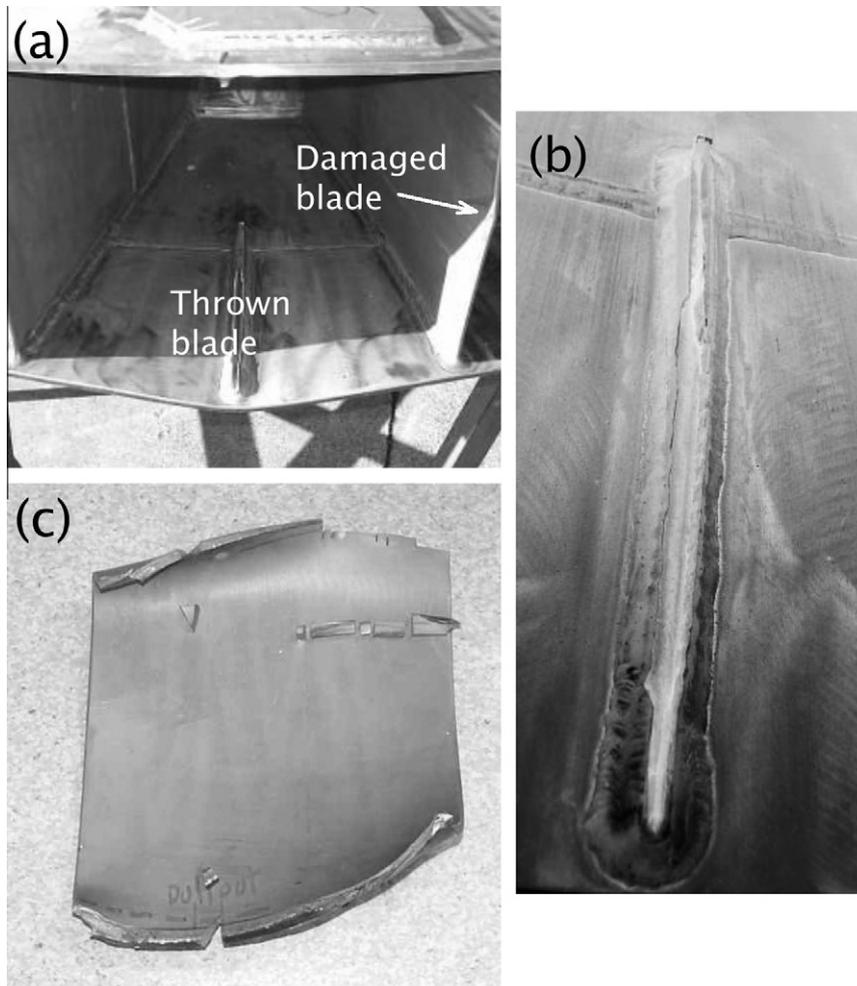
Fig. 3. (a) Original location of the thrown mid-blade and (b) a closer view indicating that there was incomplete fusion on the back plate weld. In (c), the thrown mid-blade is shown as cross-sectioned for subsequent analysis.

Visual examination of the failed MVR impeller indicated that there was a lack of fusion in the thrown mid-blade back plate weld, since the plate had simply pulled out of the weld with little adherence evident. Damage to the adjacent blade shown in Fig. 3 indicates the likely sequence of events:

- (1) mid-blade pulled out of the back plate weld;
- (2) the mid-blade fractured by fatigue along the length of the front ring weld;
- (3) the mid-blade was thrown into the adjacent blade denting it as the mid-blade passed out of the impeller.

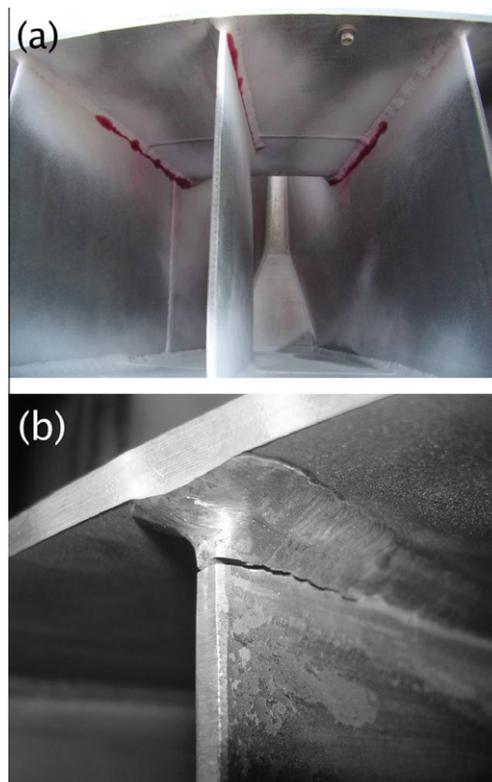
Visual examination and dye penetrant testing revealed crack indications in almost every blade weld (see Fig. 4). Cracks that led to the edge of blades were yawning, which indicates that residual tensile stress was present. A cracked blade was cut away from the impeller and the crack was opened up for examination (Fig. 5). Beach marks were visual indications of fatigue and numerous initiation sites could be seen on either side of the blade. Scanning electron microscopy revealed the presence of fatigue striations on the thrown blade, which is clear evidence that high cycle fatigue was the cracking mechanism.

Fig. 4. (a) Numerous crack indications were found on almost every blade. (b) Cracks leading to edges of blades were yawning.

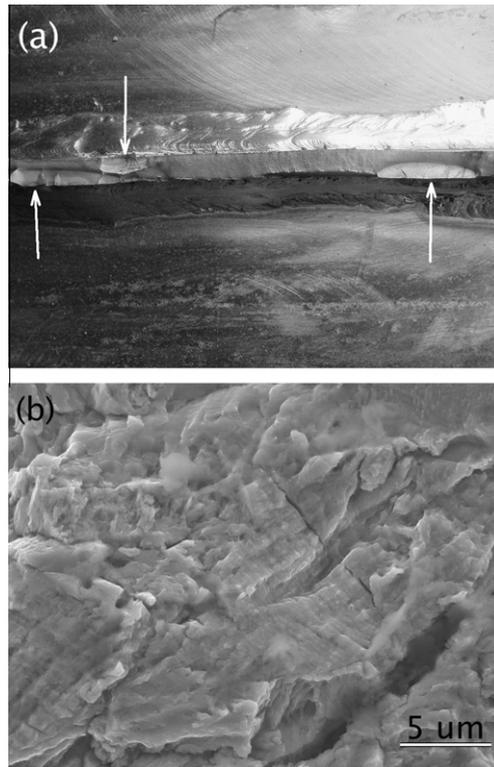
Fig. 5. (a) Opened cracks showed the classic visual appearance of fatigue with many initiation sites on either side of the blade indicated by arrows and (b) Scanning electron microscopy showed fatigue striations on the thrown mid-blade fracture surface.

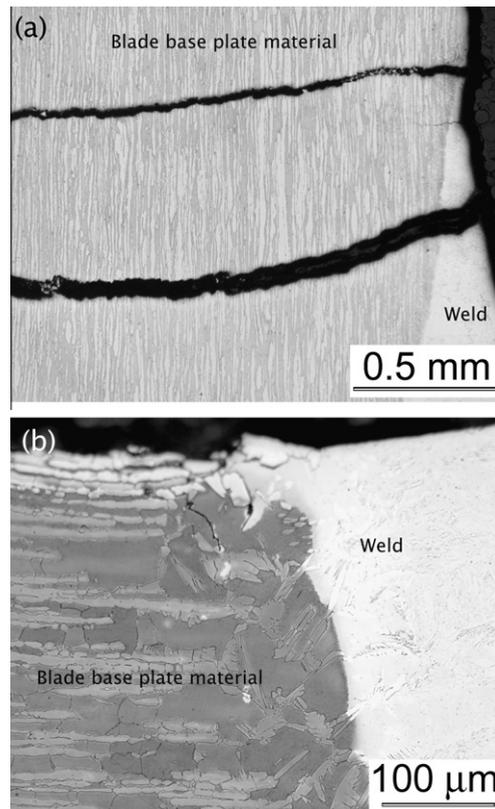
Fig. 6. Metallographic sections of the cracked blades shows that cracks initiate in the vicinity of the toe of the weld metal and the heat-affected zone of the blade base plate.

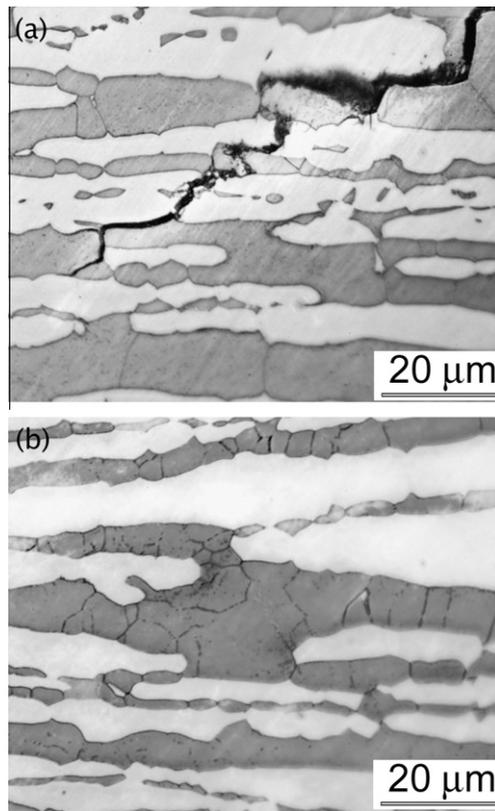
Fig. 7. Cracks preferentially propagate along ferrite (dark phase) grain boundaries and through austenite grains (white). Ferrite grain boundaries may have been embrittled by fine carbide or sigma phase precipitation.

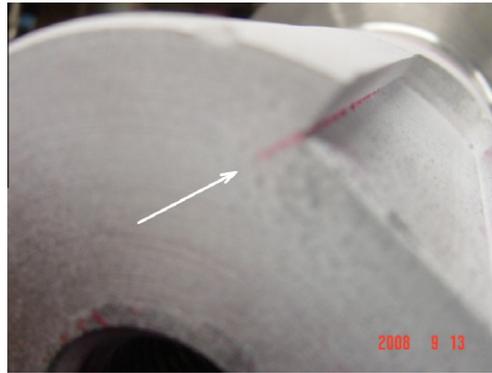
Examination of other components revealed damage to the shaft and coupling bushings. Damaged elastomeric elements are signs of high dynamic torque in the coupling. The shaft exhibited a crack emanating from a keyway oriented at approximately 45° from the shaft surface (Fig. 9), which is typical of failures due to high torsional vibration.

Fig. 9. Impeller shaft keyway with crack revealed by dye penetrant.

1. The motor and fan shafts should have a 2% fillet radius at the base of the keyways to reduce the stress concentration factor from 5 to 3. This is recommended by ASME Standard B17.1 “Keyseats and Keyways”. Square cut keyways have higher stress concentration factor (SCF) than ones with fillet radius [11]. Using an interference fit and eliminating the keyway would further reduce the SCF.

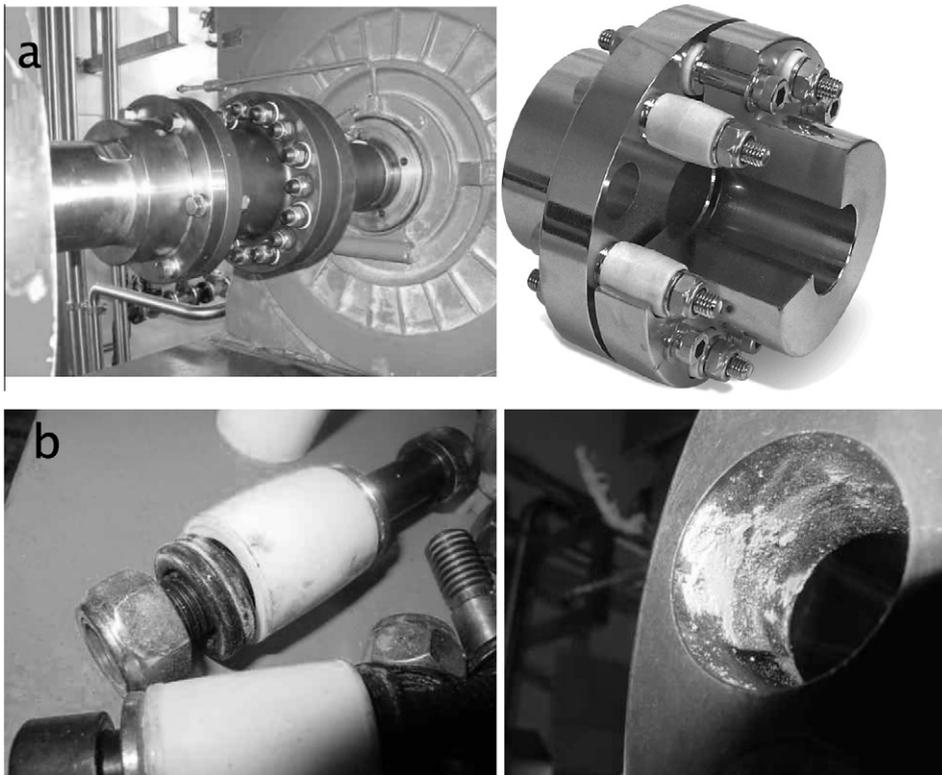
Images of a coupling in place and a cut away to reveal bushings are shown in Fig. 10a. Coupling bushings were heavily worn after service (see Fig. 10b) and were directly observed to be losing material as fine shavings during operation. These two pieces of evidence indicated that there was a significant source of torsional stress that had been unanticipated during design and was previously undetected during operation.

Fig. 10. (a) A shaft coupling in place and a cut-away view showing bushings and (b) worn bushings and wear debris.

2. The rubber elements in the coupling must be periodically inspected for wear. Historically, excessive wear is indicated by white powder collecting inside the coupling guard. Once the bushes start showing increased wear, they should be replaced as part of the regular maintenance program. Excessive misalignment, high ambient temperatures and/or frequent rapid reversing may necessitate more frequent inspections.
3. As mentioned previously, torsional vibration analysis should be considered part of the design process [7]. In the present case, for example, a different coupling could have changed the torsional characteristics of the mechanical system and may have reduced torsional vibration, regardless of the VSD operating mode.

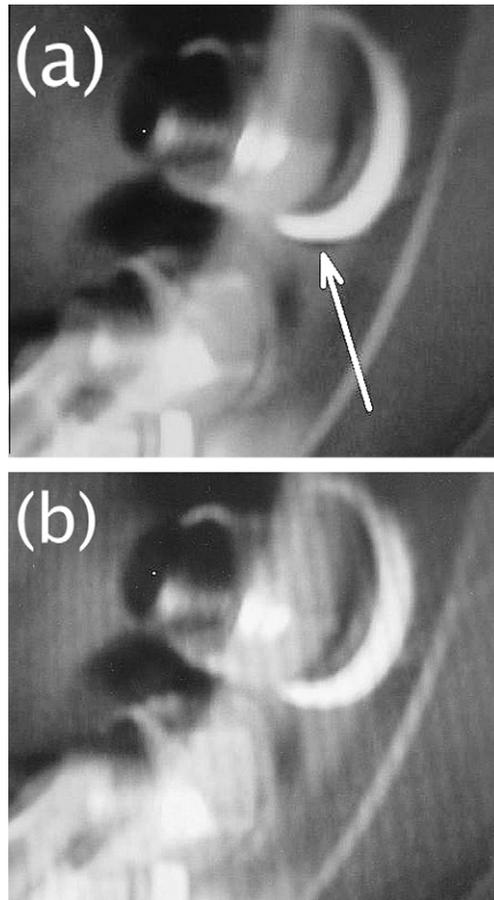
Fig. 11. Two frames from a video recording shows excursions of an elastomer bush. Comparison of the frames shows a gap under the bush in the first frame (indicated by an arrow) not present in the second frame. The gap was measured from the video frames to be approximately 1.7 mm.

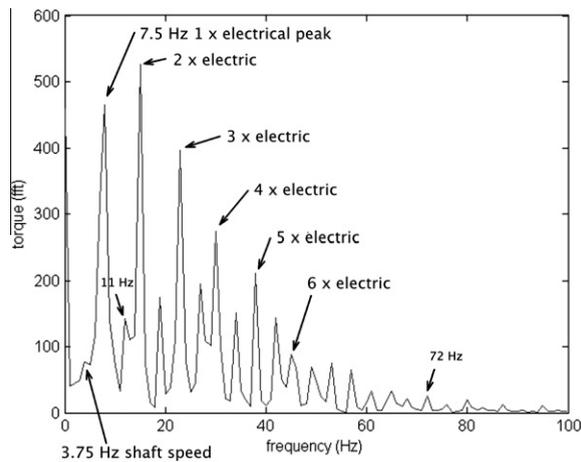
Fig. 12. Fast Fourier Transform plot of torque data for a rotor speed of 225 rpm (3.75 Hz) and controller driving frequency = 7.5 Hz. The shaft was oscillating during this data capture.

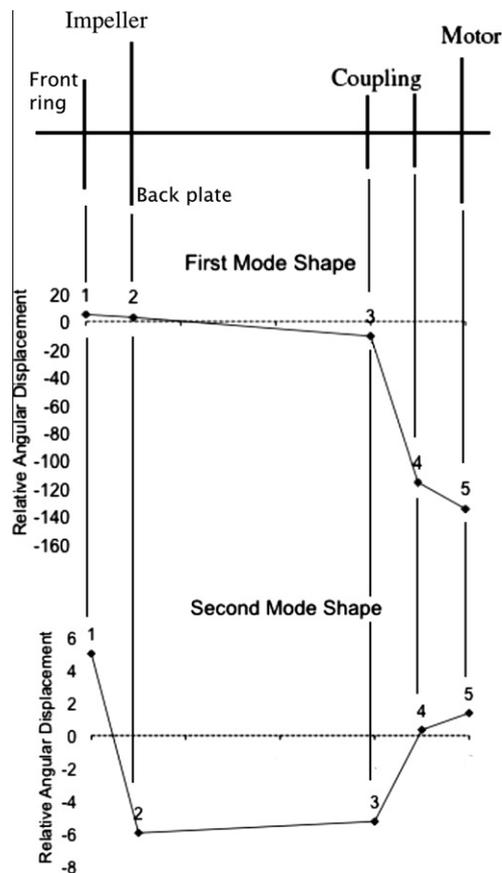
Fig. 13. The first two mode shapes for torsional vibration. These shapes remain relatively constant with coupling stiffness. Note that the scales of the plots are unrelated to each other. Large angular deflections are shown across the coupling in the first mode and across the impeller in the second mode.

first torsional natural frequency would be responsible for causing fatigue cracks in the shaft keyways near the coupling hubs and damaging the coupling rubber elements. The 2nd mode is the one most likely to cause a large oscillatory motion between the impeller front and back plates. The damaging effect of 2nd mode oscillations is by rotating the impeller front ring and back plate to rotate in opposite directions (twisting), which in turn causes large strains at the blade welds.

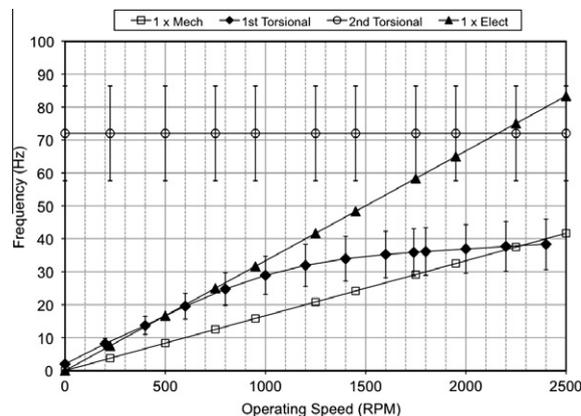
1. It can be seen that there is a close correspondence between the 1x Electric line (triangles) and the 1st torsional mode line (diamonds) from 0 rpm up to about 800 rpm. This would suggest that any time the controller is induced to act assertively in this rpm range (by a PLC request for example) it will deliver pulses at a frequency that virtually corresponds to the first mode natural frequency. This will excite the 1st mode and potentially drive the system unstable. This seems to be what happened during the data capture at 225 rpm.

2. From 1750 rpm upwards, the 1st TNF mode $\pm 20\%$ (indicating the region for design where natural frequencies should be avoided [9]) overlaps with the 1x Mechanical (i.e., shaft speed) and is at risk of being excited by the shaft rotation alone. This has nothing to do with the controller, but is to do with a low coupling stiffness (a higher coupling stiffness would lift the first mode torsional line clear of the 1x Mechanical line).

3. The 1x Electric line (triangles) overlaps with the 2nd torsional mode from about 1800 rpm onwards. This means that if the controller is induced to act assertively in this range (by a PLC request for example) it will deliver pulses at a frequency that correspond to, and excite the 2nd mode directly. The centre of this range is very close to 2150 rpm, maximum running speed for the impeller.

Fig. 14. Campbell diagram. The vertical "error bars" show $\pm 20\%$ the calculated TNFs. Potential resonant condition exists when these bars overlap with the excitation.

8. The present solution to the immediate problem of rapid failure is to use a V/Hz motor controller (open loop), rather than a SVC controller algorithm (with 'virtual feedback'). This avoids significant excitation from the controller and is adequate for the MVR process.

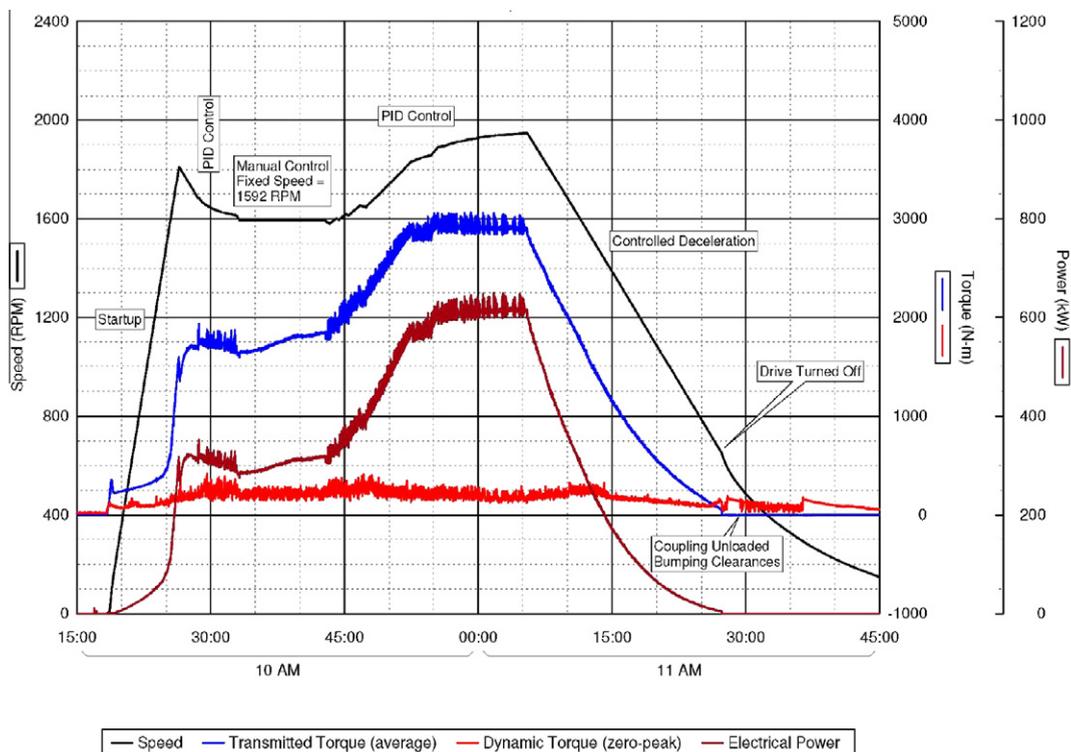
As shown in Fig. 15, the torque and power readings appeared smoother during manual control (fixed speed) compared with automated (power PID) control. For example, PID control increased dynamic torque by 150 N m (zero-peak) compared

Fig. 15. Final field test measurements of torque in fan shaft.

to fixed speed. In any case, the measured dynamic torque was below 1400 N m throughout the entire speed range, which is considered acceptable for the coupling. In addition, the alternating shear stresses were below estimated endurance limit of the shaft material. Therefore, this level of dynamic torque should not be damaging to the system components.

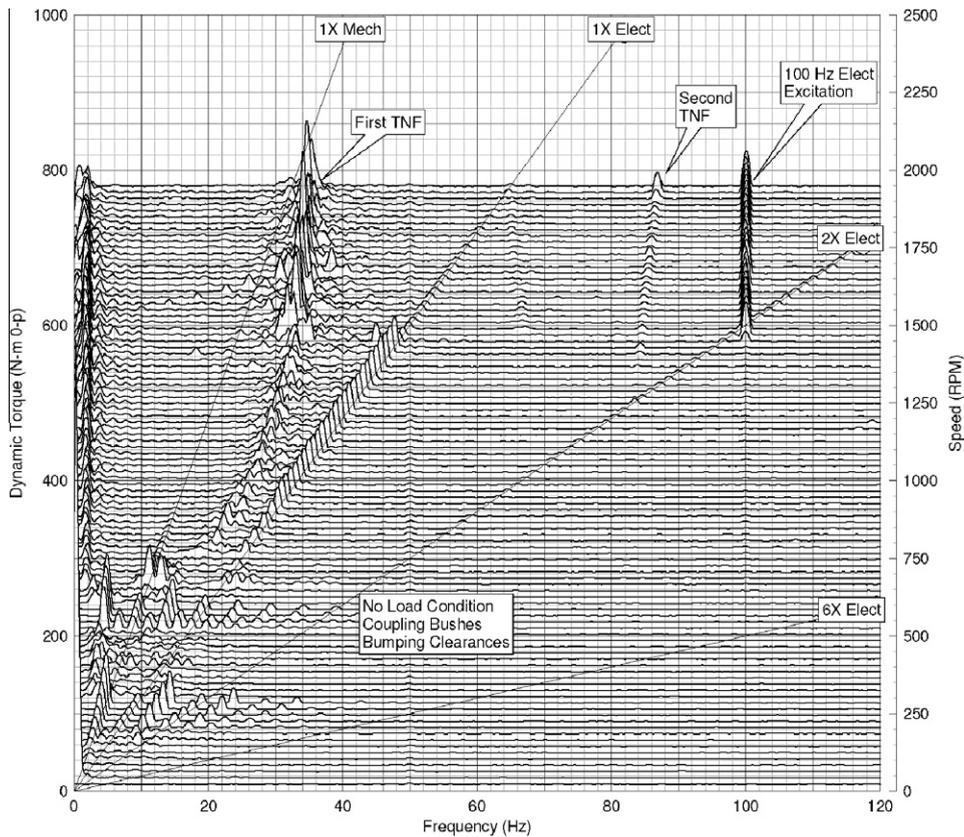
Fig. 16. Waterfall plot taken from torque measurement data.

Waterfall plots were made from the torque measurement to help identify torsional natural frequencies of the system. Fig. 16 shows a waterfall plot of the torque during the powered shutdown. The first TNF, which is associated with twisting through the coupling varied from 20 Hz (at 750 rpm = 12.5 Hz) up to 36 Hz (at the maximum speed of 2115 rpm = 35.25 Hz). The variation in frequency is due to the increased load at higher speeds and the progressive torsional stiffness of the coupling. The second torsional natural frequency of the system, which is associated with twisting through the fan impeller, was found to be approximately 82–88 Hz.
