Axial Thrust Measurement in Vertical Turbine Pump

By Troy Feese and James Clark

Engineering Dynamics Incorporated – San Antonio, Texas, USA

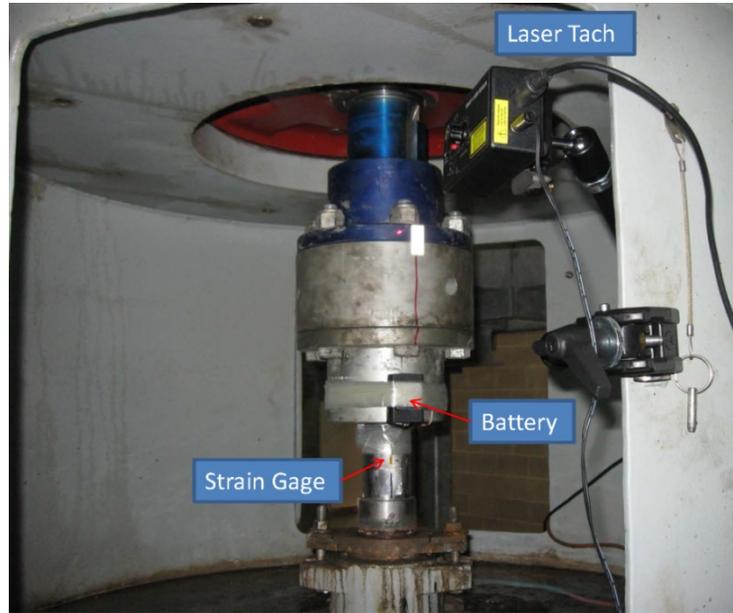
Figure 1

The Binsfeld TT10K telemetry system and single-axis strain gages were installed on the shaft as shown in Figure 1. Calibration was done using hydraulic cylinders and a lifting plate under the coupling hub. The scale factor was experimentally determined based on the slope of the linear fit as shown in Figure 2.

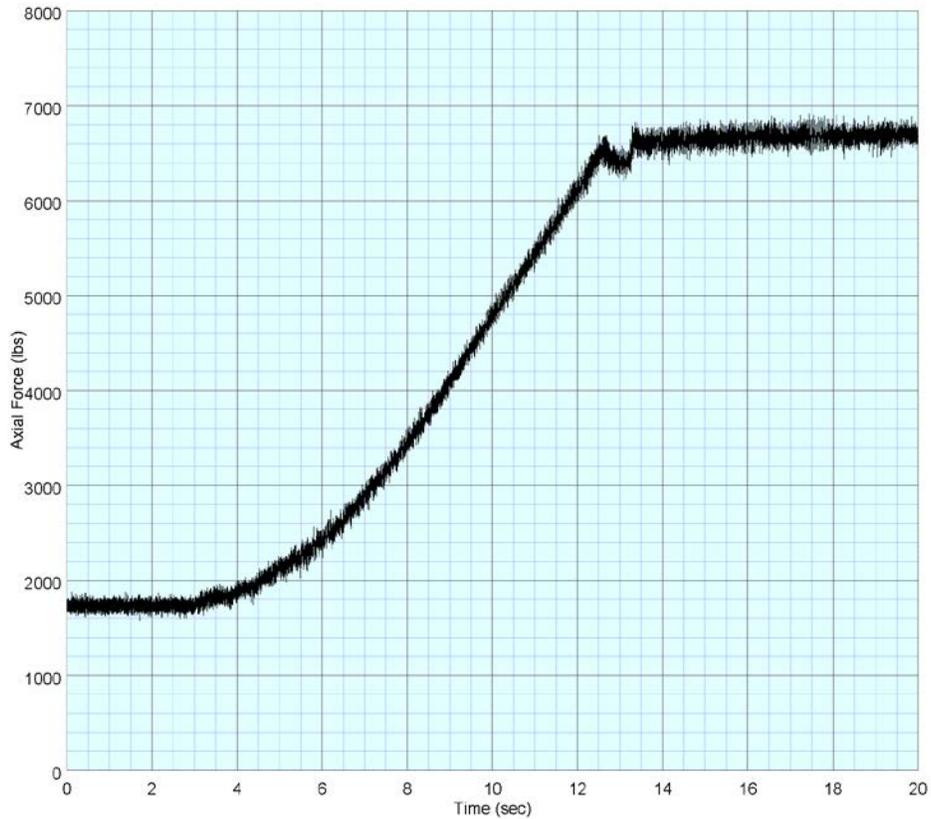
Figure 3

EDI's data acquisition system was used to record all test data. The pump was started and brought to 100% speed. As shown in Figure 3, the axial force started at 1700 lbs (hanging weight of pump) and then increased to 6600 lbs. A positive reading indicates downward axial force. Therefore, no up-thrust condition was observed during startup.
