Motor / ID Fan System for Main Crude Unit at Refinery

By Troy Feese, P.E.
Engineering Dynamics Incorporated, San Antonio, Texas, USA
www.engdyn.com

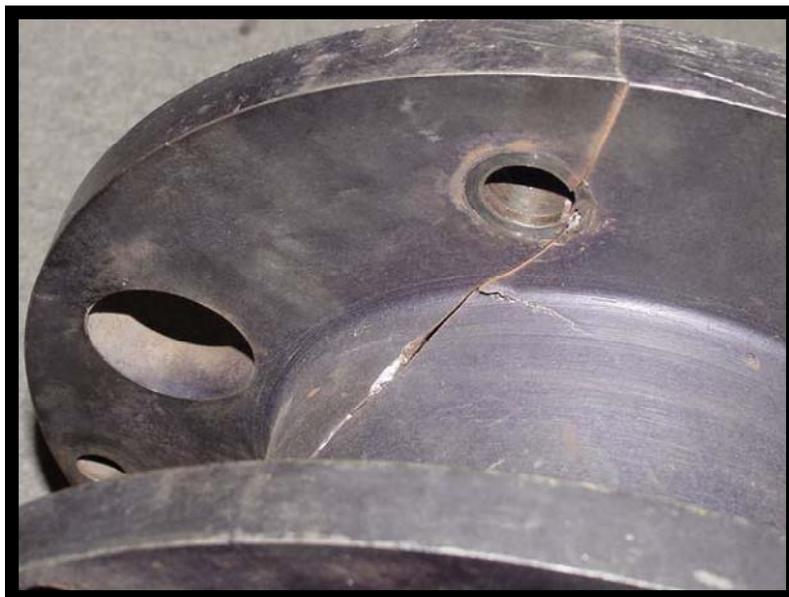
The failure of the original flexible disc coupling consisted of a crack in the spacer, which appeared to originate at a bolt hole. Initially, plant maintenance was blamed for possibly over tightening the coupling bolts. The 45 degree angle of the crack in the coupling spacer is a typical indication of high torsional vibration.

EDI performed a torsional analysis of the system and selected an alternate coupling with standard rubber blocks in compression to detune the TNF away from the 1x electrical frequency of the VFD. The new coupling was installed and the equipment has been working satisfactorily ever since. This case history shows the importance of performing a torsional analysis on a new system or when a system is modified. The TorqueTrak 10K strain gage telemetry system from Binsfeld Engineering was very valuable in collecting data and determining the cause of the original flexible disc coupling failure.

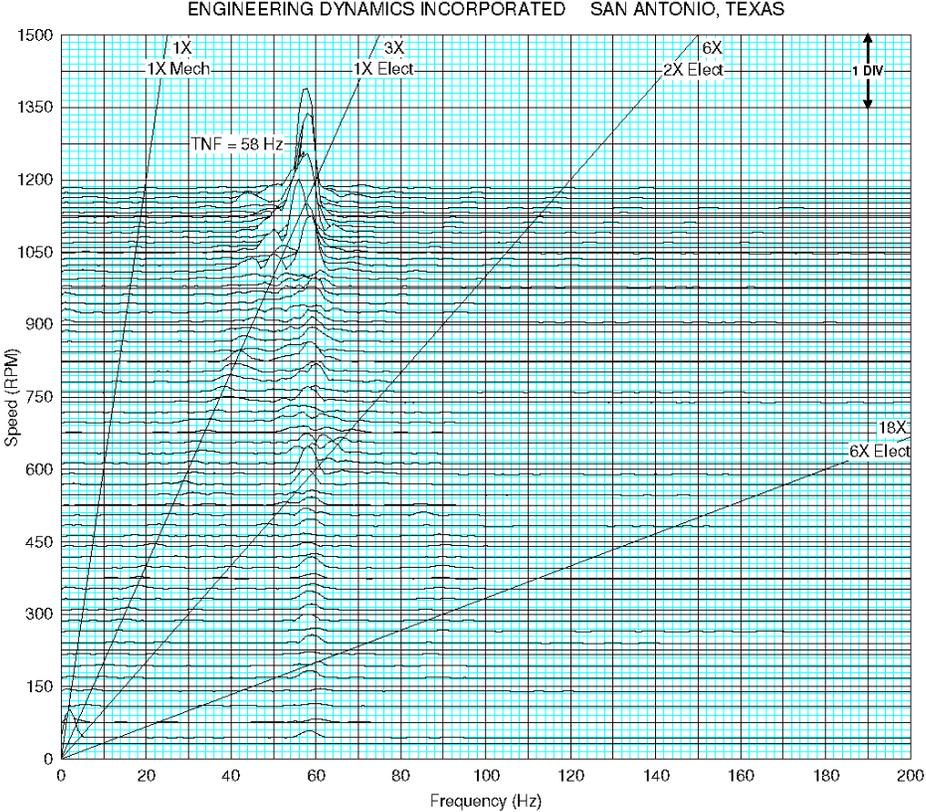
To quantify the transmitted and dynamic torque in the coupling, a TorqueTrak 10K telemetry system from Binsfeld Engineering was used. The waterfall plot below shows a torsional natural frequency (TNF) of the system near 58 Hz, which was being excited by 1x electrical frequency of the VFD. This resulted in high dynamic torque in the coupling when operating the fan at 1000 – 1200 RPM.
