Special Considerations for Electric Motors Driving Reciprocating Compressors

Troy Feese, P.E. - Senior Staff Engineer
Engineering Dynamics Incorporated – San Antonio, TX
and
William (BJ) Schnitzler, P.E. - Electrical Engineer Supervisor
Western Midstream*

Abstract

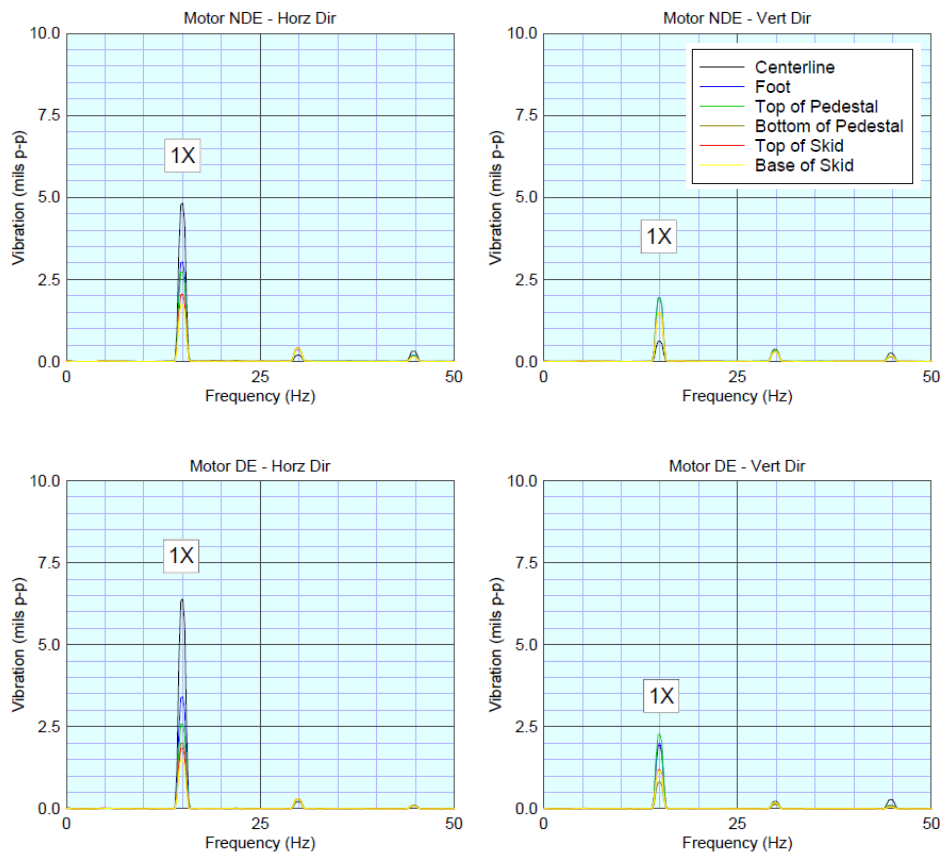
Figure 2. Vibration Measurements Taken on Motor, Pedestal, and Skid

To help diagnose the problem, vibration readings were taken at various elevations on the motor, pedestal, and skid. A profile plot was made that indicated possible rocking motion of the motor frame. Figure 2 shows that the centerline of the drive end (DE) and non-drive end (NDE) bearings had similar vibration levels in the horizontal direction, whereas the motor feet and top of the pedestal had the highest vibration in the vertical direction.

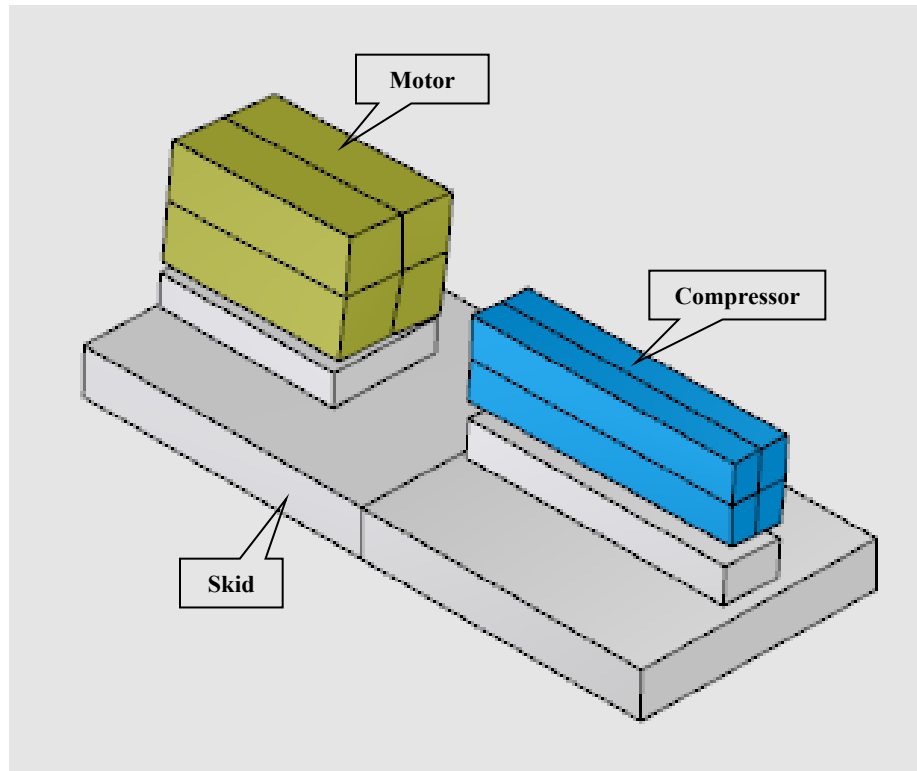
Figure 3. Operating Deflection Shape

To visualize the motion, operating deflection shape (ODS) data were obtained. The overall rocking motion of the motor frame was confirmed at 1× running speed, as seen in the exaggerated shape in Figure 3. There was also differential movement observed between the motor feet and pedestal support.

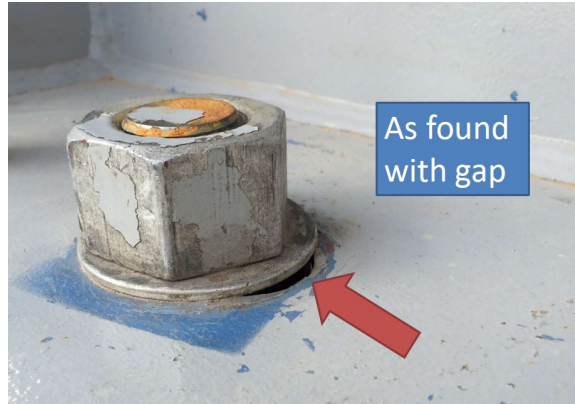
Figure 4. Anchor Bolt at Motor Base

Upon further inspection, it was observed that the anchor bolts for the motor were pulling the top washer through the slot and had reduced torque (see Figure 4). This could allow the differential motion measured with the profile plot and ODS animation.

Thicker washers were fabricated in the field and the torque was increased on the anchor bolts. After these modifications, the indicated vibration on the control panel was reduced to approximately 0.16 – 0.18 ips, and the motor was no longer in alarm condition. Comparison vibration plots measured at the motor centerline are shown in Figure 5.

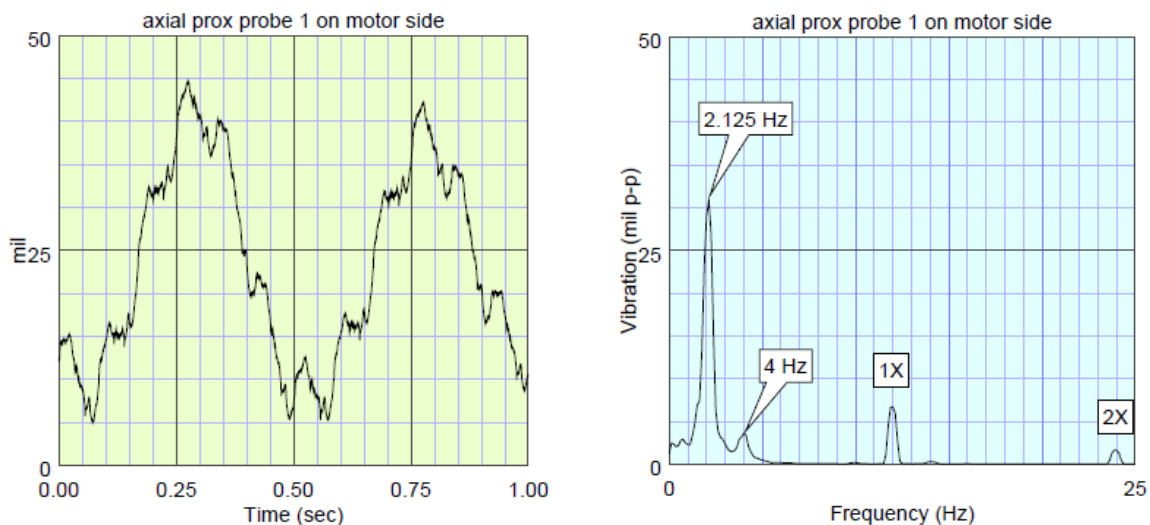
Figure 8. Axial Measurements

The highest axial motion on the motor side of the coupling hub was observed at compressor load steps 13 and 11 and exceeded the probe range of 50 mils peak-to-peak (p-p). Approximately 45 mils p-p was measured in the axial direction at 2.1 Hz. At load step 11, over 50 mils p-p was measured in the axial direction at 2.1 Hz. As shown in Figure 8, sub-synchronous frequencies of 2.1 Hz and 4.0 Hz were observed while operating at compressor load step 7.

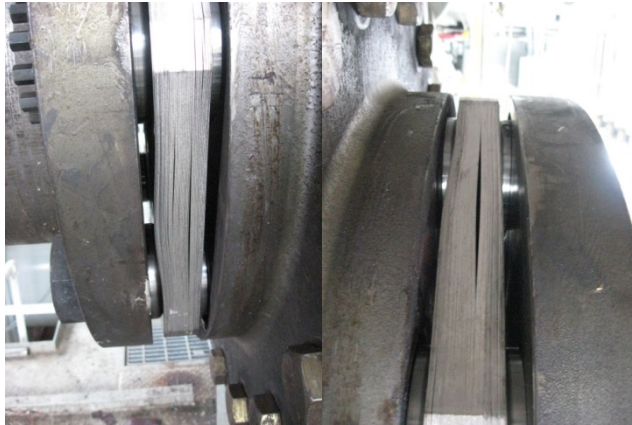
Figure 12. Coupling Disc Packs

Distorted disc packs were found in the new coupling before operation of one of the units, as seen in the photos in Figure 12. This may be caused by improper alignment and/or installation procedure.

Magnetic center was verified for both motors during solo runs. One of the motor shafts moved 5/8 inch during coastdown while the other motor shaft moved 9/16 inch away from compressor. The motor rotors were not repositioned back to the magnetic center marker before re-installing the disc packs, which might have caused distortion.

- Since the couplings in both units were subjected rough operating conditions, inspections of the disc packs were recommended.
- It was recommended to verify alignment on both units. Previous experience of the compressor manufacturer showed that improving axial alignment solved the axial vibration problem.

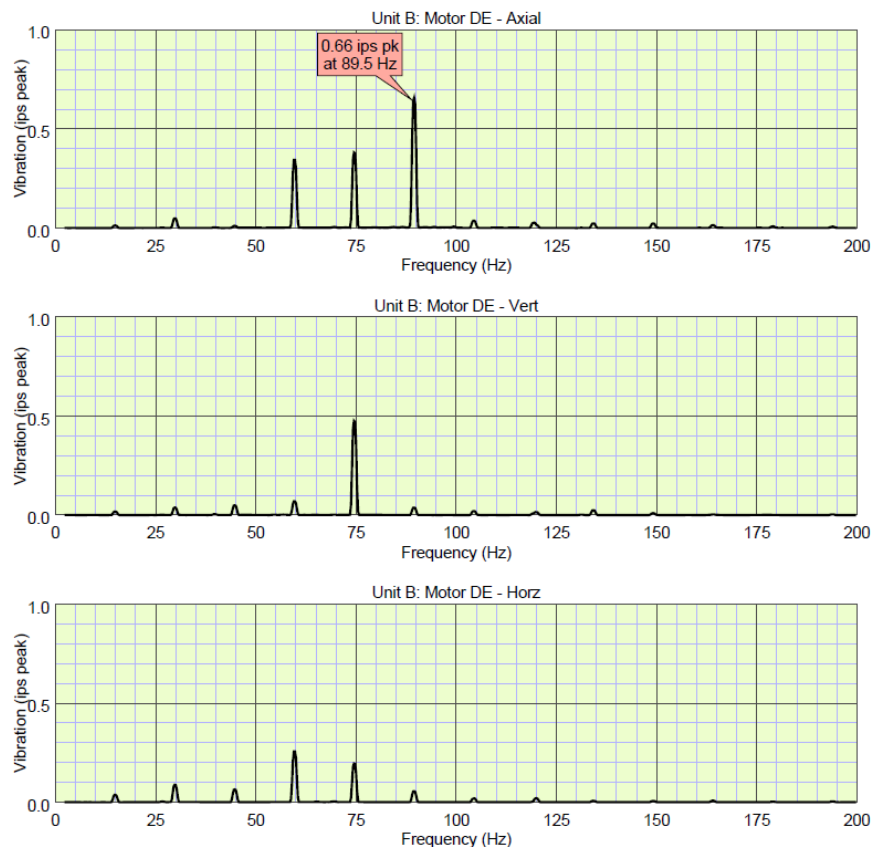
Figure 13. Motor Vibration

A survey of the other units at the plant showed that the bearing housing vibration was similar. It was also reported that another motor at a different location was experiencing a similar problem. The vibration primarily occurred at higher frequencies (5× and 6× running speed) as shown in Figure 13.

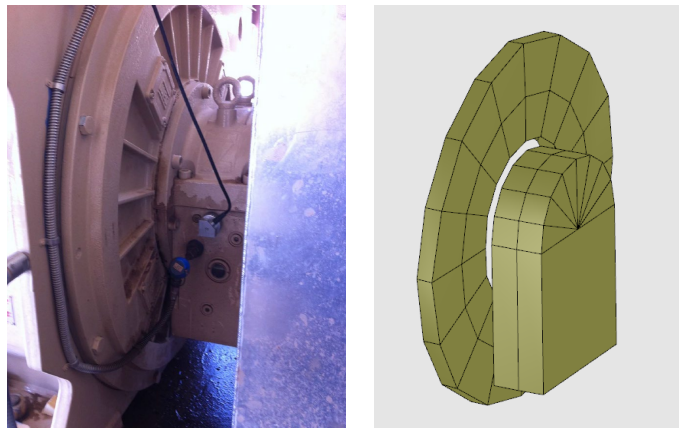
Figure 14. ODS of Motor End Bell

There was concern that the bolts around the end bell could loosen over time. Upon closer inspection, four of the eight bolts around the motor end bell were found to be loose.

After the bolts were tightened, a detailed operating deflection shape (ODS) was performed while the motor was running and coupled to the compressor. Based on this ODS measurement, the end bell is acting as a “drum head” and appeared to be resonant, Figure 14.

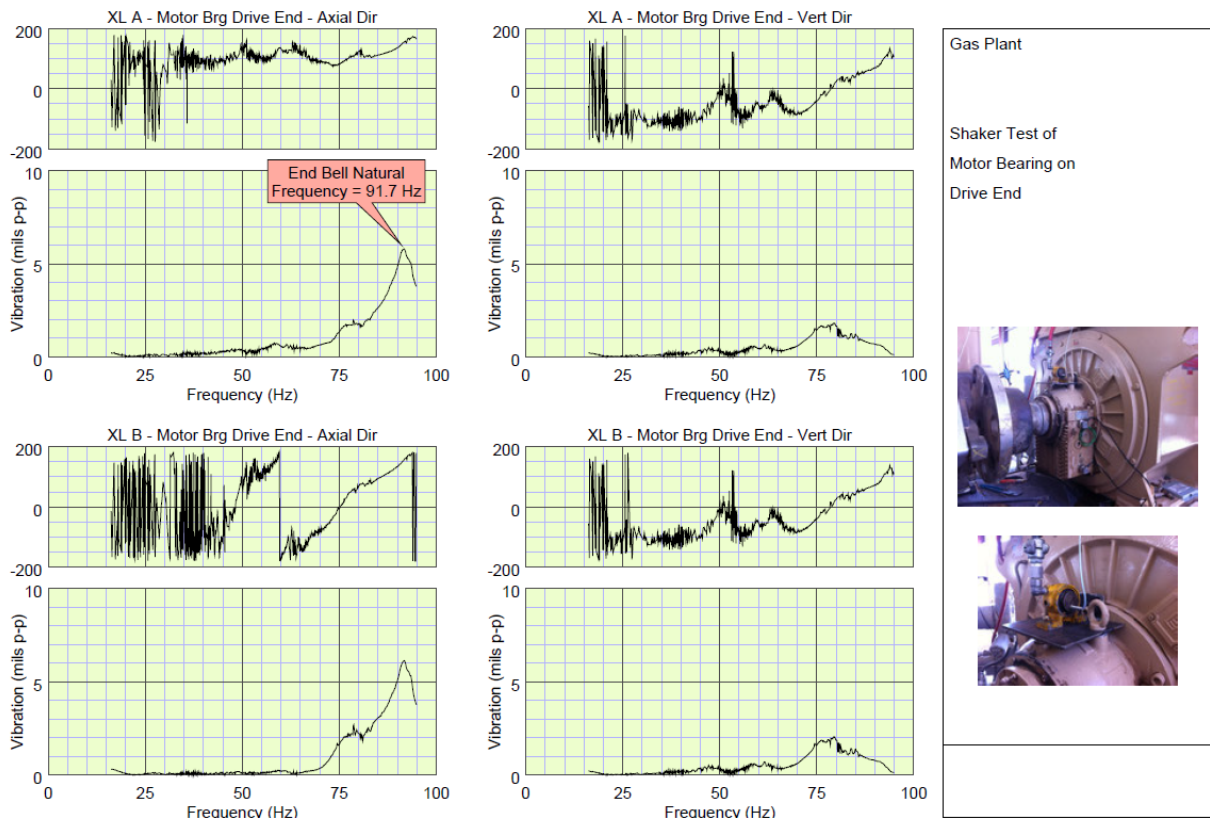
Figure 15. Results of Shaker Test

A shaker test was recommended to confirm the mechanical natural frequency (MNF) of the motor end bells. The shaker has a known imbalance of 0.24 lb-in, which produces a force that varies with speed squared. The shaker speed is controlled by throttling the supply air. The motor was tested while running (rotor on oil film) and decoupled from the compressor. It is important that the motor shaft be on the oil film to correctly measure the MNFs. Baseline vibration was low before starting the shaker test. A natural frequency was found at 91.7 Hz in the axial direction on the drive end (see Figure 15).

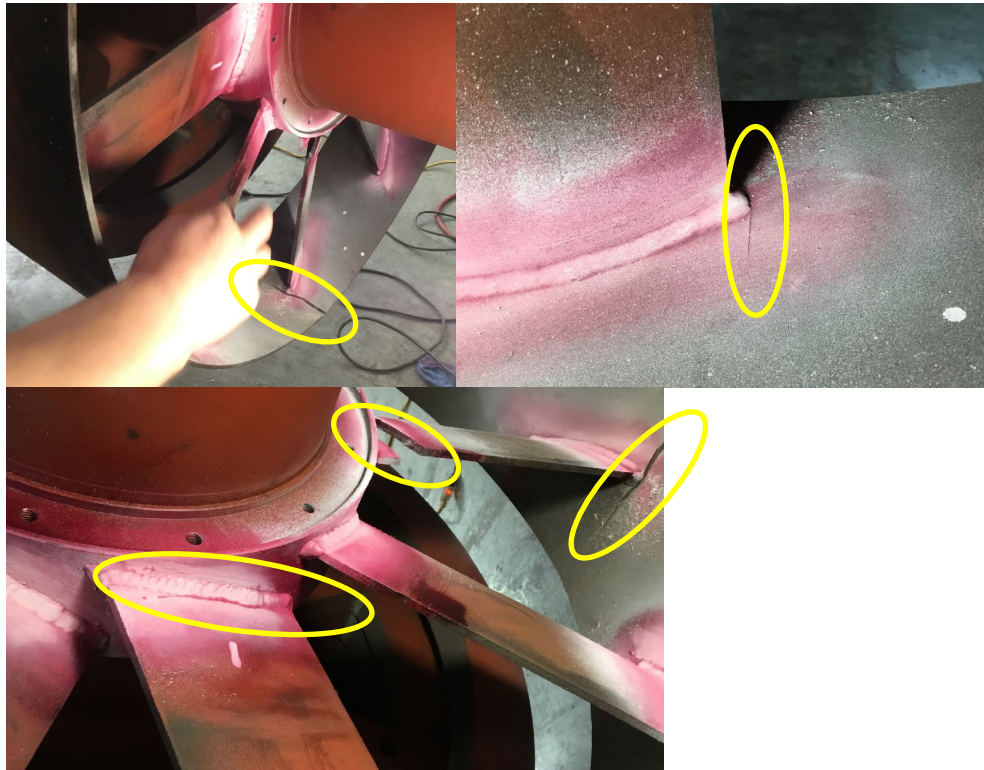
Figure 18. Cracks in Fan

The fan failures are shown in Figure 18. Cracks appeared to start at the welds, which act as a stress riser and then propagate through the blades and shroud. The metallurgical study found fatigue fractures caused by reverse bending. This indicated vibration was likely causing stresses in the fan during operation.

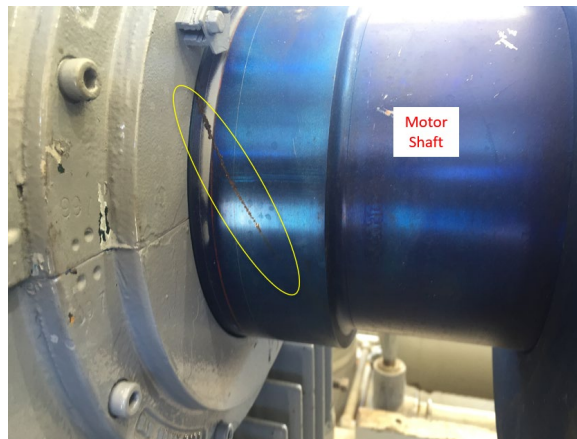
Figure 24. Failed Motor Shaft

The initial concern was high vibration on the motor in the axial direction. When the coupling guard was removed for further testing, a 45-degree crack was noticed on the motor shaft (see Figure 24). This is a classic indication of a torsional fatigue failure.
