## ENGINE CRANKSHAFT FAILURES DUE TO TORSIONAL NATURAL FREQUENCY EXCITED BY DUAL FUEL OPERATION

Troy Feese<sup>\*1</sup> and Greg Beshouri<sup>2</sup>

<sup>1</sup>Engineering Dynamics Incorporated  
San Antonio, Texas, USA

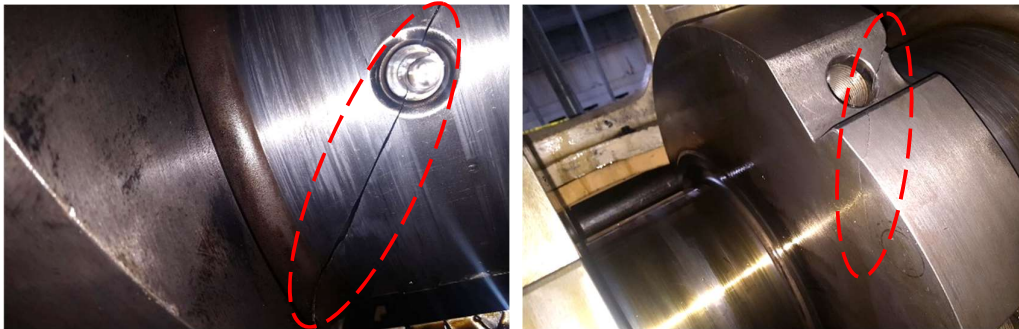
Figure 3. Photos of cracks in engine crankshafts

Prior to DF conversion, the engines had accumulated ~2,000 hours each. Shortly after conversion, the engine crankshaft on Unit B failed after 1,300 hours of operation in the DF mode. The engine crankshaft on Unit A failed after accumulating 8,700 hours of operation in the DF mode. Both failures occurred in the main bearing section of the engine crankshaft between throws 7 and 8 as shown in Figure 3.

A crack occurring at a 45-degree angle to the shaft rotation is typical of a system experiencing high torsional vibration [2]. Cracks will normally start at a stress riser such as oil hole and then propagate through the crankshaft web, etc. The cracks were typical of high-cycle fatigue failure normally associated with ~10 million cycles (~700 hours of operation). While the engines, particularly Unit A, had operated longer than this since conversion, the life in the diesel mode prior to conversion strongly suggested some intermittent operating condition in the dual fuel mode was the root cause of the problem.

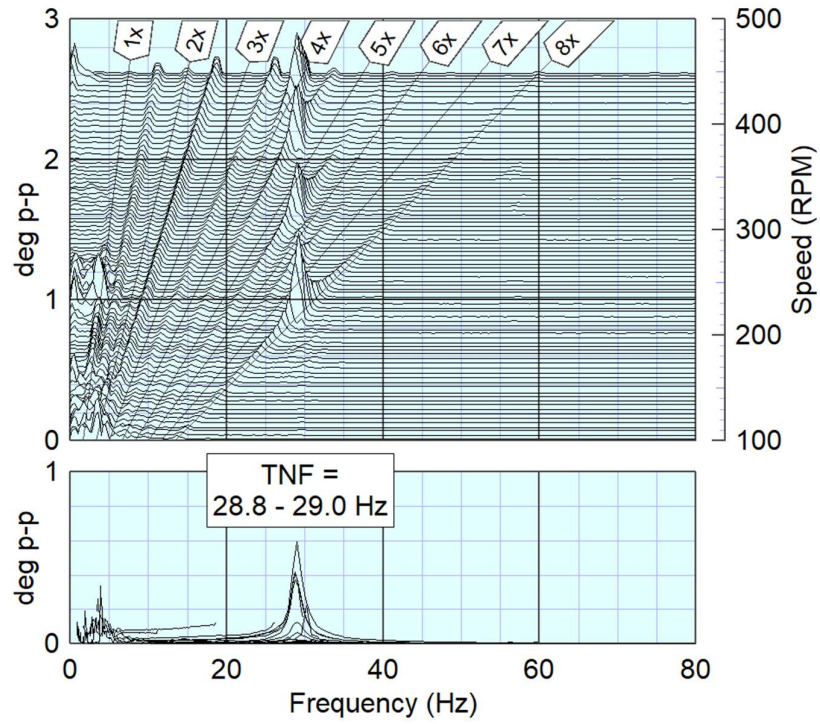
Figure 5. Waterfall plot taken during shutdown

Multiple shutdowns were captured. The ramp rate is slow enough that waterfall plots could be created as shown in Figure 5. By tracking the engine orders, the TNFs could be verified. As shown in Figure 6, the first TNF was 28.8 – 29.0 Hz. The torsional mode had an amplification factor (AF) of 32. Note that this engine crankshaft does not have a torsional damper.

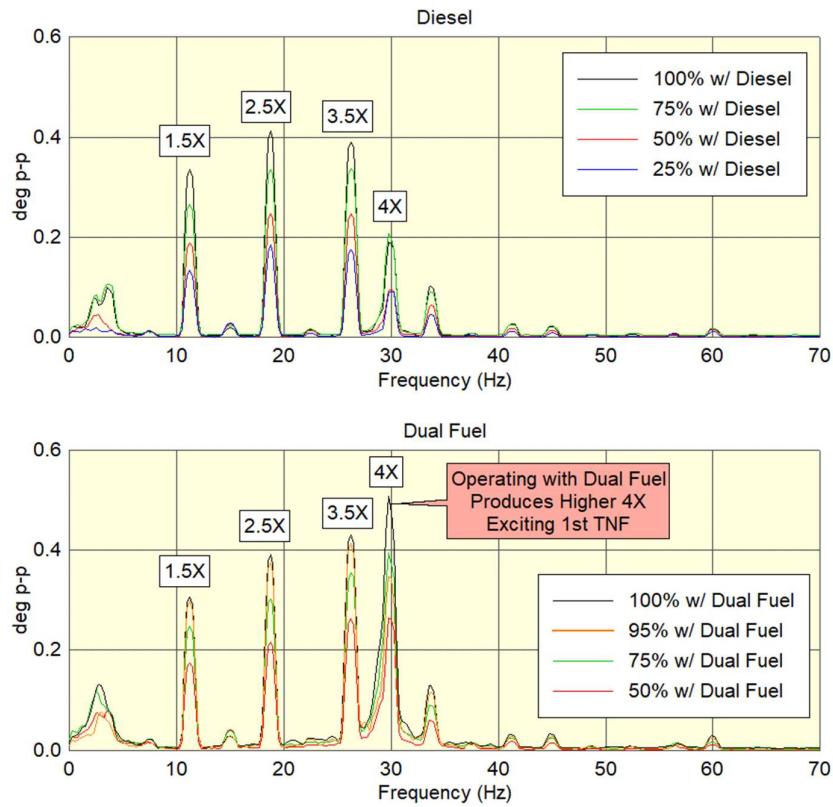
Figure 7. Comparison of torsional response in diesel and dual fuel modes

Therefore, the field test program examined all three aspects in comparison to diesel operation (Figure 7). These test results confirmed that dual fuel operation had the potential to excite the 4<sup>th</sup> engine order for all three reasons.

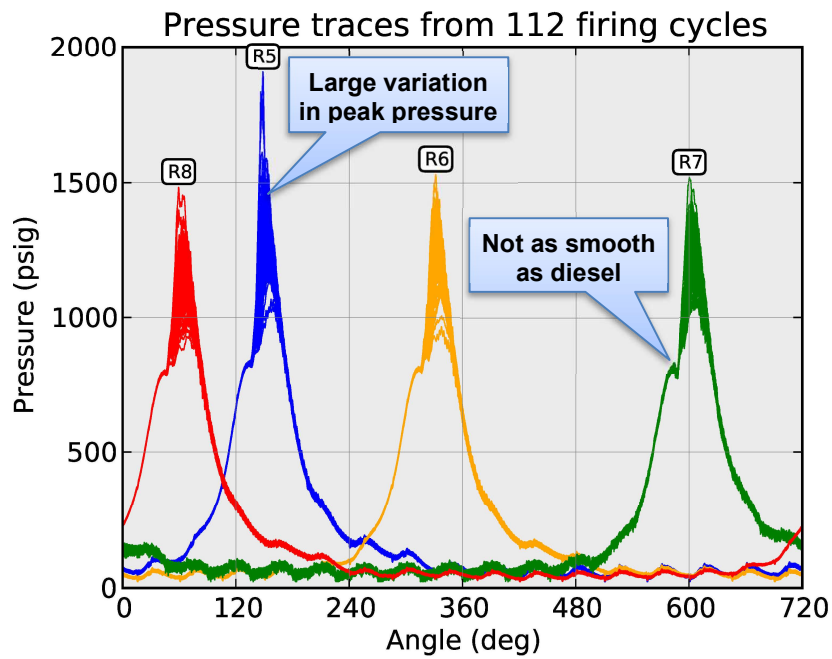
Figure 8. Engine firing cycles with dual fuel operation and 9 mm diesel rack position

Some of these random solutions are little different than diesel operation where others, including misfires and over-pressure cycles, result in double or more the 4<sup>th</sup> order response exceeding the stress level for infinite crankshaft life. Figure 8 shows an example of pressure traces from 112 firing cycles that had cycle-to-cycle instability as well as cylinder-to-cylinder imbalance.

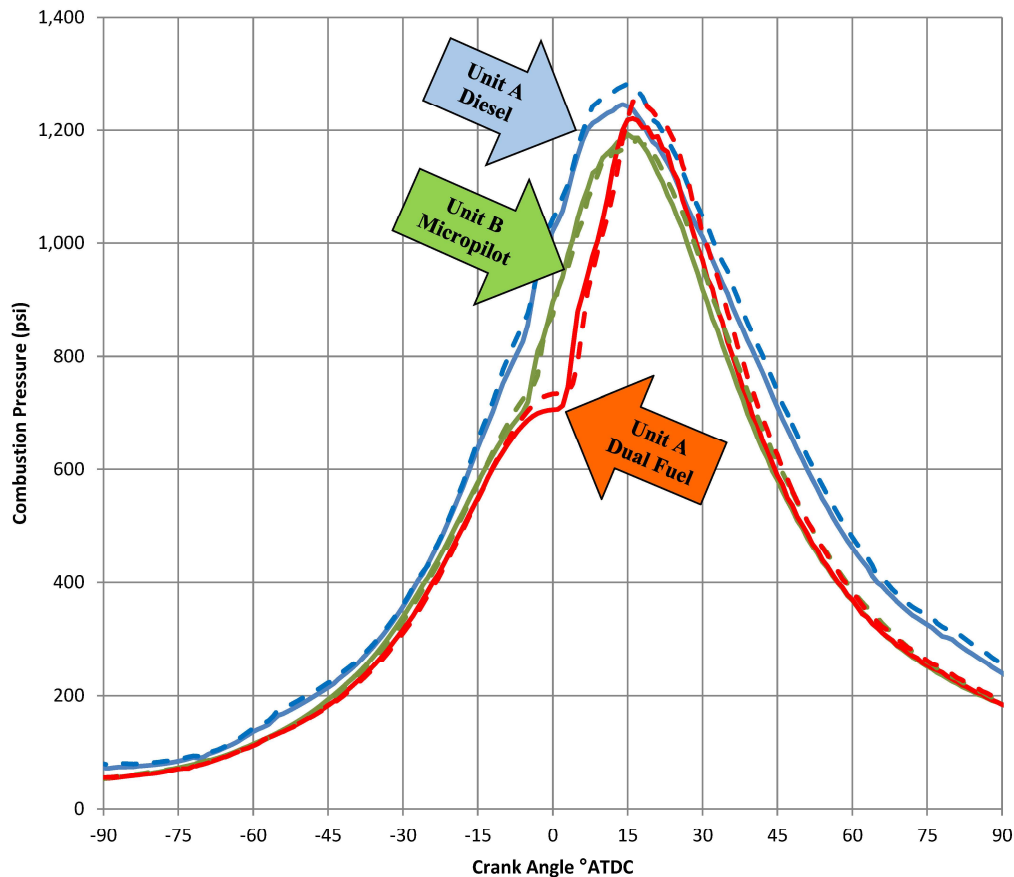
Figure 9. Comparison of pressure traces for diesel, dual fuel, and micropilot combustion

The testing focused on Unit A utilizing a conventional diesel fuel injection system to deliver 5% to 6% pilot fuel. Unit B had been fitted with a dedicated micropilot system delivering 1% to 2% pilot fuel. As reflected in Figure 9, the diesel traces are significantly smoother than operation on dual fuel, which exhibits a relatively rapid rise in combustion pressure at top dead center (TDC).

Although the micropilot system on Unit B exhibited some instability it was generally more stable than the conventional dual fuel. Moreover, the micropilot pressure traces were smoother and closer to the typical shape for diesel [4] eliminating the rapid rate of pressure rise seen with the conventional dual fuel system. While beyond the scope of this work, subsequent analysis indicates this is due to the poor fuel injection consistency and poor fuel preparation of the conventional diesel injection system. While 5% to 6% pilot is injected, less than 1% triggers ignition with the remainder burning in near knock-like combustion near TDC [1] in this case contributing to excitation at the 4<sup>th</sup> engine order.

- a. Install a micropilot system to smooth the dual fuel pressure traces (similar to diesel).
  - b. Continuous pressure monitoring of all engine cylinders.
