HIGH VIBRATION OF INTEGRALLY GEARED COMPRESSOR DUE TO VARIABLE FREQUENCY DRIVE

Tim Robertson¹ and Troy Feese, P.E.²

Abstract

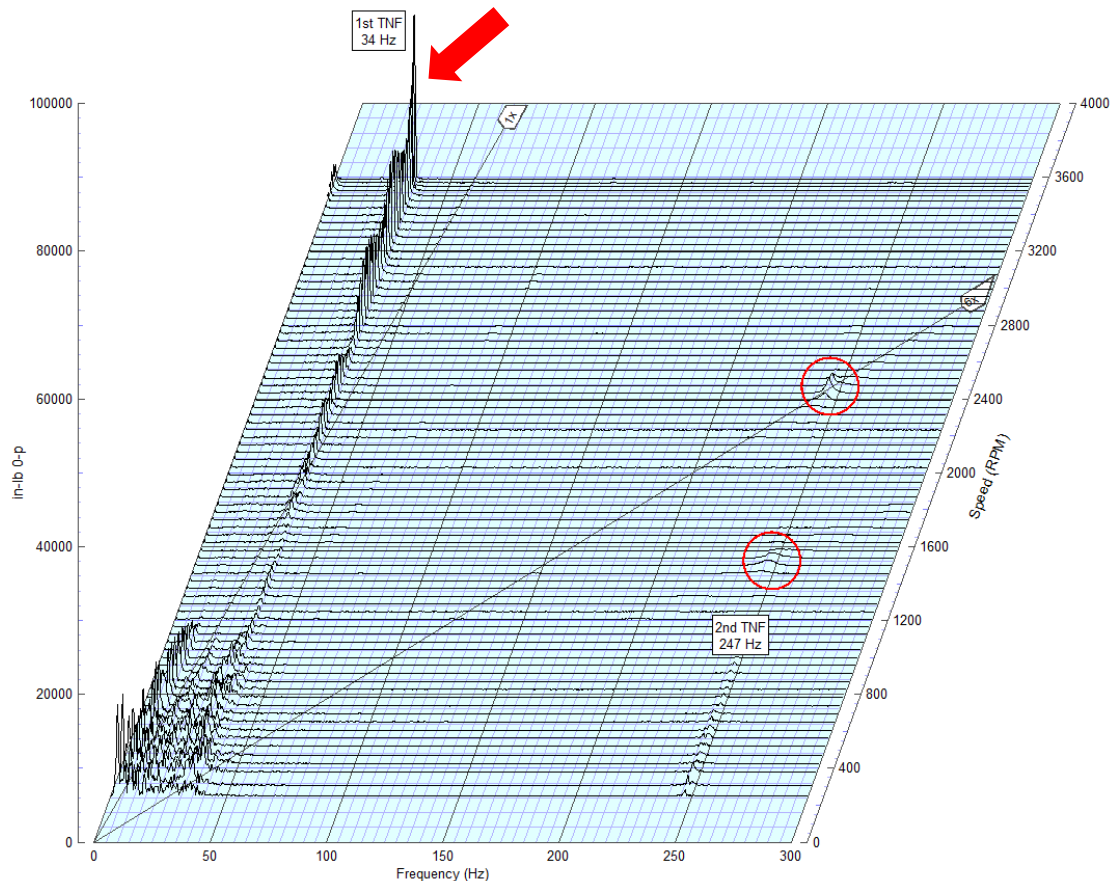
Figure 4 shows the waterfall plot of the measured alternating torque during startup. The first TNF was 34 Hz, which agreed with the predicted value. The second TNF was found at 247 Hz. Note that even when the electrical drive frequency was well above 34 Hz, the first TNF was still being excited, which is indicative of unstable VFD operation.

Figure 4 – Waterfall Plot of Alternating Torque During Startup

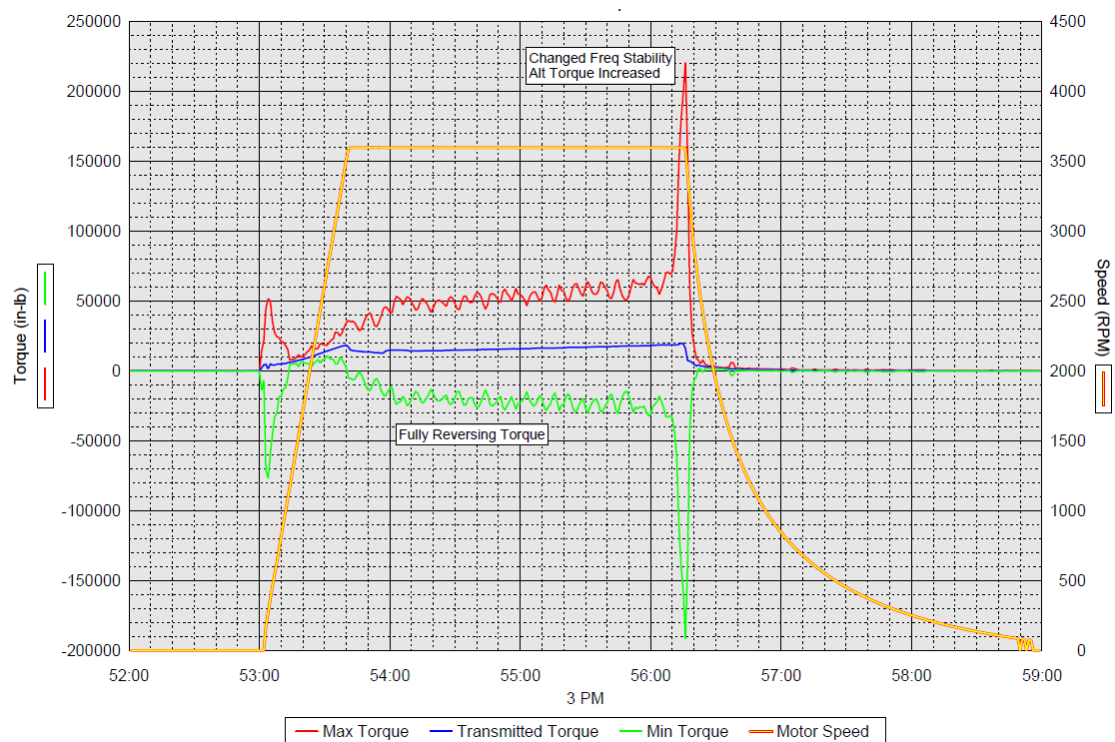
Figure 5 shows the trend plot of torque while the frequency stability setting was adjusted (VF_DVCMP_A to 1000). Note that the alternating torque increased dramatically indicating the sensitivity of this system to the drive parameters previously discussed.

Figure 5 – Trend Plot of Measured Torque in Motor Shaft

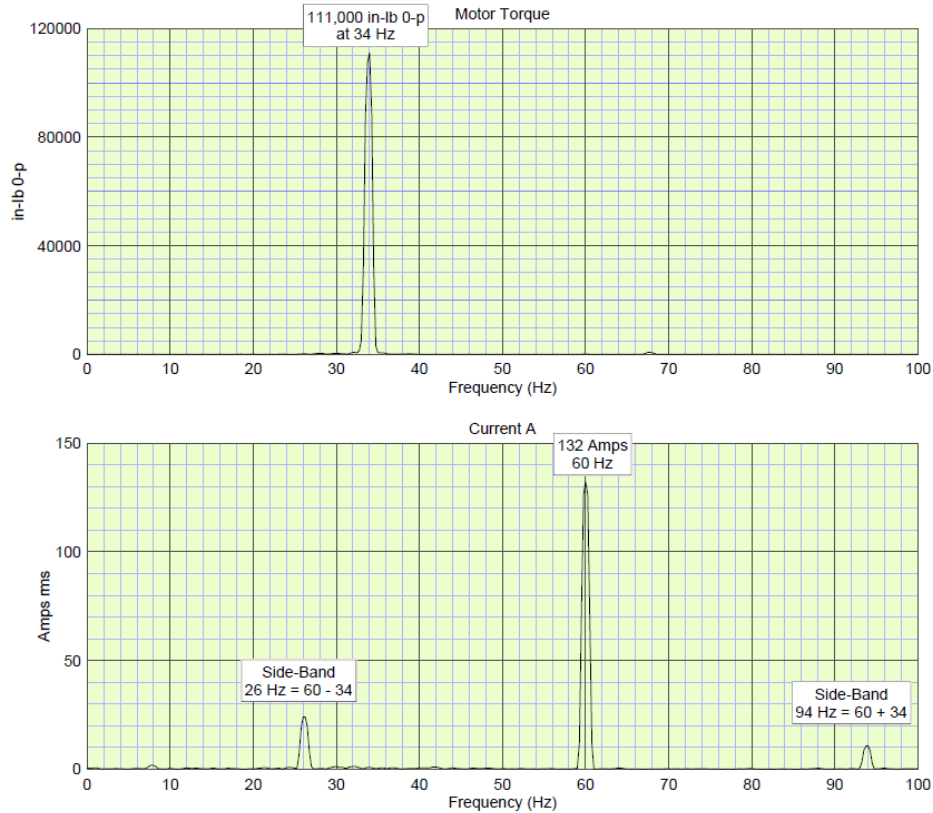
Figure 6 shows frequency spectra plots captured while operating at full speed. The alternating torque is well above FLT and occurred at 34 Hz (the first TNF). The motor current is 60 Hz but has notable sidebands at \pm the first TNF. This also indicates instability in the electrical system.

Figure 6 – Frequency Spectra Plots of Torque and Motor Current

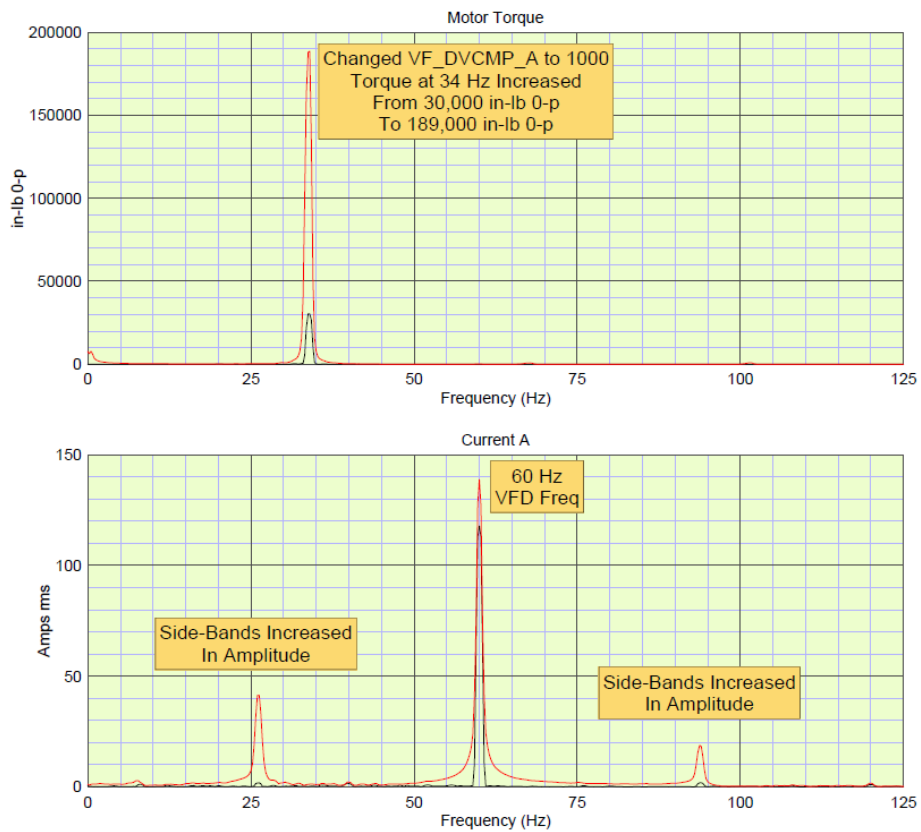
Figure 7 shows a comparison of before (black trace) and after (red trace) the VFD parameter VF_DVCMP_A was changed to 1000. This dramatically increased the amplitude of alternating torque occurring at 34 Hz as well as the sidebands in the motor current. Note that the motor was operating near 3597 RPM and the VFD was at 60 Hz electrical frequency so there is a wide separation margin from the TNF at 34 Hz (not operating near a torsional resonance).

Figure 7 – Effect of Changing VFD Parameter

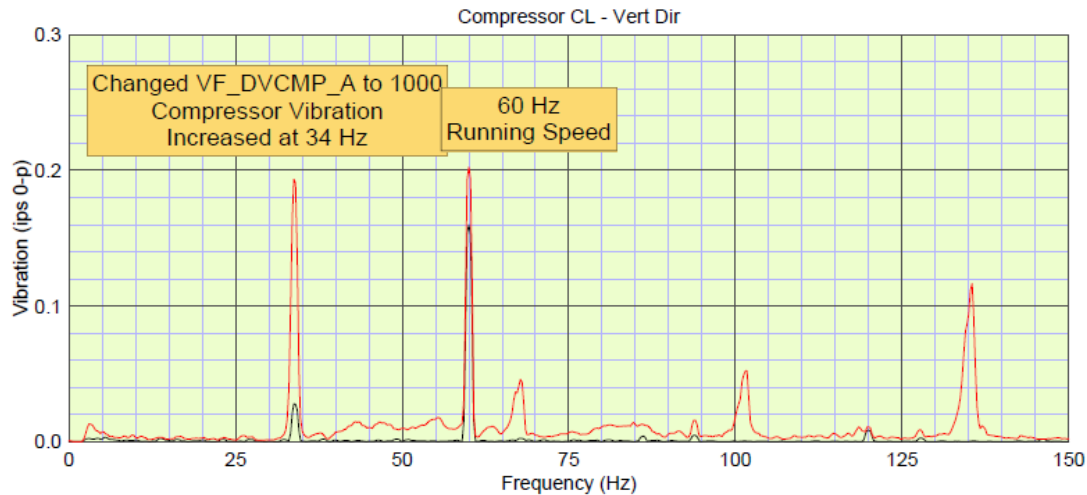
Since the alternating torque briefly reached 188,000 in-lb 0-p or 230% of FLT, this would increase the variation of separation and tangential forces on the gearing inside the compressor case. These forces due to high alternating torque translate into increased vibration on the compressor case as noted at 34 Hz in Figure 8.

Figure 8 – Frequency Spectra Plot of Compressor Vibration

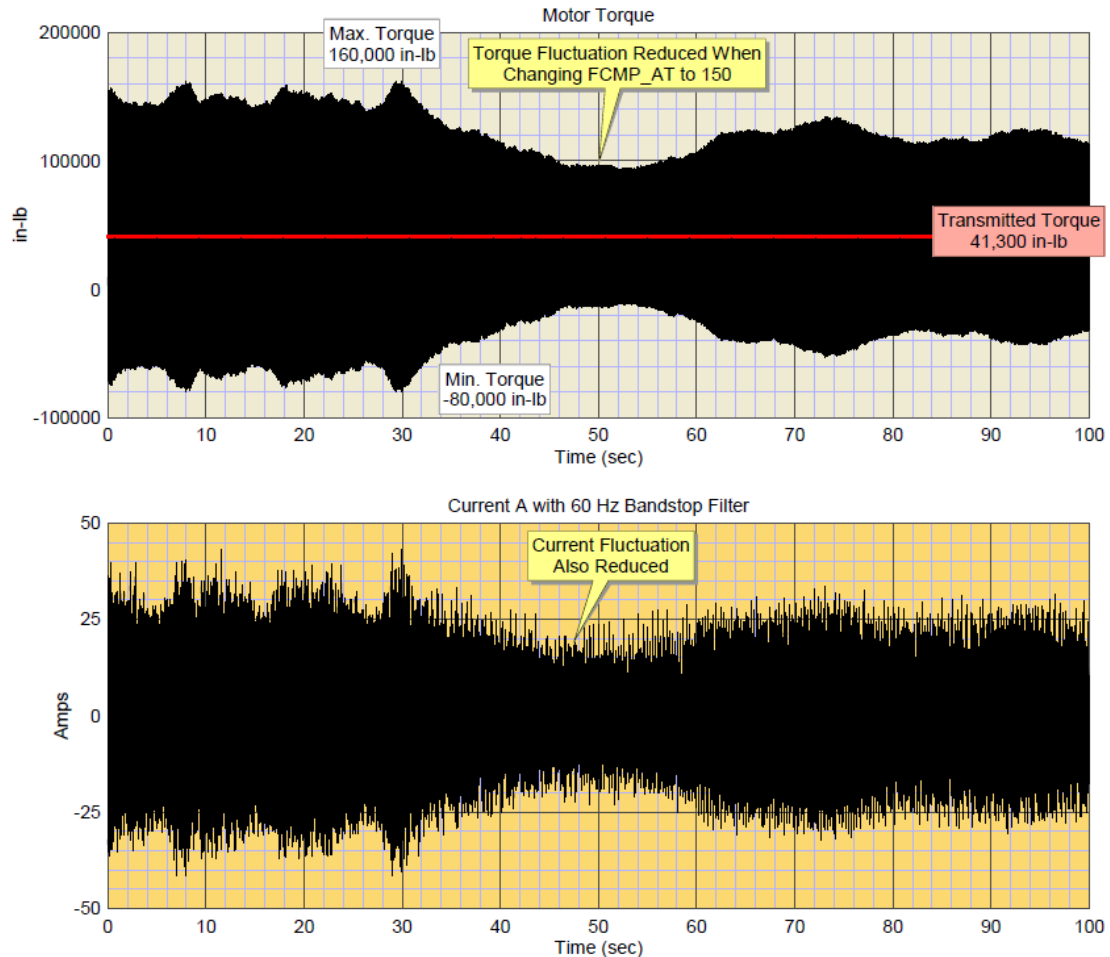
Adjustment of the VFD parameter, VF_FCMP_AT, had a noticeable effect on the measured alternating torque and current. The torque fluctuation briefly reduced in amplitude while the VF_FCMP_AT parameter was adjusted to values of 150, 220, and 300 as shown in Figure 9. Once this parameter was adjusted below 150, higher alternating torque and current returned. Even though the measured alternating torque was reduced with the adjustment of the FCMP_AT parameter, it was never reduced to an acceptable level.

Figure 9 – Time Wave Forms of Torque and Motor Current

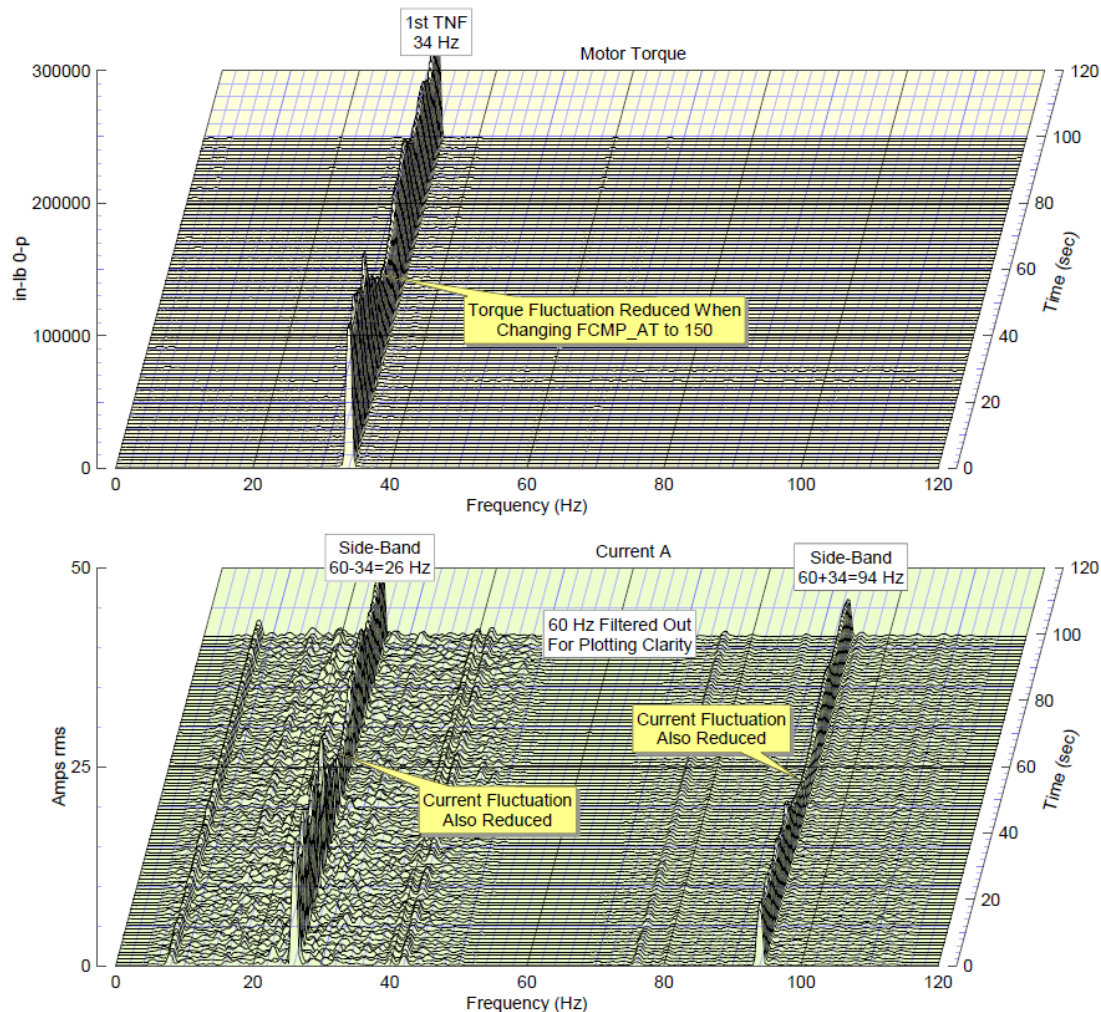
Figure 10 shows a correlation between the ± 34 Hz sidebands (26 and 94 Hz) above and below the 60 Hz motor current and the alternating torque measured in the motor shaft. This is also indicative of an instability of the VFD/mechanical system. Note that 60 Hz electrical frequency was filtered out for plotting clarity.

Figure 10 – Correlation of Torque Fluctuation and Current Sidebands

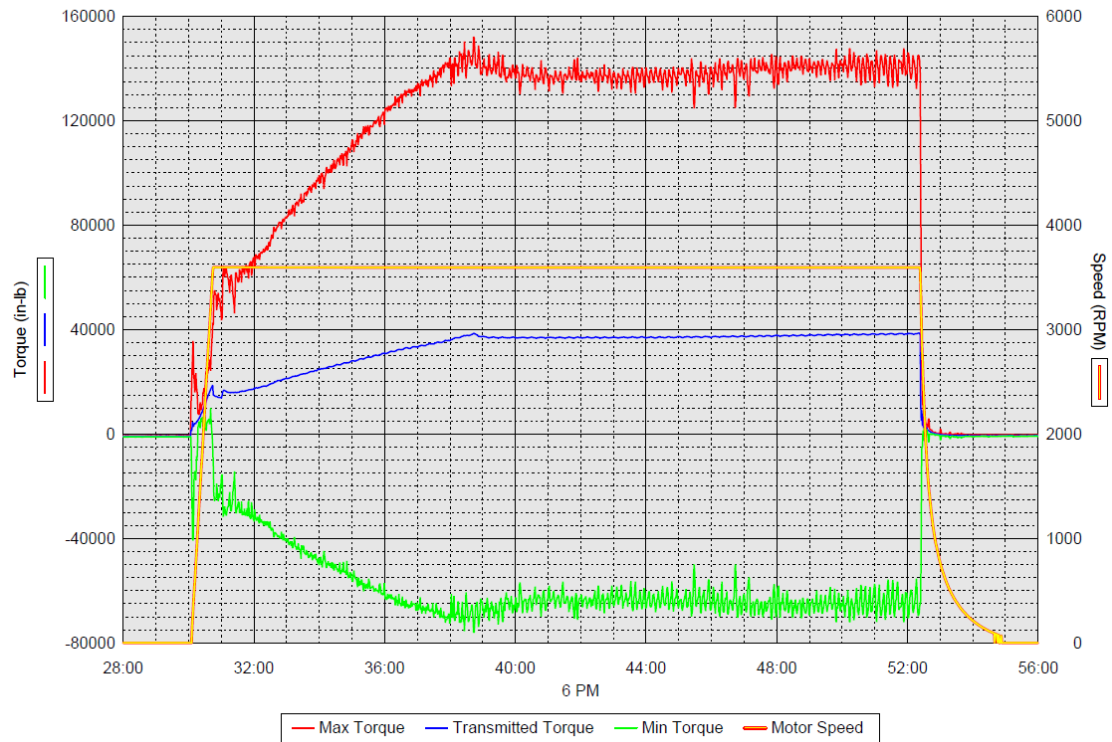
Figures 11 and 12 provide a before and after comparison of the alternating torque in V/Hz mode and sensorless vector mode, respectively. As represented by the green and red curves in Figure 12, torque fluctuations were drastically reduced to only 5% or less in sensorless vector mode and are considered acceptable.

Figure 11 – Trend Plot of Motor Torque with VFD in V/Hz Mode

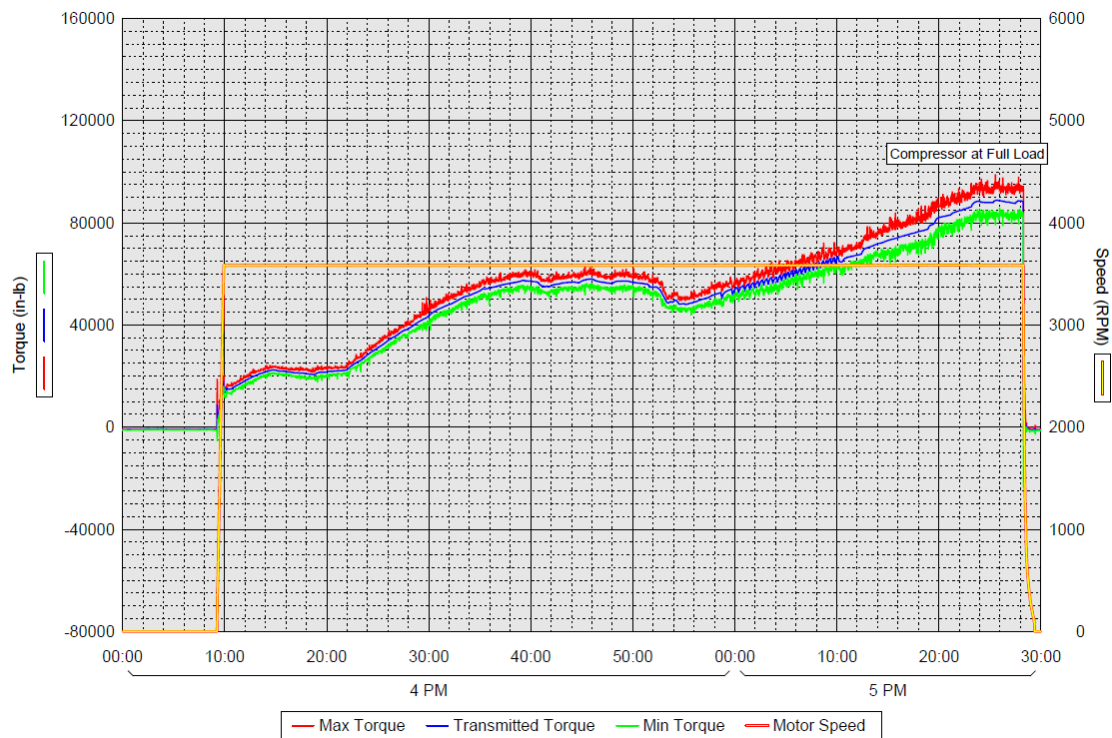
Figure 12 – Trend Plot of Motor Torque with VFD in Sensorless Vector Mode

Measurements were repeated with V/Hz mode to demonstrate the ongoing problem to the VFD representative. Some additional adjustments were tried, but he felt the problem would be better solved by switching the VFD to sensorless vector mode. The next day, the VFD was switched to sensorless vector mode and tuned with the motor running solo (coupling disconnected).

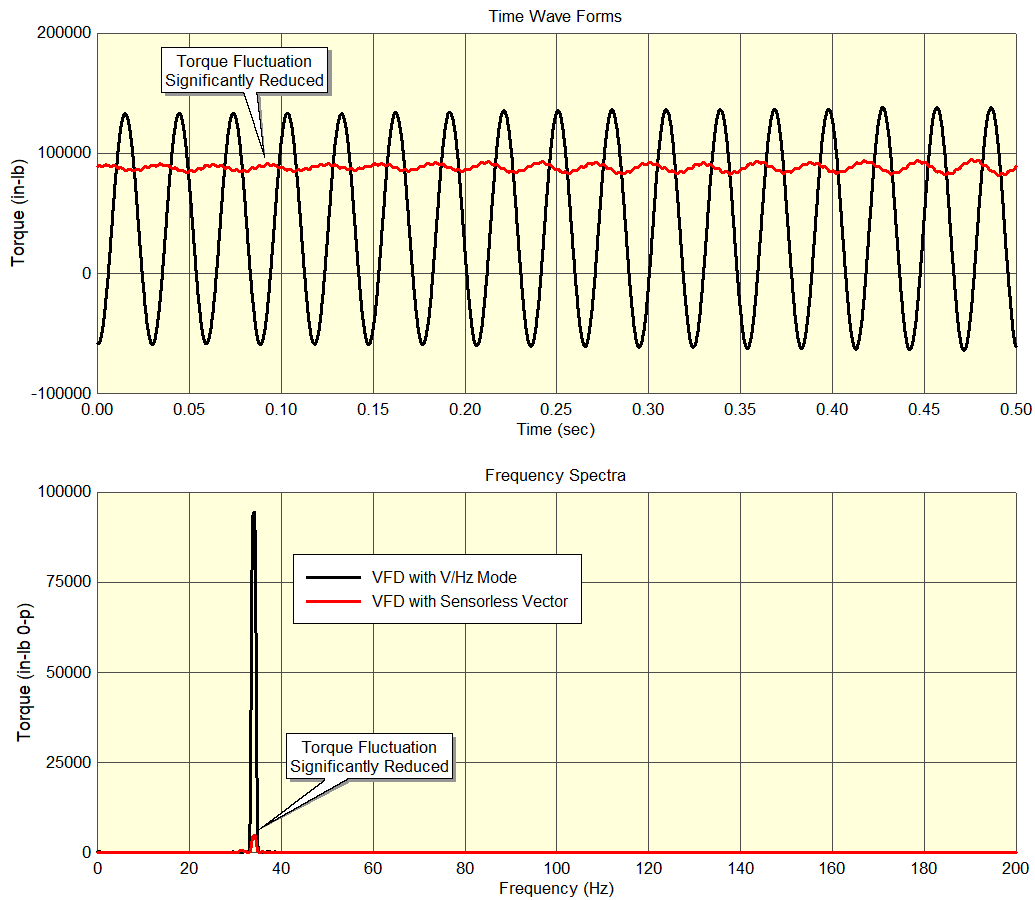
Figure 13 shows that the torque fluctuation at the first TNF of 34 Hz was significantly reduced with the VFD operating in sensorless vector mode.

Figure 13 – Torque with V/Hz vs Sensorless Vector

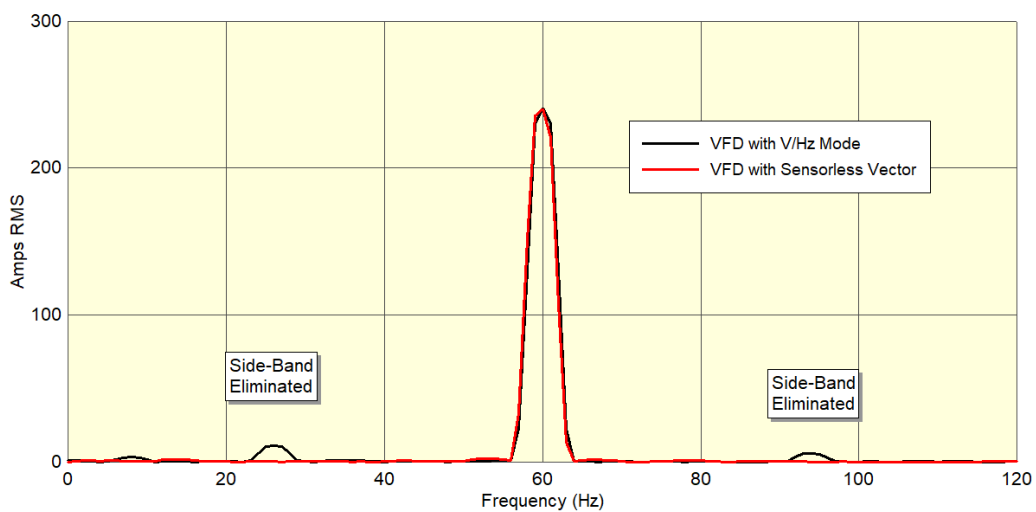
Figure 14 shows that the current sidebands at 26 and 94 Hz have been eliminated with the VFD in sensorless vector mode. With the reduction of subsynchronous torsional vibration and sidebands in the motor current, the system appears to now be operating in a stable manner.

Figure 14 – Current with V/Hz vs Sensorless Vector
