Balancing FD For of an FD Fan at a Troy Feese Refinery

Background

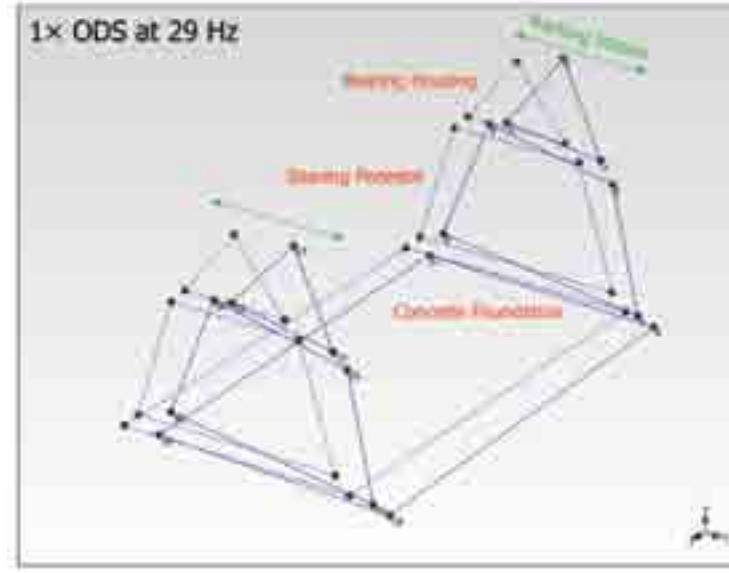
The FD fan supplied air for a boiler and was driven by a steam turbine through a speed-reducing gearbox as shown Figure 1. Refinery personnel reported high vibration several days after replacing the fan roller bearings. In an attempt to reduce the vibration, a second set of replacement bearings was installed; however, the vibration remained high. Initial vibration data were acquired with a hand-held analyzer. The predominant vibration was in the horizontal direction and occurred at 1× running speed of 1745 RPM (29 Hz) of the fan.

The highest vibration occurred at the top of the bearing housings in the horizontal direction. Figure 2 shows the rocking motion in which both ends (air inlet and coupling) were moving in-phase. The maximum vibration was approximately 6 mils p-p at 1× running speed (29 Hz). Vibration on the concrete foundation was 3 - 4 mils p-p, which was also considered excessive. However, no significant separation was found between bearing housings, pedestals, and concrete foundation. Therefore, looseness was ruled out as a possible cause of the high vibration.

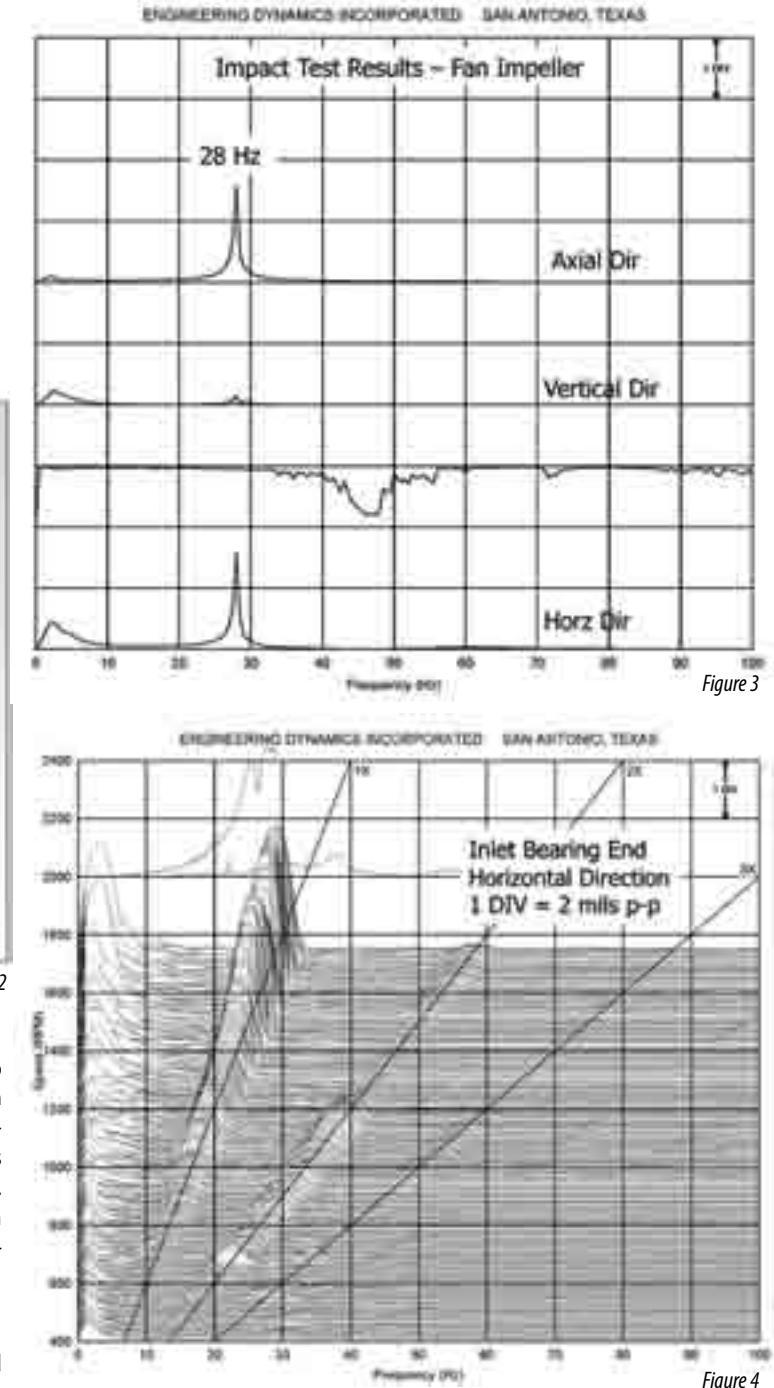
Figure 2

However, a natural frequency of the fan impeller was measured at 28 Hz and appeared to be more sensitive in the axial direction, as shown in Figure 3. This natural frequency could be a wobble mode of the impeller and could increase in frequency during operation due to gyroscopic effects. The EPRI paper by Smith² gives an example of a wobble mode.

There is an insufficient separation margin between the 28 Hz natural frequency of the impeller and the operating speed of 29 Hz. For reliable operation, a separation margin of at least 10% is recommended. Therefore, the fan vibration could be amplified due to the resonant condition, and the fan would be sensitive to even small amounts in unbalance. A change in unbalance condition could be caused by dirt build-up, a lost balance weight, or insufficient press fit of the impeller on the shaft allowing the impeller to shift slightly.

With one or two natural frequencies near the operating speed, the fan was still very sensitive to small amounts of unbalance due to dirt build-up, etc. For long-term reliability, natural frequencies of the fan rotor, impeller, and foundation should have a separation margin of at least 10% from the operating speed range. The refinery maintenance department reports that this fan was always difficult to balance and has now been replaced with a new one, which is more reliable.

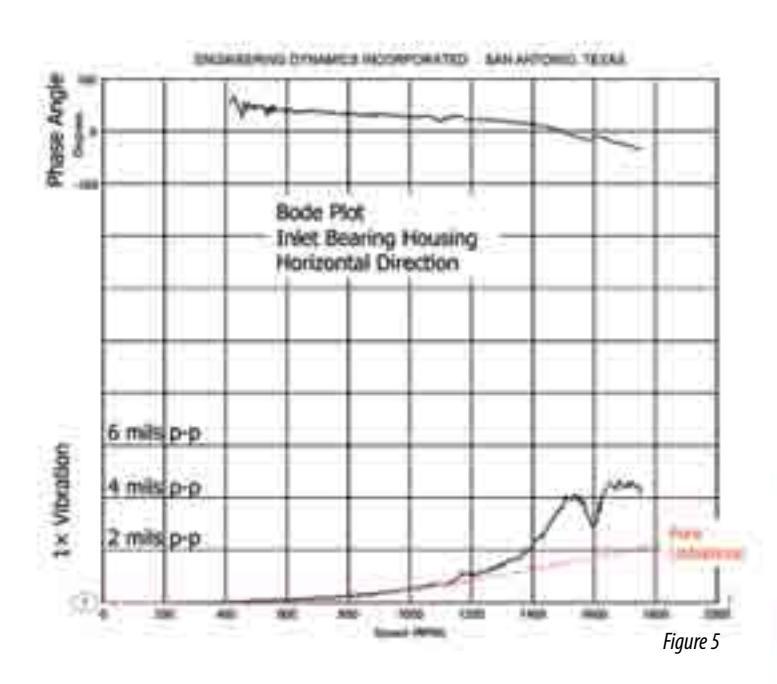
Vibration waterfall (Figure 4) and Bode (Figure 5) plots showed that two peaks occurred during the coastdown. It was unknown if the second peak was caused by a sudden change in speed as the steam was cut off to the turbine or if this might be a critical speed of the fan. The phase shift confirmed a resonance. In addition, the vibration is amplified above the expected speed squared relationship due to pure unbalance.
