TT10K Used to Identify Cause of Coupling Failure in Motor Driven Reciprocating Compressor System

By Troy Feese, P.E. Engineering Dynamics Incorporated - San Antonio, Texas, USA www.engdyn.com

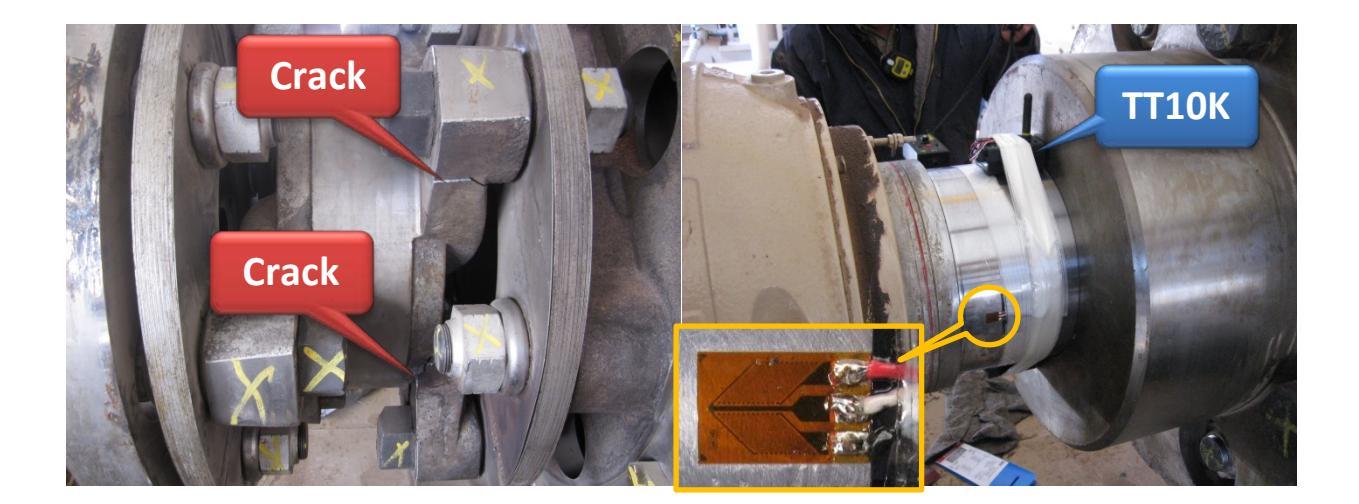
Weeks after commissioning, a compressor unit tripped on high motor vibration. Upon inspection, cracks were found in the center piece of the coupling indicating a possible torsional vibration problem.

The unit consisted of a 3150 HP induction motor operating at 894 RPM, shim pack coupling, flywheel, and 4-throw reciprocating compressor. Full load torque (FLT) of the motor was 222,000 in-lb. After the coupling was repaired, a Binsfeld TorqueTrack (TT10K) strain gage telemetry system was installed on the motor shaft to measure both transmitted (average) torque and dynamic (alternating) torque.

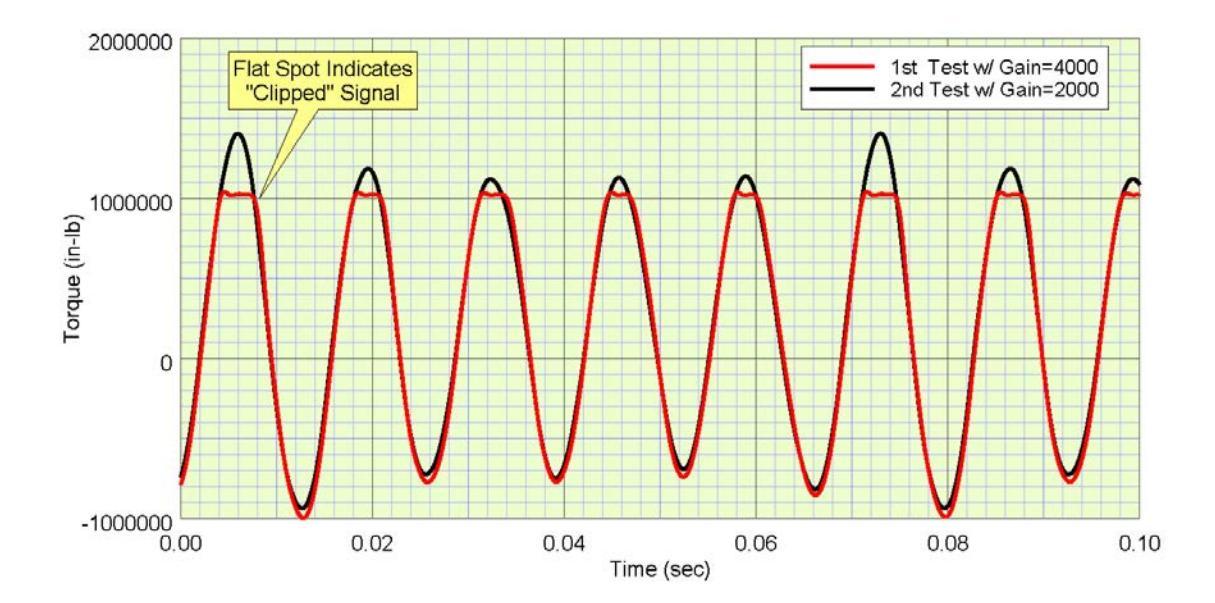
Binsfeld includes a convenient remote control that allows easy changing of settings such as channel and gain. Without any soldering of pads, the remote was used to quickly switch the gain from 4000 to 2000. The unit was re-started and the maximum torque was actually 630% of FLT (1,400,000 / 222,000 = 6.3).

The high torque exceeded the coupling manufacturer's allowable limits and caused the failure. The first torsional natural frequency (TNF) was coincident with 5× running speed, which greatly amplified the dynamic torque (AF \approx 80). For a reliable system, the TNF should have a separation margin (SM) from significant compressor harmonics. API recommends a SM of 10% if possible.
