TORSIONAL FAILURES IN HYDROGEN RECIPROCATING COMPRESSOR SYSTEM WITH STEPLESS CAPACITY CONTROL

Dong-Ju Lee¹, Dr. Jae-Yeol Park¹ and Troy Feese^{*2}

¹Samsung Engineering Seoul, Korea

²Engineering Dynamics Incorporated San Antonio, Texas, USA

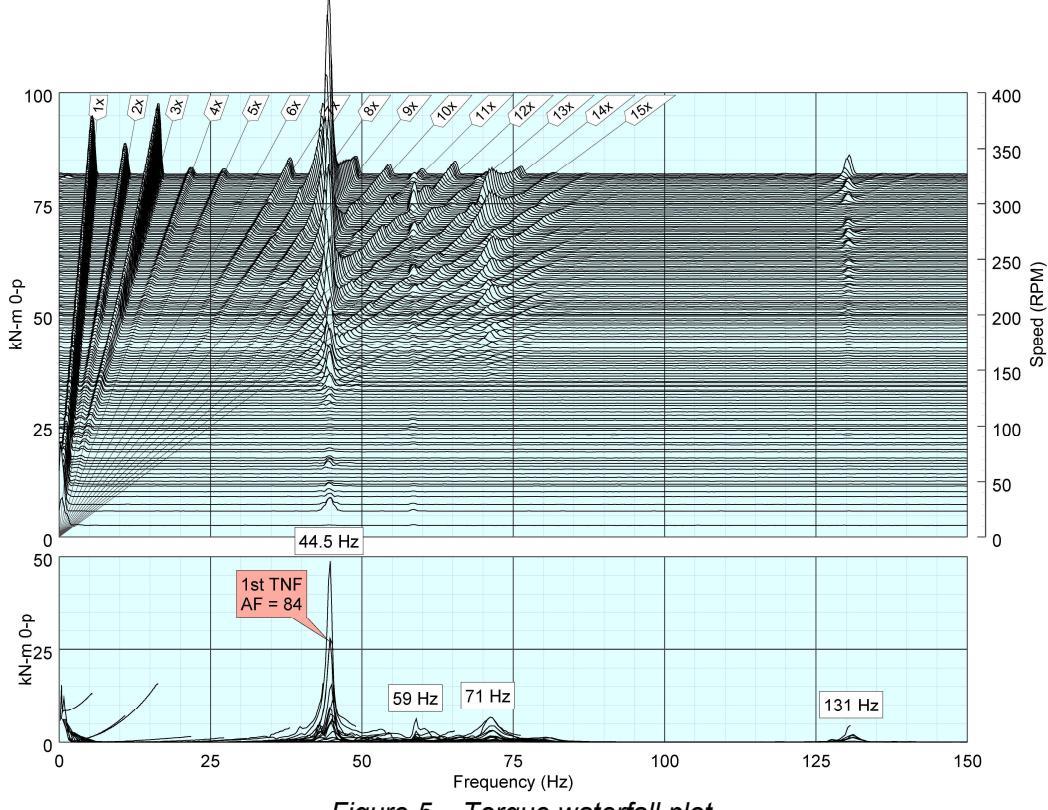
Figure 5 – Torque waterfall plot

As shown in Figure 5, the first TNF was measured at 44.5 Hz, which is within 2% of 8× running speed. Consequently, the alternating torque levels were very sensitive to compressor load as shown in Figure 6. Alternating torque levels reached approximately $\pm 800\%$ of FLT with 55% compressor load, which is excessive. Alternating torque at the other compressor harmonics were much lower in comparison to 8× running speed. For reference, the GMRC torsional document provides a guideline for designing motors shafts up to $\pm 200\%$ alternating torque when driving a four-throw compressor [10].

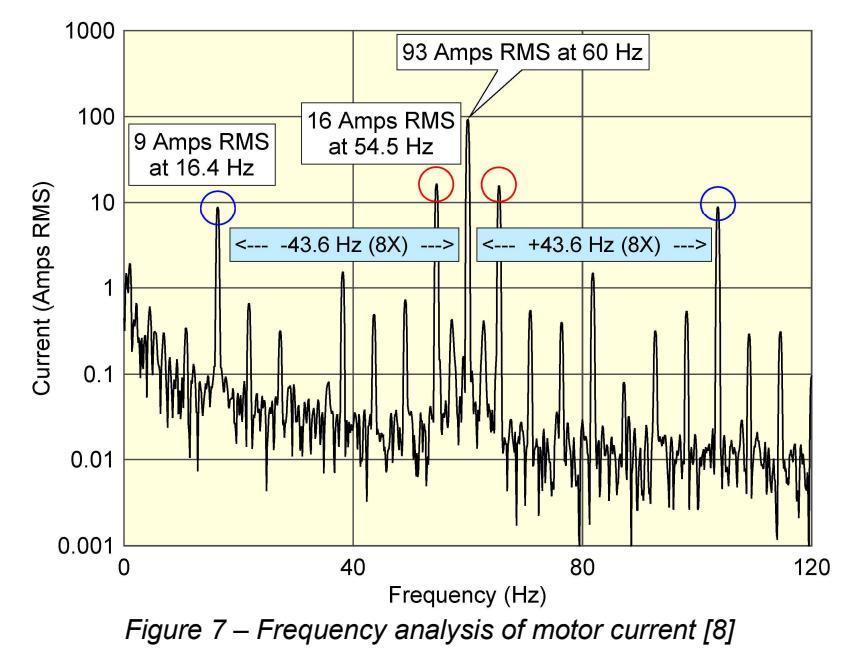
The frequency analysis of the motor current is shown in Figure 7. The highest sidebands at $\pm 1 \times$ operating speed (red circles) are typical of the rigidbody torsional mode. However, there were also significant sidebands at $\pm 8 \times$ operating speed (blue circles) due to the first TNF, which could be detected.

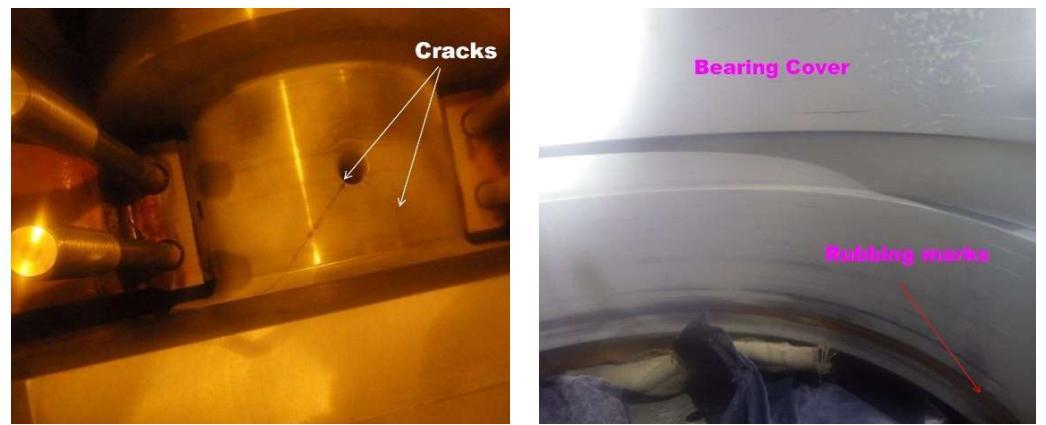
Figure 8 – Compressor crankshaft cracks and bearing damage

Before Unit B could be tested, it tripped on high compressor bearing temperature. Inspection revealed a spiral crack in the compressor crankshaft likely originating from a lubrication oil hole on the drive-end of the shaft. Lube oil holes are common stress risers in compressor and engine crankshafts.

As a result of the initial testing and subsequent TVA, bolt-on inertia rings were manufactured and installed on the flywheel and external fan of Unit A. Prior to testing, the compressor crankshaft in Unit A was inspected, which revealed spiral cracks similar to those previously found in Unit B. Damage was also observed on the bearing cover as shown in Figure 8.

Trending of the torque data indicated that the first TNF appeared to shift down in frequency during a one-hour load test to approximately 39.25 Hz. The cause of this shift of the first TNF was believed to be caused by the cracks in the compressor crankshaft. As these cracks progress in size, the first TNF would likely be closer to 7× running speed, thereby amplifying, and increasing the alternating torque due to resonance.

A new compressor crankshaft was delivered and installed on Unit B. Inertia rings were also installed on the flywheel and motor fan. Testing was requested on Unit B to confirm that it behaved similarly to Unit A. The results showed that during start-up the first TNF was 39.5 Hz. However, the first TNF decreased during operation to 38.3 Hz, which was lower than predicted. The trend plot showed some variation in the minimum and maximum alternating torque values. This indicated the possibility of additional looseness or broken parts in Unit B. For example, one of the authors had previous experience diagnosing a loose pole on a synchronous motor driving a reciprocating compressor when the first TNF changed with speed during a coastdown [9].

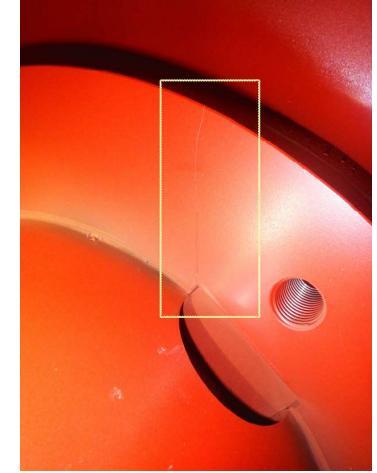
Figure 9 – Crack in motor

After a thorough inspection, cracks were found in the motor shaft originating at the base of the keyway on the drive-end as shown in Figure 9. The key was also found to be slightly cocked, which can increase stresses in the keyway [4]. These cracks were believed to be the result of the high alternating torque experienced in the motor shaft prior to the installation of the inertia rings. The motor for Unit A was later inspected and found to have similar cracks. The motor manufacturer began fabricating new shafts with the added inertia integrated into the external cooling fan design. New one-piece flywheels were also fabricated with the specified increased inertia.

A new motor shaft and flywheel were installed on Unit B. Test data showed that the first TNF was 40.4 Hz (7.4× running speed), which was the optimal separation margin. With the system now in "like new" condition, the measured TNFs agreed well with the TVA.
