Vibration Issues with Engine Driven Reciprocating Compressor Systems

Engine driven reciprocating compressors are commonly used for gas pipeline systems. These units need to be reliable over a range of operating conditions and speeds. This paper presents three case studies detailing issues that were encountered on otherwise standard packages consisting of a 16-cylinder engine driving a six-throw reciprocating compressor in natural gas service.

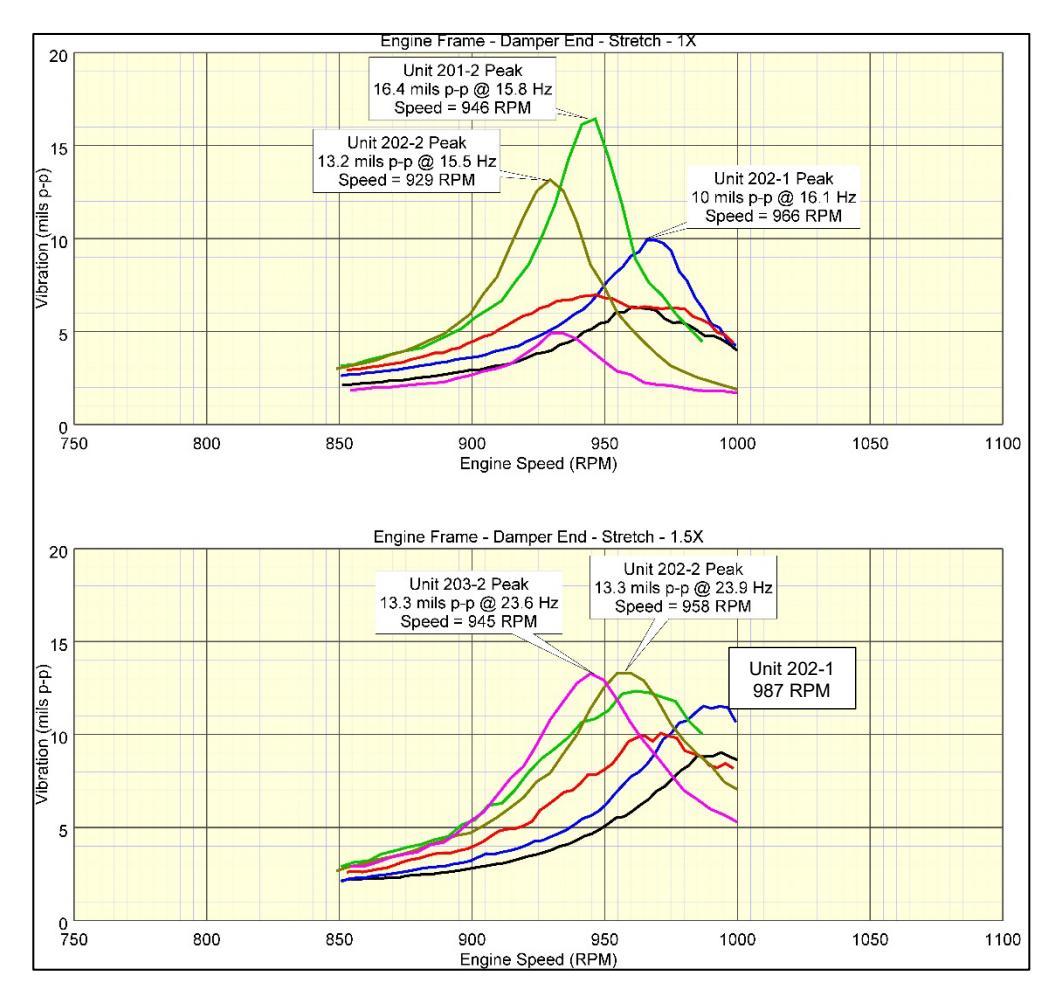
Figure 2. Engine Vibration at 1× and 1.5× Harmonics - Speed Sweep Tests

The overall (unfiltered) vibration on the engine frames of all six units exceeded the manufacturer's vibration guideline of 8.5 mils p-p within the speed range. The elevated vibration primarily occurred at the 1× and 1.5× harmonics. Figure 2 shows a comparison plot of each unit for the 1× harmonic (top plot) and the 1.5× harmonic (bottom plot).

- Stretch direction vibration (i.e. perpendicular to crankshaft) at the 1× harmonic was high at all locations, while vibration at the 1.5× harmonic in the same direction was only high at the damper and flywheel ends of the engine frame.
- The vibration data indicated two MNFs of the engine, which were resonant with the 1× and 1.5× harmonics.
 - The maximum response due to first MNF occurred between 929 and 966 RPM, which corresponds to 15.5 16.1 Hz, with a peak amplitude exceeding 16 mils p-p at 1× running speed. The peak amplitudes at the 1× harmonic varied somewhat between units.

- The maximum response due to the second MNF occurred between 945 and 987 RPM, which corresponds to 23.6–24.7 Hz, with a peak amplitude of 13.3 mils p-p at 1.5× running speed. The amplitude of this harmonic was more consistent between units than the 1× harmonic.
- A slight variation in natural frequencies was observed among the units and could be due to differences in underlying soil, grout contact, skid weldments, adjustable chock bolt preload and auxiliary equipment weight.

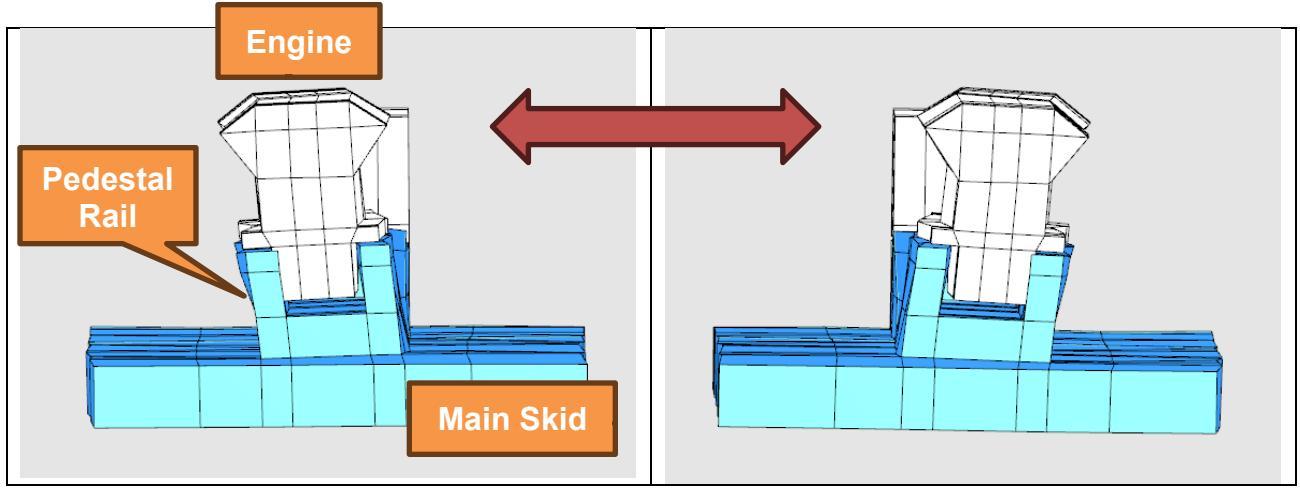
Figure 4. ODS of Engine 1× Run Speed

As shown in the deflection still plots in Figure 4, the response at 1× running speed involved the engine frame moving in the stretch direction. The skid base remained relatively stationary while the pedestal rails under the engine were bending. The difference in motion between the engine mounting feet and the top of the pedestal was relatively small (less than 1 mil p-p) and therefore was not indicative of slippage of the chock mounts.

The ODS also showed that the vibration at the center of the engine was about a quarter of a cycle out-of-phase with the vibration at the ends of the engine frame. This behavior was due to the phasing of the engine throws and their individual unbalanced loads, which is normal for an engine.

This rocking mode of the engine is typically the first MNF of an engine supported on rails, which acts to amplify normal levels of engine unbalance. Pedestals should normally be designed so that they have sufficient stiffness to raise the frequency of this mode to a safe margin above the maximum speed. An ideal separation margin would be 10% or more, but is not always possible.

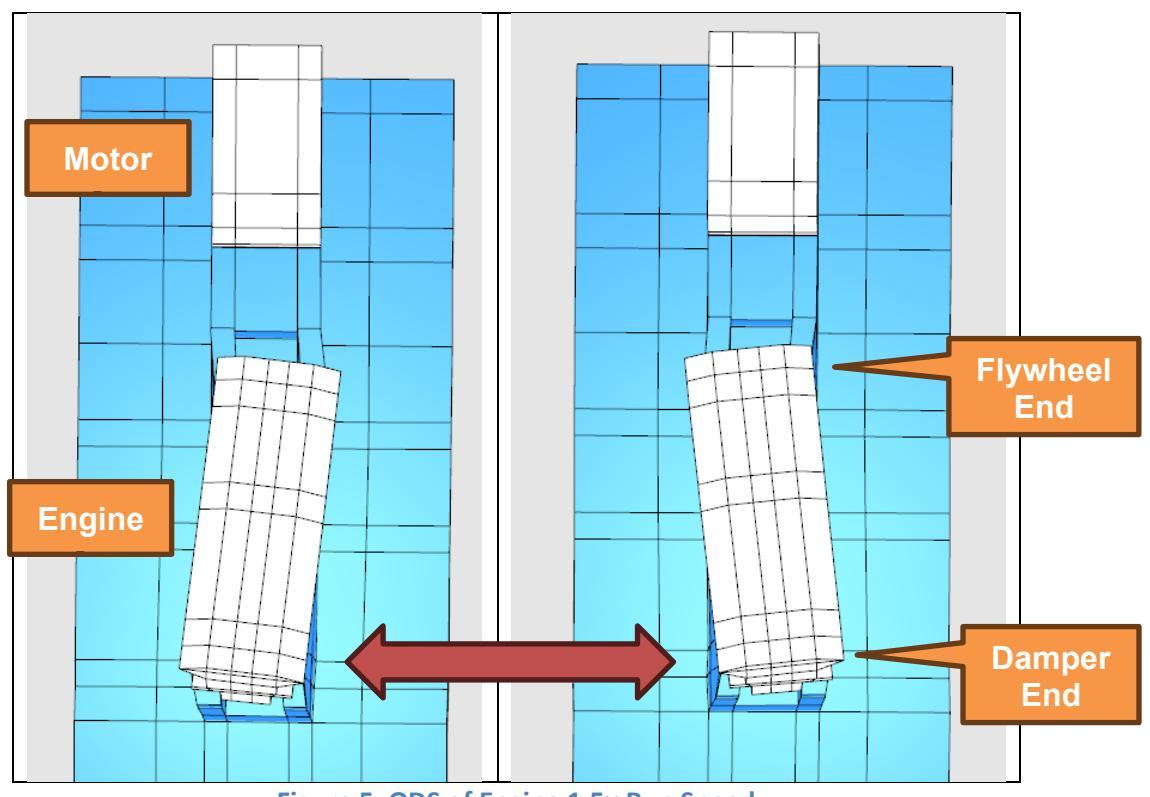
Figure 5. ODS of Engine 1.5× Run Speed

Figure 5 shows the deflection still plots for the 1.5× engine harmonic. This is the engine yaw mode, with twist about the vertical axis. The skid base was relatively stationary with the pedestal rails bending, but with the damper and flywheel ends out-of-phase. Motion at the center of the engine was minimal for this mode.

This yaw motion is typically the second or third MNF of an engine supported by rails. It is important that this resonant frequency also has a sufficient separation margin from the operating speed range to avoid amplified vibration of the engine. Again, an ideal separation margin would be 10% or more, but is not always possible. From a practical standpoint, the minimum required separation margin is what is needed to reduce the vibration to an acceptable level.

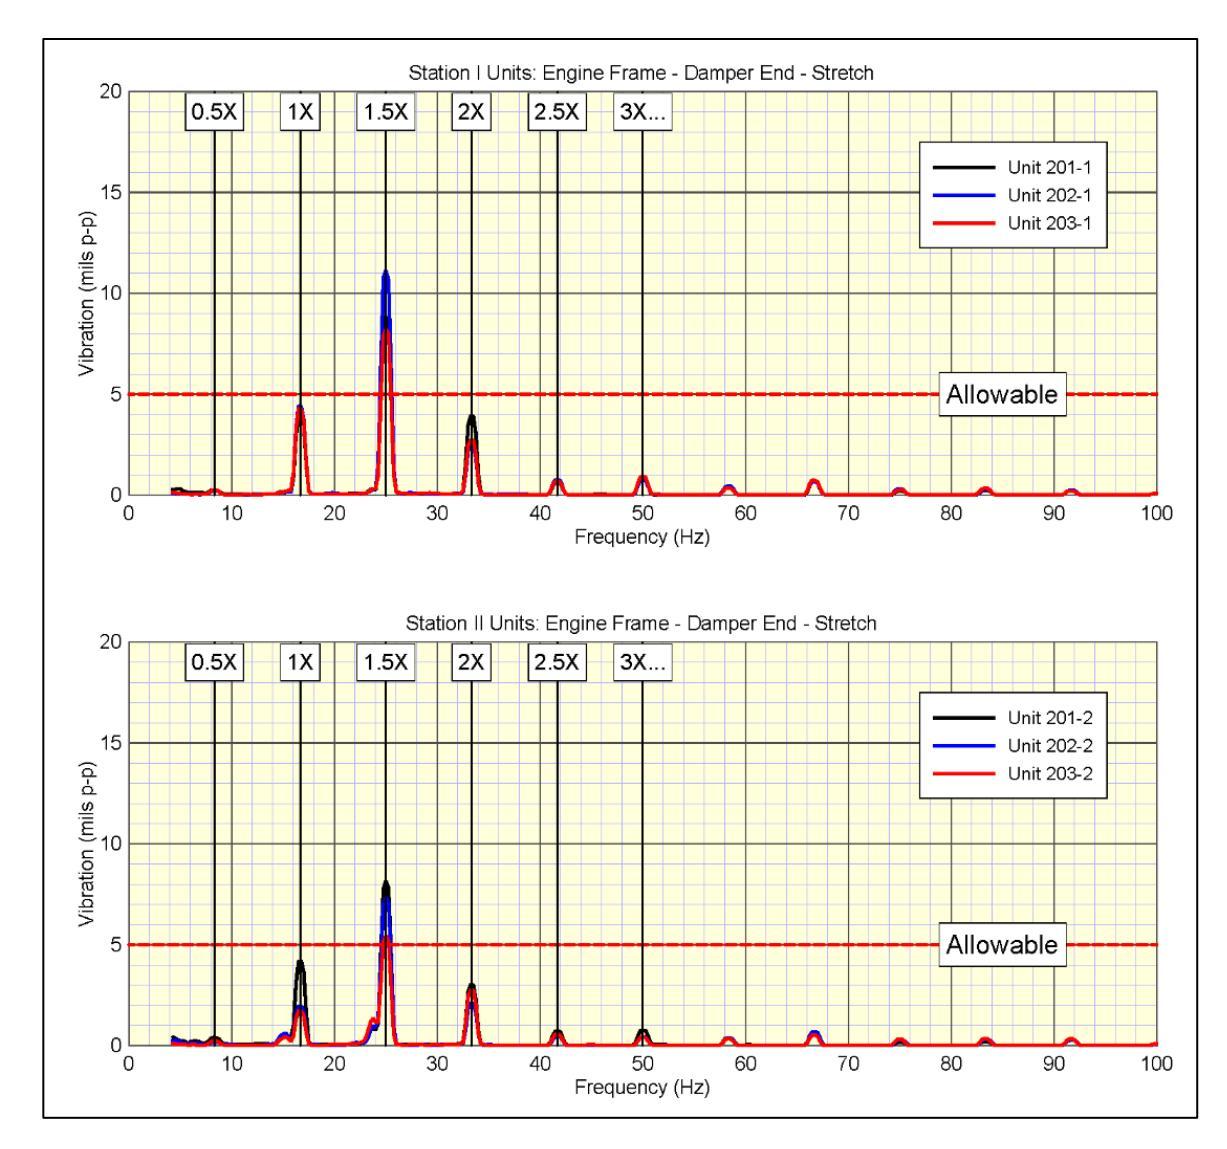
Figure 6. Engine Vibration at 850 RPM

Engine vibration was measured while operating at minimum and maximum speeds with the compressor loaded. Figure 6 shows that all individual harmonic peaks were below 5 mils p-p at 850 RPM (minimum speed).

Figure 7 shows that the 1.5× harmonic on all units exceeded 5 mils p-p when operating at 1,000 RPM. Engine vibration met the allowable at all other harmonics.

- The short-term recommendation was to operate the units at minimum or maximum speed (preferably at minimum speed) until the resonances were corrected. For these two operating speeds, the engine vibration was much lower than when operating at resonance within the middle of the speed range. However, the plant really needed to operate at maximum speed to make production.
- Install vibration sensors on the engine frame and trend the overall vibration levels.
- Stiffen the engine pedestals in the stretch direction. Figure 8 shows some examples of various modifications from other projects.

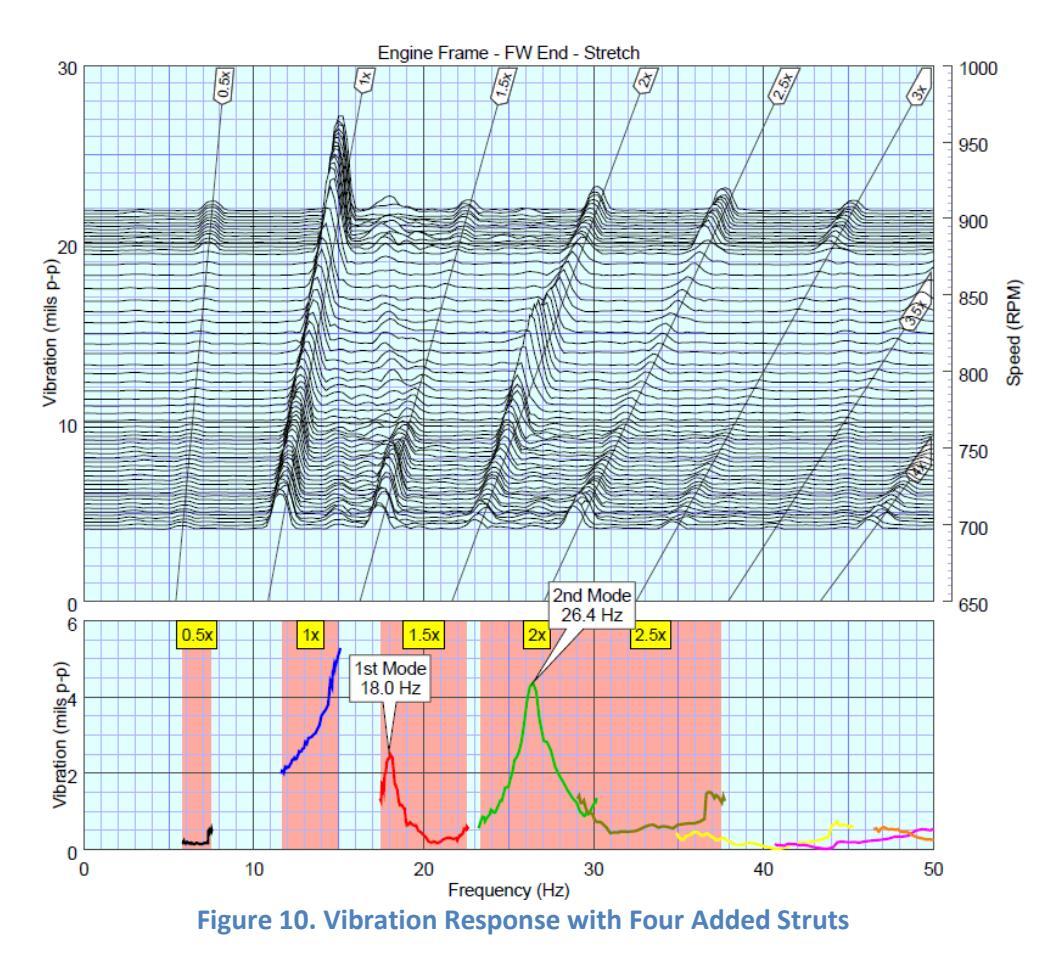
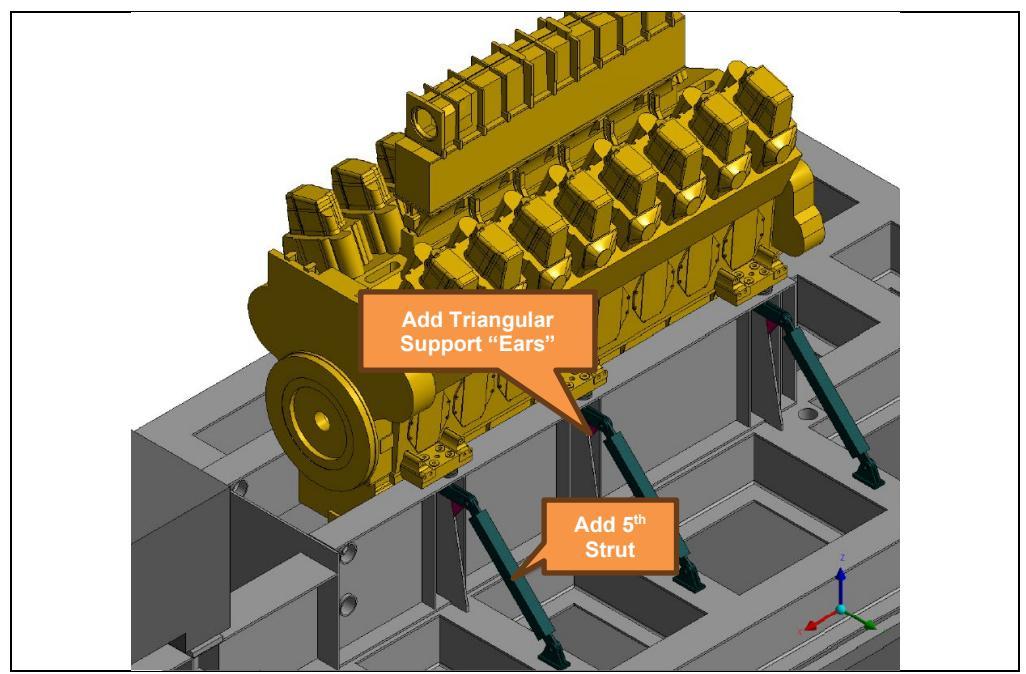
Figure 11. Model with Five Struts

Several problems were found with the struts installed. The overall vibration on the flywheel end of the engine frame was still too high at maximum speed. The problem was that the first mode was pushed into the 1.5× range, and the second mode into the 2× range. The four struts were not as effective as predicted by the FEA. Figure 10 shows the vibration response data and slice plots. Five struts were modeled as shown in Figure 11.

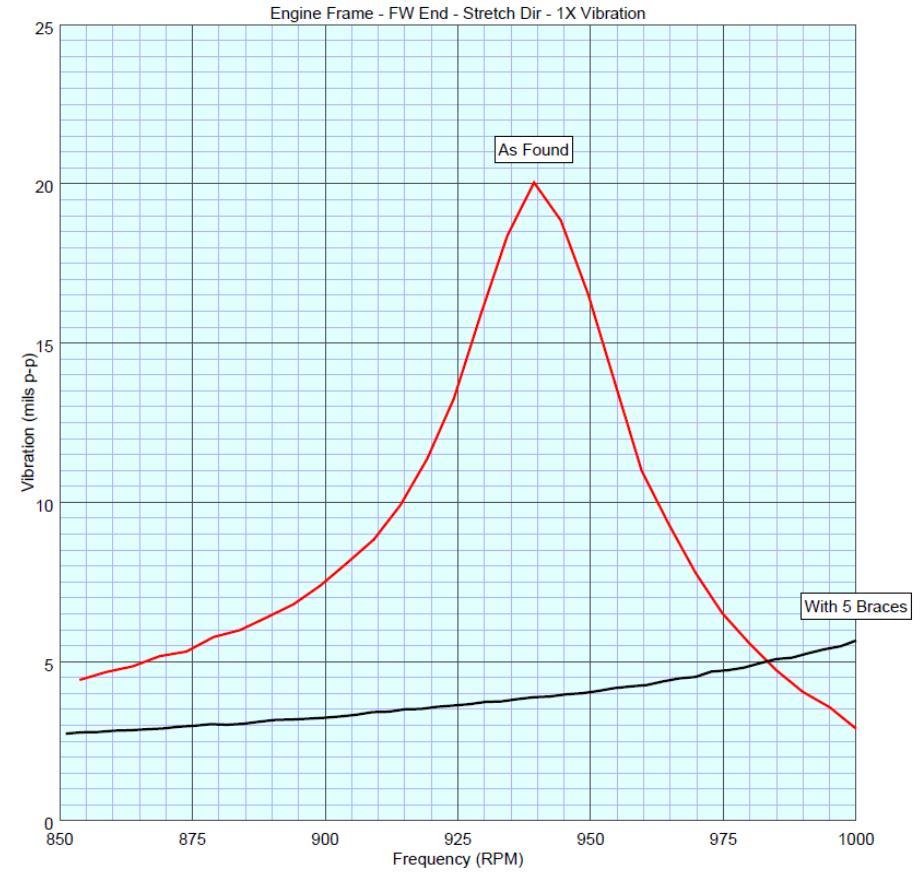
Figure 13. Comparison of 1× Engine Vibration as Found vs. Modified

The unit was much improved with five struts on the engine pedestal. The $1\times$ response at maximum speed (1,000 RPM) reached 5.5 mils p-p on the flywheel end of the engine. The maximum response at the $2\times$ harmonic was 4.5 mils p-p at the damper end. Figure 13 compares the "as found" condition on the flywheel end (maximum of 20 mils p-p) with the final condition (maximum of 5.5 mils p-p). Because these modifications were successful, the struts were then used to modify other existing units already installed at this plant.

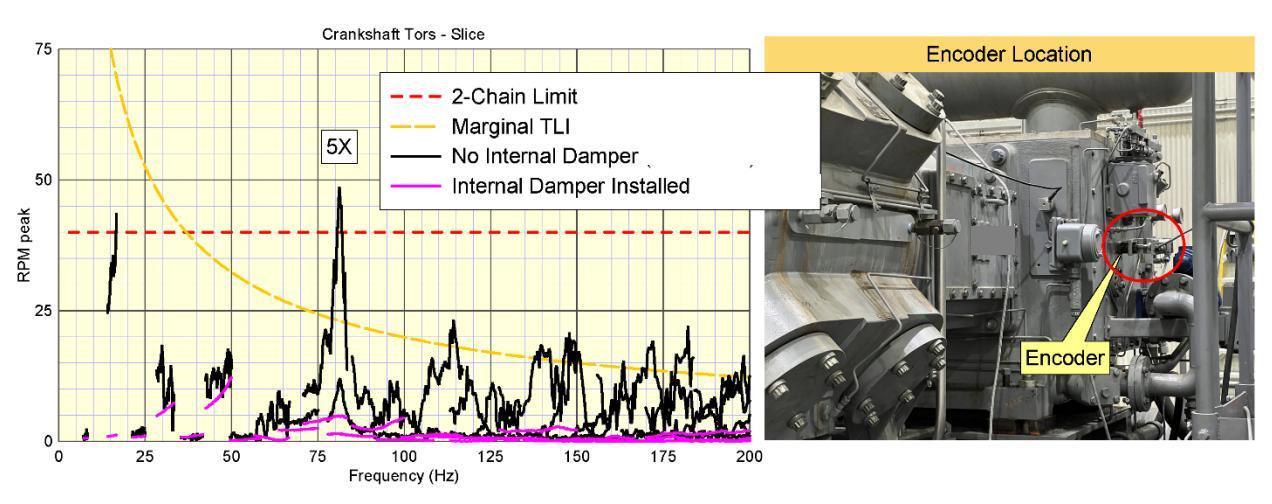
Figure 15. Comparison of Torsional Vibration Levels

Torsional vibration was measured at the auxiliary end of the compressor crankshaft. The encoder location is shown in Figure 15. The system had a torsional natural frequency (TNF) near 80 Hz that was being excited by 5× running speed. This resulted in torsional vibration exceeding the manufacturer's limit, meaning damage to the oil pump and drive chain would likely occur if continuously operated on the resonance.

The torsional vibration was greatly reduced by installing the compressor manufacturer's internal damper to the auxiliary end of the compressor. The peak amplitude at 5× running speed went from 48 RPM 0-p (black line) to 5 RPM 0-p (magenta line), which is well below the limit (40 RPM 0-p) and below the guideline for torsional-lateral interaction (TLI).

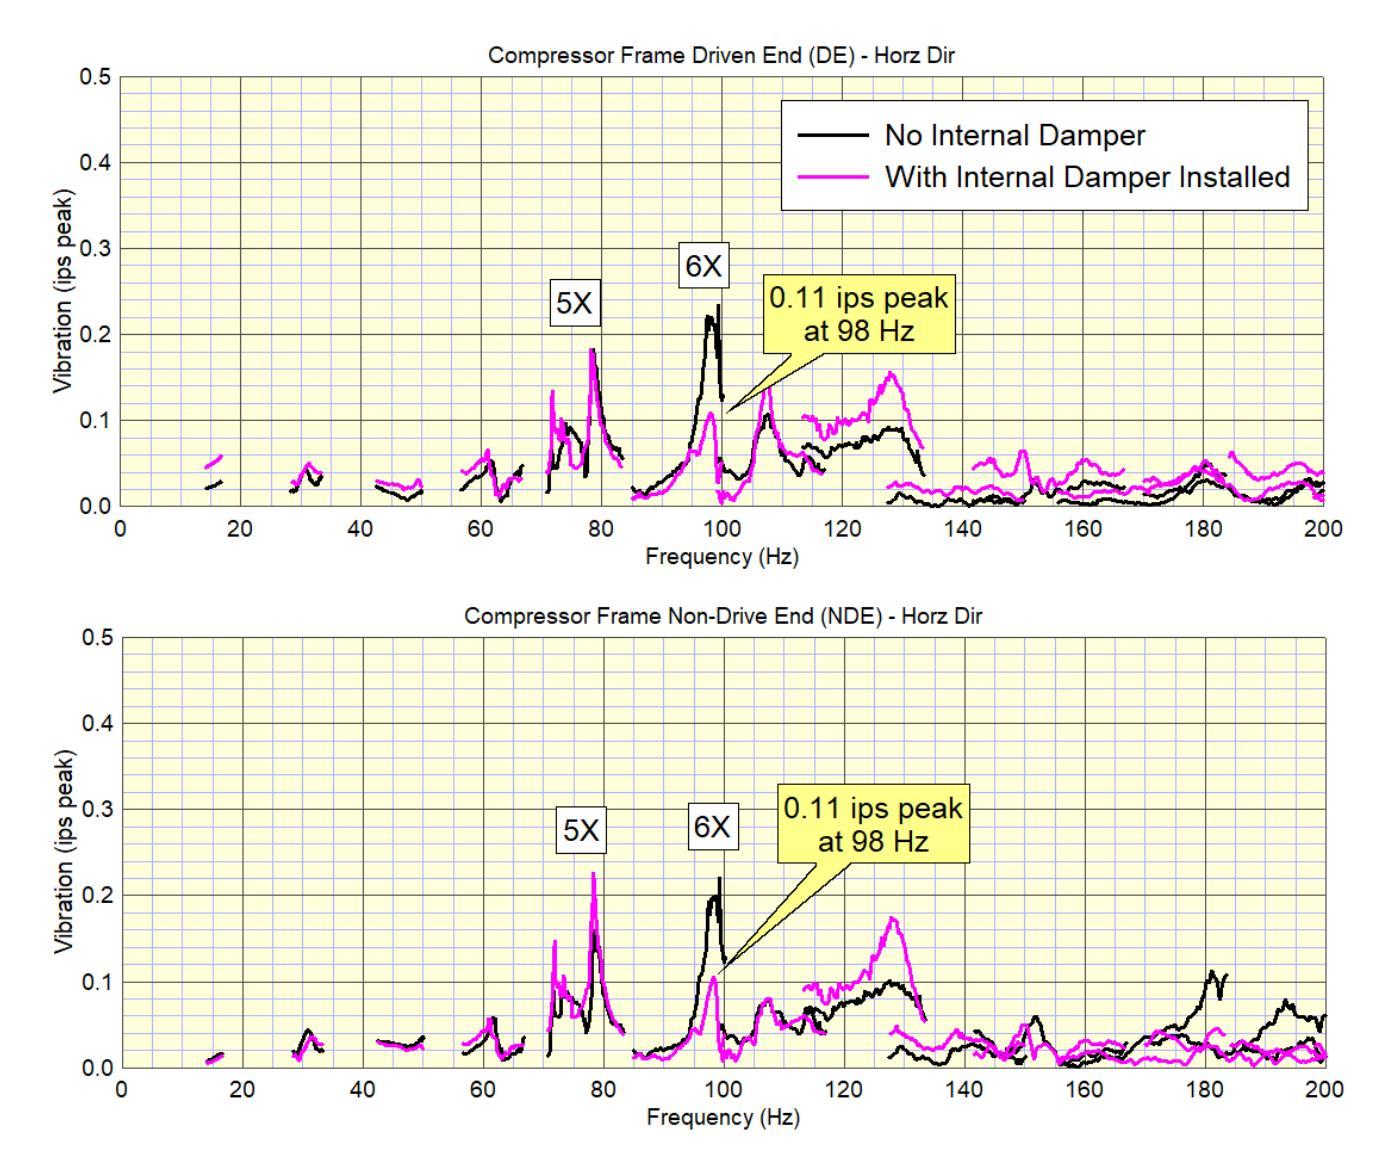
Figure 16. Slice Plots – Lateral Vibration Measured on Compressor Frame

The reduction in torsional vibration at 5× running speed after installation of the internal damper also reduced the lateral vibration of the compressor frame at 6× running speed. This is because TLI can occur at ± 1 order of the torsional vibration harmonic. Figure 16 shows spectra slices extracted from the waterfall plots of the compressor frame horizontal vibration with and without the internal damper. The significant reduction in 6× running speed amplitude helped reduce buzzing of some of the small-bore attachments on the compressor.
