**BALANCE THIS!  
CASE HISTORIES FROM DIFFICULT BALANCE JOBS**

**ABSTRACT**

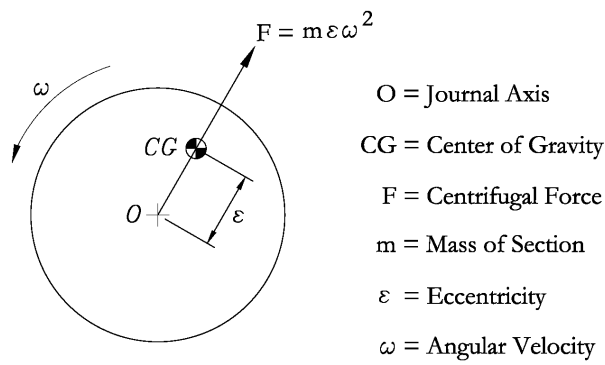
Figure 1: Rotor Section with CG Displaced Due to Unbalance

As a rotor spins, centrifugal forces act upon it. The surface around the periphery is stressed as particles are pulled outward from the axis of rotation. If all of these radial forces are equal, the rotor is said to be balanced and should not vibrate. However, if the rotor contains a heavy spot to one side, these radial forces will not cancel and the unbalanced force will tend to pull the rotor from the center of rotation. Figure 1 shows that the centrifugal force produced by unbalance depends on the mass and radius as well as the rotational speed of the rotor.

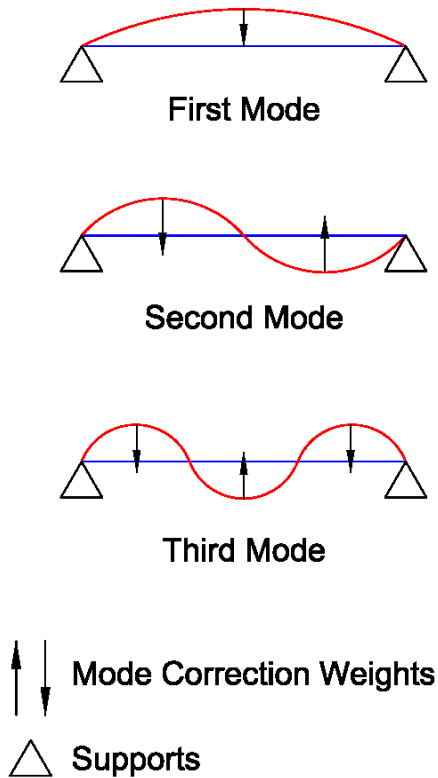
Figure 10: Basic Flexible Modes and Correction Weights.

As discussed previously, rotors have lateral critical speeds that can affect vibration amplitudes and phase angles. At resonance, the rotor deflection will be similar to the mode shape of the lateral natural frequency, which depends on the physical characteristics of the rotor and the bearing properties. Using simplified beam theory where the shaft is flexible compared to the support stiffness, the undamped mode shapes at the first three lateral critical speeds resemble those shown in Figure 10.

Nodes are locations where minimal shaft movement is expected for a particular mode. For the first mode shown, there are two nodes, one at each support location. The midspan of the rotor has the highest relative amplitude, which is at the anti-node. The response of a rotor running near a critical speed will usually correspond to the mode shape provided the unbalance is located at the proper location. Therefore, unbalance near the center of the rotor would be expected to cause the most vibration due to the bowed shape of the first mode. However, unbalance near the supports would create very little vibration. The actual vibration amplitudes at resonance will depend on the unbalance and damping in the system.

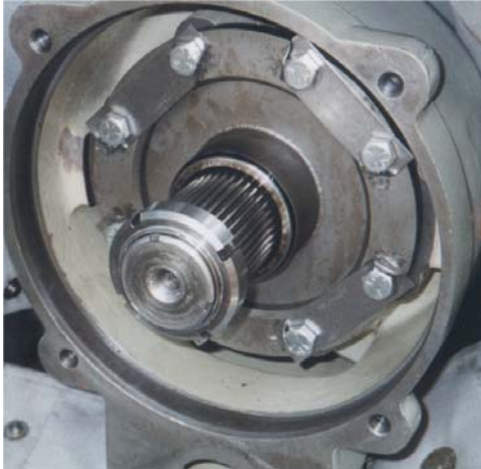
Figure 12: Spline on Power Turbine

It was determined that the interconnect shaft and power turbine coupling adaptor were not match marked when initially balanced. Residual unbalance from each piece can add or cancel out depending on the angular orientation. By clocking the pieces 120° during three separate runs, the best position was found. However, there were still some problems which increased the vibration.

It was suspected that the worn splines allowed the coupling to lockup or allowed the coupling adaptor or interconnect shaft to shift radially due to the centrifugal force, thus causing an unbalance. The problem was corrected without balancing.

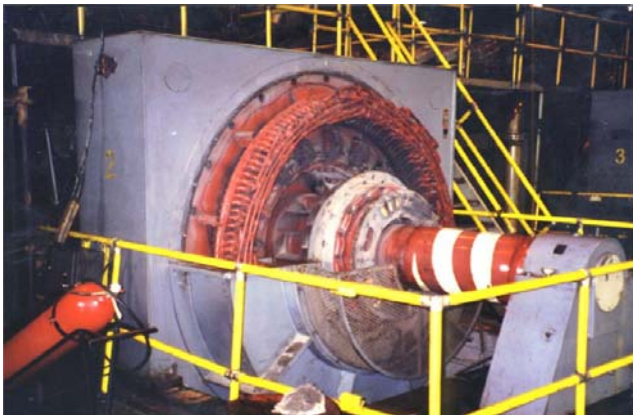
Figure 15: Generator and Bearing Pedestal

The synchronous generator shown in Figure 15 was driven by a diesel engine through a bolted flange at the engine flywheel. The single generator bearing (outboard) had excessive vibration at 1× running speed of 450 RPM. The maximum reported generator bearing life was only four months. It was also reported that the engine bearings on the flywheel end had experienced failures.

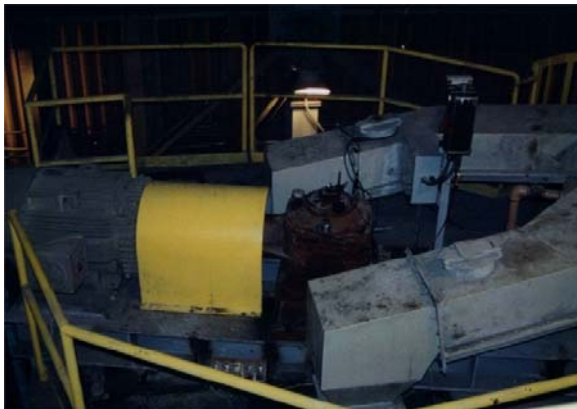
Figure 22: Motor and Right-Angle Gearbox

The motor and gearbox are installed on a pair of wide flange beams, which are mounted on the top of the separator (Figure 22). The separator rejector cage assembly is attached to the end of the vertical gear shaft. Replaceable vertical tubes are located around the periphery of the cage assembly.

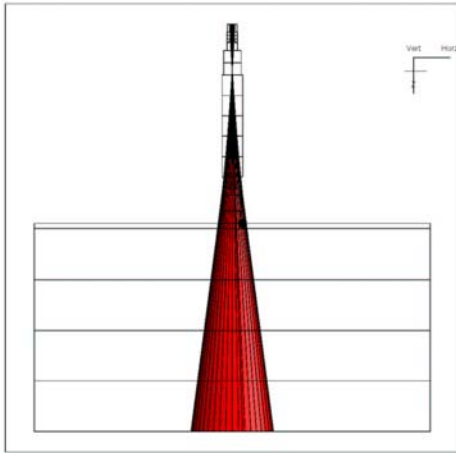
Figure 24: Unbalanced Response of Separator Shaft and Cage

Results of the shaker test indicated that the horizontal stiffness at the gear housing was approximately 100,000 lb/in, which would result in an undamped lateral natural frequency of approximately 450 CPM. The calculated response shape is shown in Figure 24.

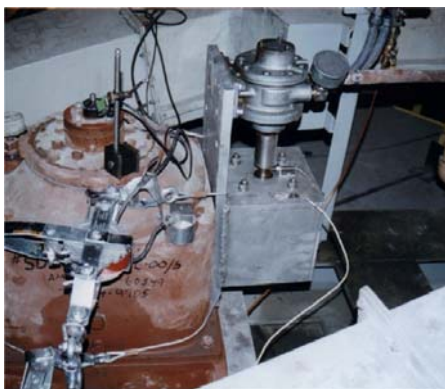
Figure 25: Shaker Temporarily Mounted to Gearbox

Shaker tests were conducted to measure the mechanical natural frequencies of the floor/separator system. The system was excited using a variable speed shaker, which was attached to the side of the gearbox (Figure 25). These tests identified mechanical natural frequencies at 220 CPM, 260 CPM, and 290 CPM.

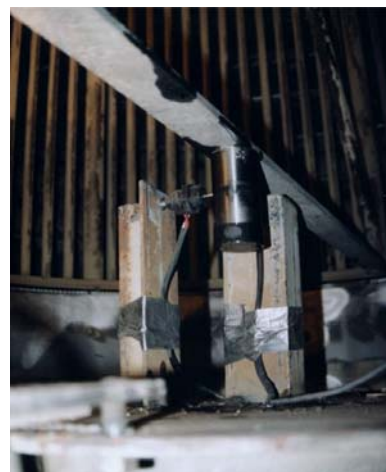
Figure 26: Potentiometers Used for Balancing Cage

Instrumentation was installed to directly measure the vibration levels of the cage. A target for the potentiometers was obtained by attaching a short section of 2 inch diameter shaft to a flat bar which was welded across the lower ring of the cage, Figure 26. The previous shaker data and the critical speed calculations indicated that the vibration levels on the lower ring of the cage could be more than 100 mils p-p when the cage was operating above 200 RPM. Proximity probes typically used to measure shaft vibration could not be used because the linear range of these probes is typically less than 50 mils p-p.

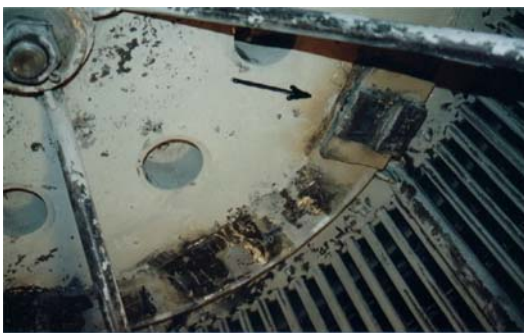
Figure 27: Balance Weights Inside Cage (Looking Toward Top of Cage)

The final balance weight was 19.6 lbs at 263° as shown in Figure 27. This weight was approximately 1.8 times larger than the original factory weights. The residual unbalance in the cage after the factory balancing can be calculated by vectorially subtracting the factory weights (10.7 lbs at 298°) from the final weights (19.6 lbs at 263°). Using this procedure, the residual unbalance in the cage after the factory balancing was estimated to be 12.5 lbs at the outer radius of the upper ring.

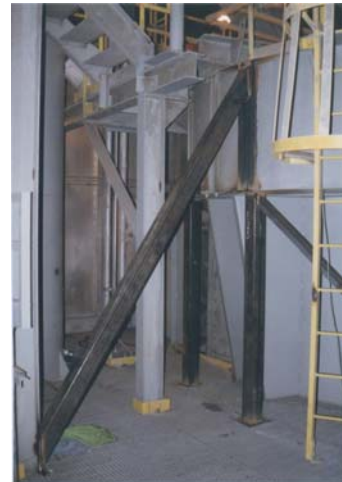
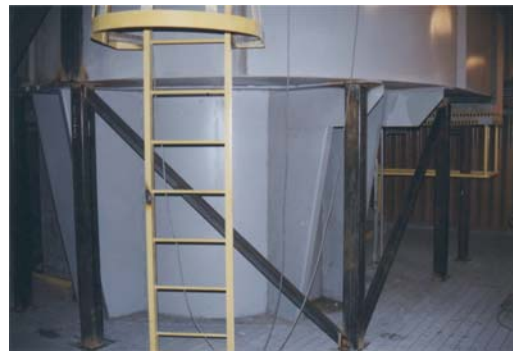
Figure 28: Additional Supports

28 and 29 were later painted and appeared to be part of the original design.

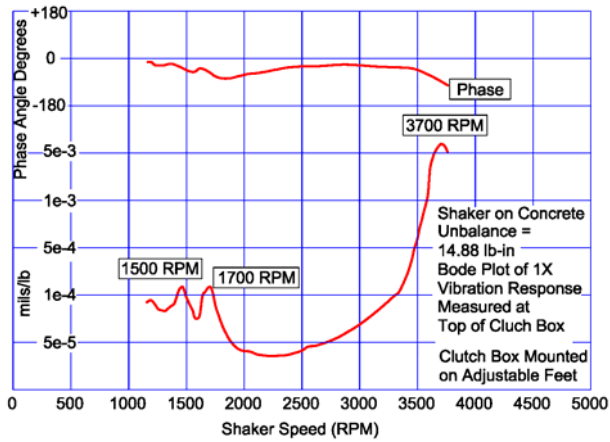
Figure 32: Bode Plot of Normalized Response of Clutch Box in Horizontal Direction during Shaker Test

vibration amplitude was divided by the unbalanced force from the shaker so that the normalized response has units of mils/lb. There was a peak response and accompanying phase shift near 3,700 RPM (62 Hz), which is in close proximity to the running speed of 3,600 RPM. Other response peaks near 1,500 RPM (25 Hz) and 1,700 RPM (28 Hz) were noted, but these peaks were more than 20 percent below the rated speed and are therefore not of concern.

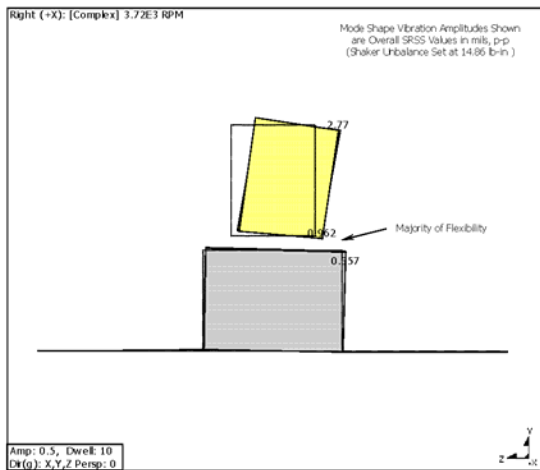
Figure 33: Vibration Mode Shape at 62 Hz

To characterize the mode shape at 62 Hz, a wire-frame model of the clutch box and foundation was developed. With the shaker speed set at 3,700 RPM, the vibration response was measured at all points in the model. Figure 33 shows that the majority of the flexibility occurred in the mounting of the clutch box. The clutch box was mounted on adjustable “feet” to allow for elevation adjustments.

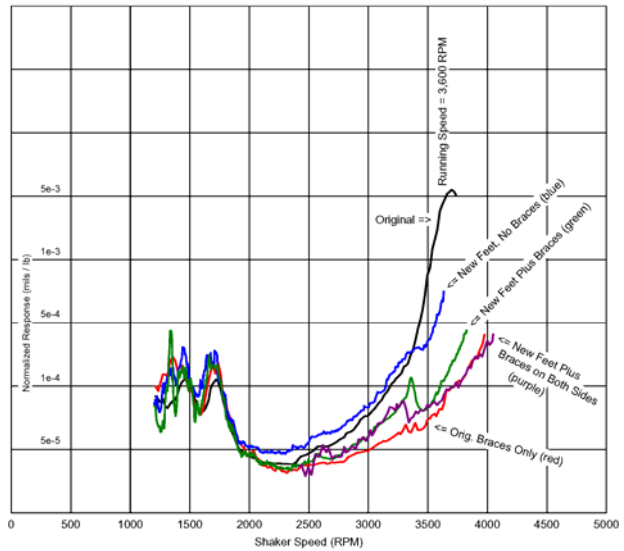
Figure 34: Comparison of Shaker Test Results

After the first shaker tests, temporary steel shims were wedged between the bottom of the clutch box and the concrete pedestal to determine if any change in the response frequency occurred. As shown in Figure 34, there was a slight increase in the response frequency (blue trace) with the temporary shims. This test indicated that improving the connection stiffness could be beneficial in detuning the resonance.

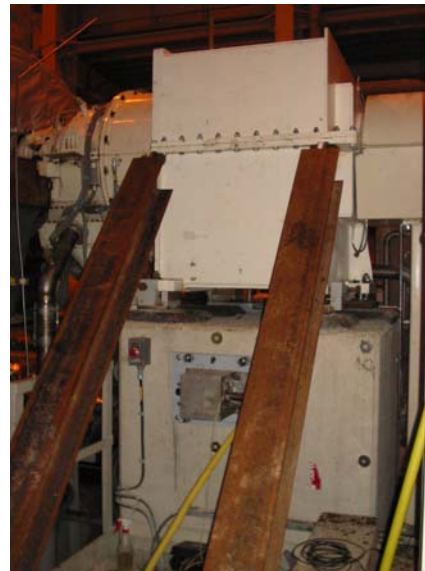
Figure 35: Clutch Box Diagonal Bracing

Next, diagonal braces from the clutch box case to the concrete pedestal as well as improved wedges between the sole plates and clutch box were installed as shown in Figure 35. The shaker tests were repeated. A comparison between the original (black trace) and modified frequency response (green trace) in Figure 34 shows a significant increase in the structural natural frequency. The exact frequency could not be identified due to the speed limitation of the shaker. Based upon the results of the shaker tests, the vibration reduction at 3,600 RPM was a factor of 2.5 with the improved mounting and diagonal braces to the clutch box.

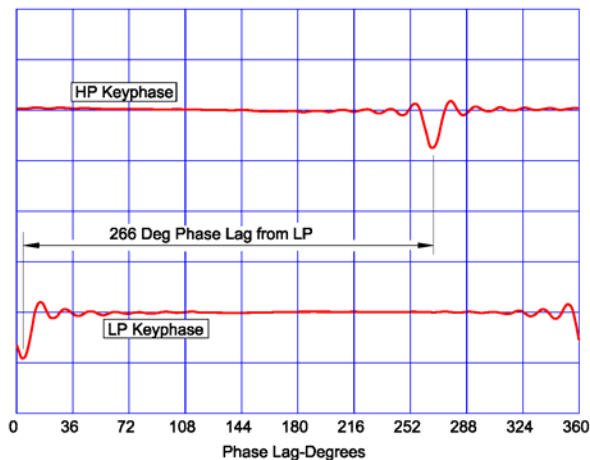
Figure 36: HP Turbine to LP Turbine Phase Lag

plotted during one revolution as shown in Figure 36. The phase lag of the HP key phasor relative to the LP key phasor was defined as the engagement angle (or “synch position”) for the purposes of the tests.

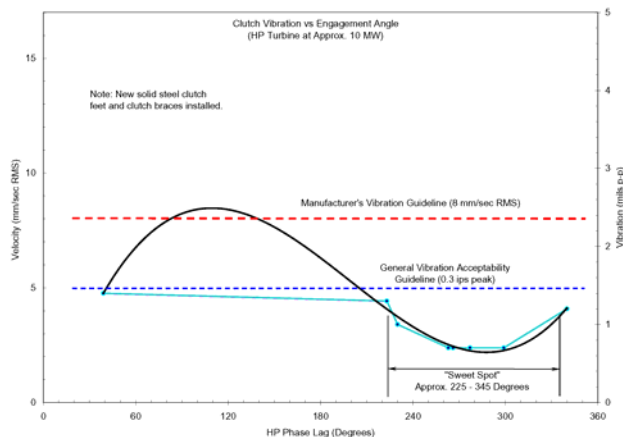
Figure 37: Clutch Vibration vs. Engagement Angle

The “sweet spot” with minimum vibration was defined with a minimum of three different engagement positions roughly equally spaced between 0 to 360 degrees. From these data, the plot shown in Figure 37 was developed. This allowed for the determination of which range of synchronizing positions would keep the vibration levels below the clutch manufacturer’s vibration allowable.
