TORSIONAL VIBRATION PROBLEM WITH MOTOR/ID FAN SYSTEM DUE TO PWM VARIABLE FREQUENCY DRIVE

Troy Feese

Engineering Dynamics Incorporated

Ryan Maxfield

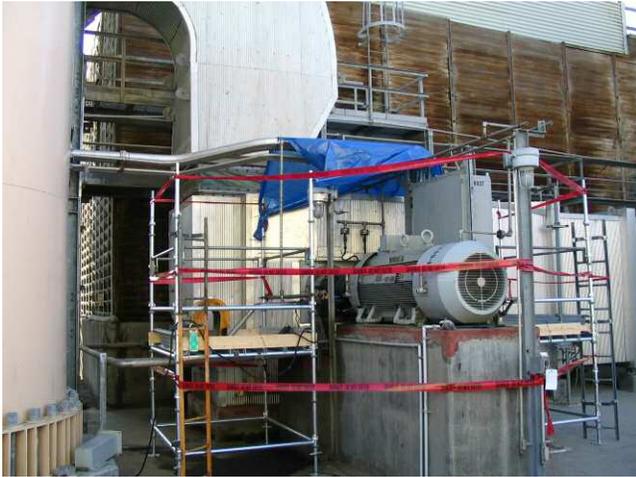
Figure 1. Picture of Motor at 50 Unit.

In this case, the end user experienced reliability problems with the ID fan system after installing a VFD for the motor control. One unit referred to as "50 Unit" consists of a 500 hp induction motor driving an ID fan for the furnace exhaust (Figure 1). Fan speeds range up to 1200 rpm during normal operation.

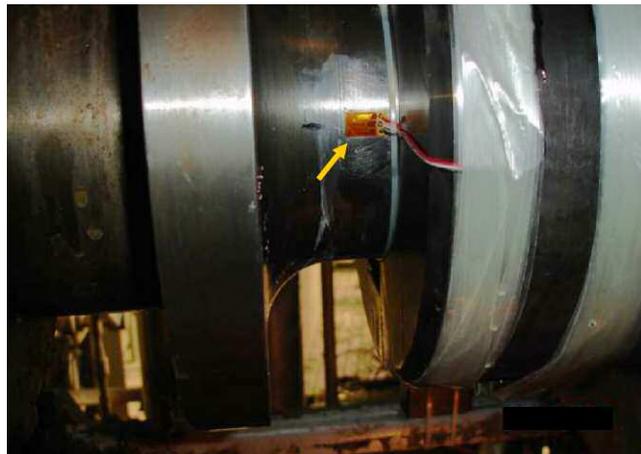
Figure 6. Strain Gauge Telemetry System.

- Strain gauges were attached to the fan shaft as shown in Figure 6. A battery powered telemetry system was mounted on the coupling hub. Gauges were oriented to measure shear strain. The output from the telemetry system was converted to static and dynamic torque.
- Flexible AC current probes were used to measure amperage. Probes were placed on electrical phases inside the VFD cabinet. Voltage signals proportional to current (1 mV/A) were recorded.
- An optical tach was used to obtain a once-per-revolution pulse from a piece of reflective tape placed on the fan shaft. The actual rotating speed of the motor/fan was determined from this tach signal.
