## **COUPLING FAILURE IN ENGINE-DRIVEN PIPELINE COMPRESSOR SYSTEM**

Troy Feese, P.E.  
Senior Engineer

Engineering Dynamics Incorporated  
16117 University Oak, San Antonio, Texas, 78249, USA

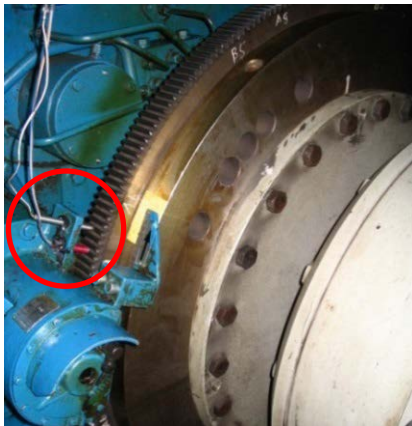
Torsional oscillation of the engine side of the coupling was measured using a proximity probe that monitored the gear teeth on the engine flywheel (Figure 3). Provided the lateral vibration is low, variations in time between tooth-passing should indicate torsional vibration. These pulses were then converted to torsional vibration using the Hilbert transform [2].

*Figure 3 – Proximity Probe at the Engine Flywheel*

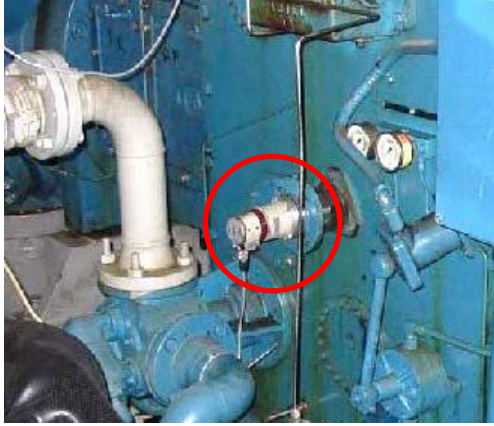
Torsional oscillation of the auxiliary end of the compressor crankshaft was directly measured using an HBM torsigraph mounted on a threaded-adaptor as shown in Figure 5. The torsigraph uses slip rings and outputs a voltage signal proportional to the measured angular oscillation.

Figure 5 – HBM Torsiograph on Auxiliary End of Compressor

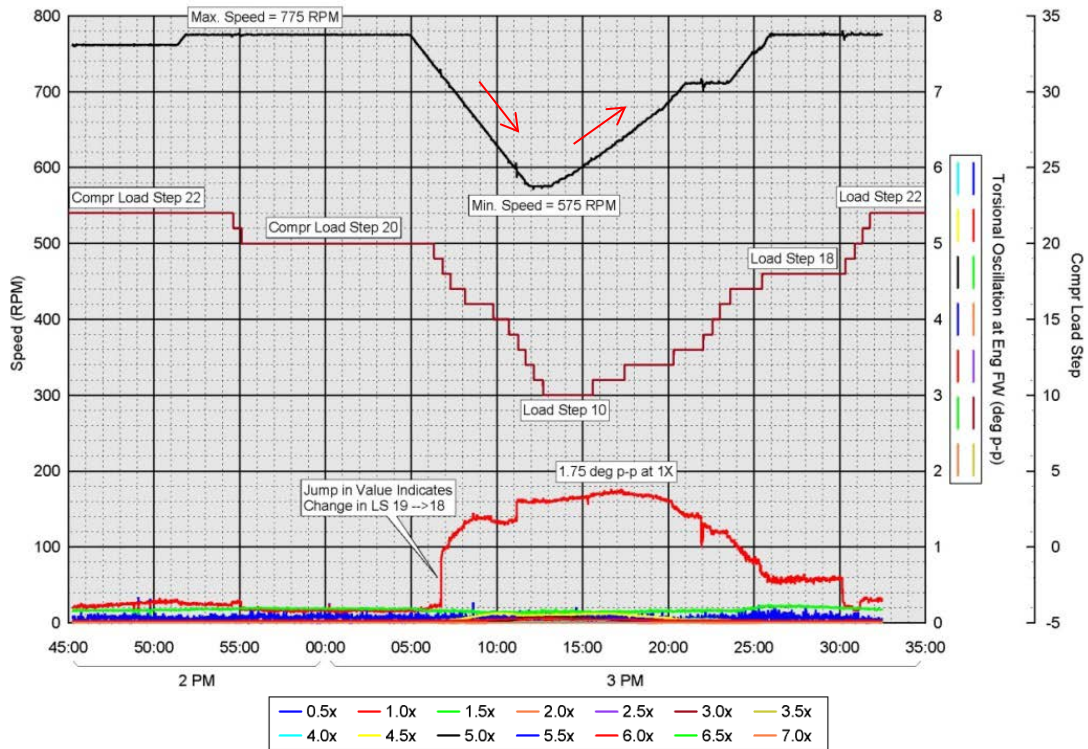
During the tests, all of the signals were simultaneously monitored and digitally recorded over the full operating speed range and at as many load steps as possible; however, based on the pipeline conditions only load steps 10 through 22 were available. The engine speed was slowly reduced from 775 to 575 RPM, and then increased back to 775 RPM. The compressor load steps were allowed to change automatically from 22 to 10. As shown in Figure 7, the torsional oscillation of the engine flywheel reached 1.75 degrees peak-to-peak when operating the compressor at lower speeds and load steps. A sudden jump of the  $1\times$  torsional amplitude was noted between load steps 19 and 18, which corresponded to loading the HE of compressor cylinder 1.

Figure 7 – Trend Plot of Speed, Compressor Load Steps, and Torsional Oscillation

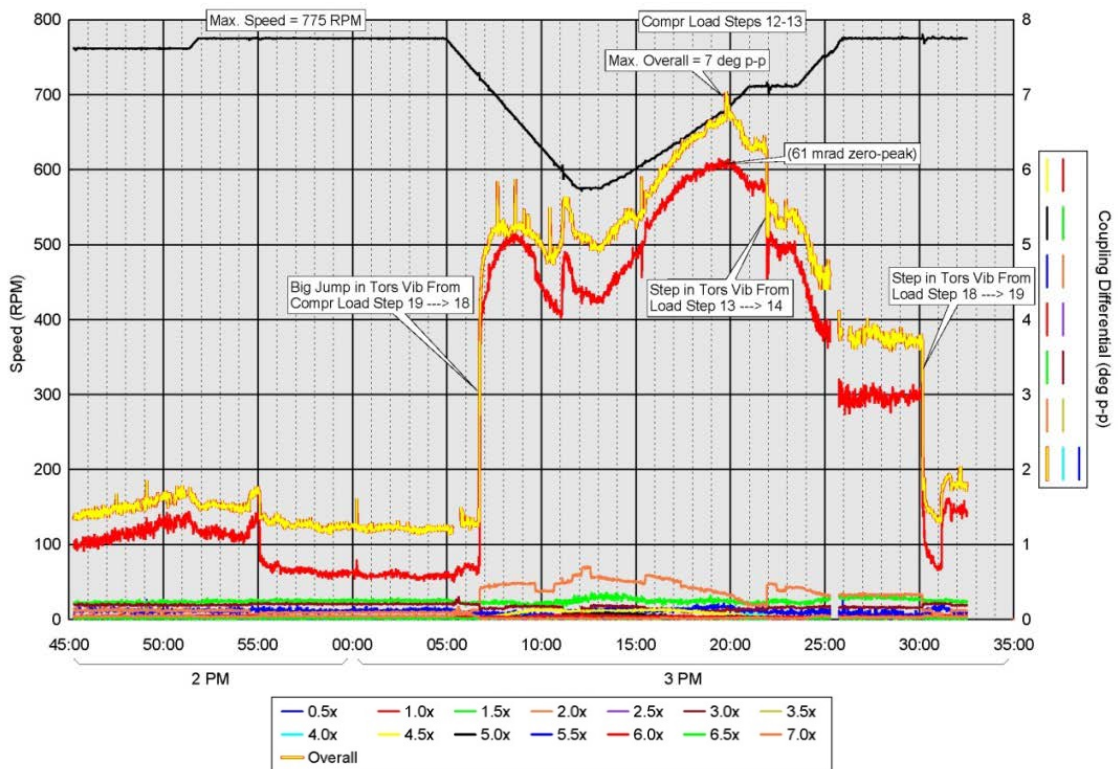
The dynamic differential angular displacement across the coupling is shown in Figure 8. The maximum amplitude occurred while operating near 675 - 680 RPM with compressor load steps 12 and 13. Cylinder 3 was single-acting which increased the dynamic torque at  $1\times$  running speed. As shown at 3:20 PM, the maximum differential across the coupling was 7 degrees peak-to-peak, or 61 milli-radians zero-peak.

Figure 8 shows that sudden jumps in torsional vibration occurred when switching between compressor load steps 18-19 and between steps 13-14. These steps correspond to loading the HE of cylinders 1 and 5, respectively. The transmitted torque results in approximately 80 milli-rad of constant angular displacement in the coupling. Combining the maximum dynamic angle of 61 milli-rad with the angle caused by the transmitted torque, sums to 141 milli-rad across the coupling. This exceeded the manufacturer's limit of 125 milli-rad, and indicated possible contact of parts inside of the coupling.

Figure 8 – Trend Plot Showing Differential Angular Displacement across Coupling

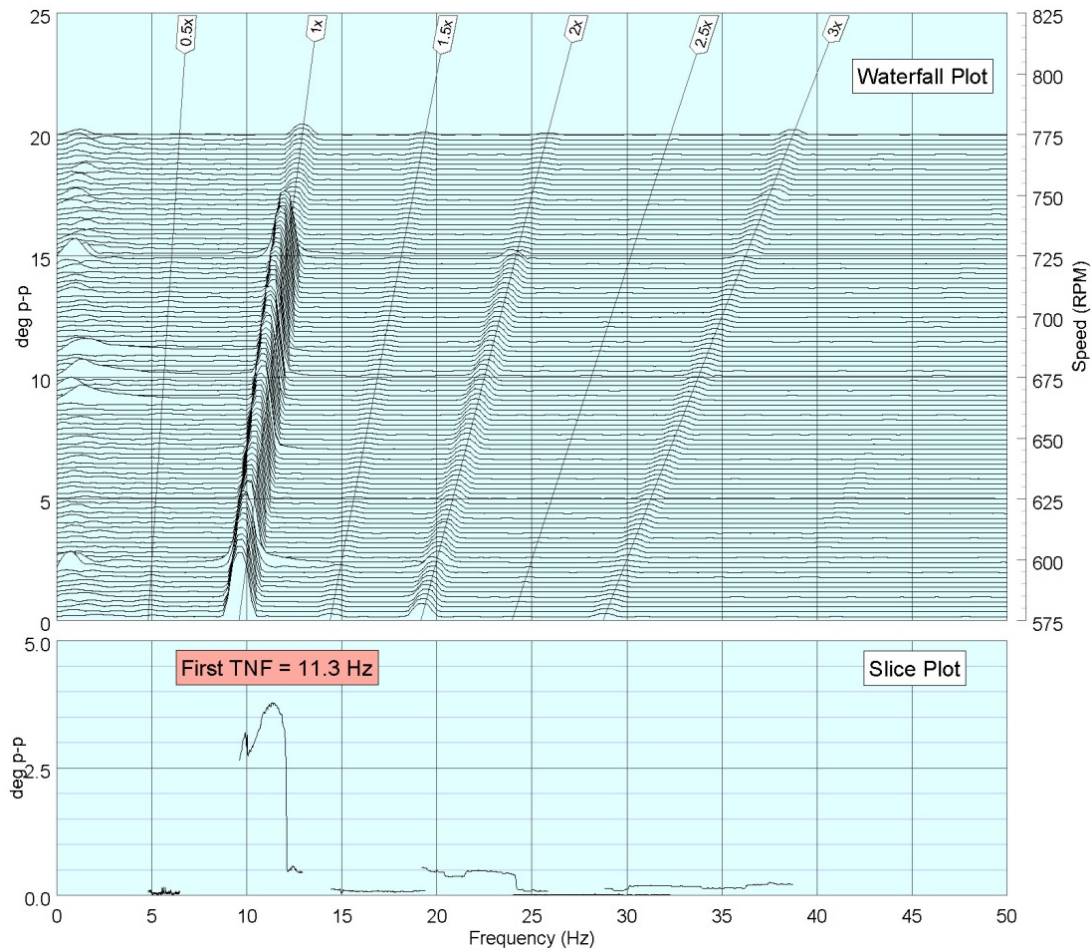
Figure 9 shows a waterfall plot of torsional vibration at the coupling flange on the compressor side as the unit speed was decreasing. The sudden jump in amplitude at 1× running speed was due to changing compressor load steps and excitation of the first TNF. The slice plot for the 1× harmonic shows the first TNF at 11.3 Hz or 678 CPM, which was within the normal operating speed range. A curve fit was used to estimate the amplification factor (AF) of 6, indicating that the actual system had less damping than was used in the original torsional analysis.

Figure 9 – Torsional Vibration of Coupling Flange on the Compressor Side

In subsequent tests, when the torsional oscillation was lower amplitude, the first TNF was found to be 10.7 Hz versus 11.3 Hz. It is thought that when the system was experiencing high torsional vibration, the springs were contacting the stops inside the coupling, thus increasing the torsional stiffness and the first TNF.
