COUPLING FAILURES IN VFD MOTOR / FAN SYSTEMS DUE TO TORSIONAL VIBRATION

Troy Feese, P.E.
Senior Engineer

Engineering Dynamics Incorporated
16117 University Oak, San Antonio, Texas, 78249, USA

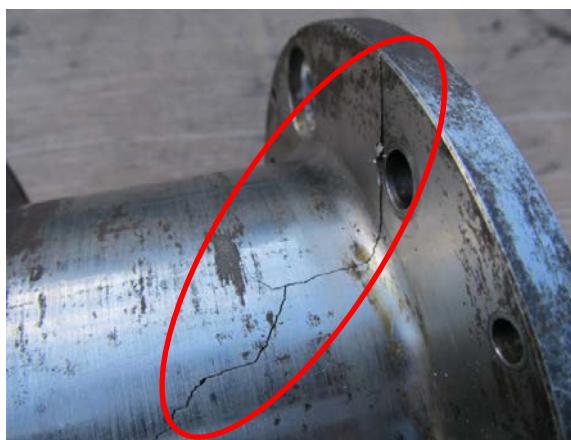
Multiple coupling failures included: cracked spacer pieces, broken bolts and disc packs as shown in Figures 1 and 2. The 45-degree angle of the crack through the coupling spacer and other broken parts are failures typically caused by high torsional vibration. These failures were not specific to just one blower unit, providing further evidence that it was a design problem.

Figure 1 – Cracked Spacer Piece

- The coupling failures were identified as typically caused by high torsional vibration (crack at 45-degree angle through coupling spacer).
- Initial field tests were conducted to obtain torsional vibration and electrical data. Excessive alternating torque was measured at certain operating conditions and found to be caused by the VFD. While at the plant, attempts were made to optimize (tune) various VFD parameters.
- A computer model was created to compute the TNFs. The computer model was adjusted to agree with the measured data.
- Possible modifications to the fan system were evaluated using the normalized computer model. The proper coupling size and durometer blocks were selected based on the worst case excitation levels.
- After the new rubber block couplings were installed, follow-up field tests confirmed that the torsional vibration problem was solved.

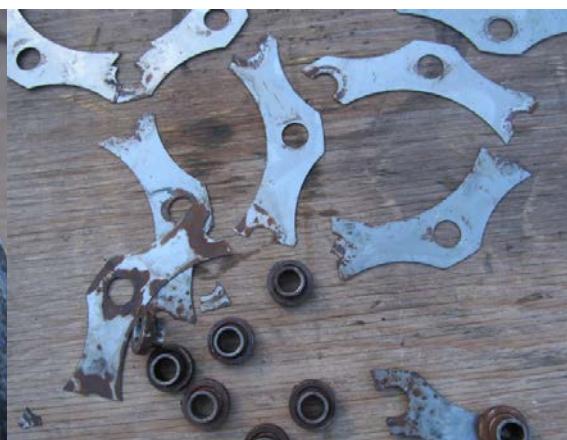
Figure 2 – Damaged Disc Packs

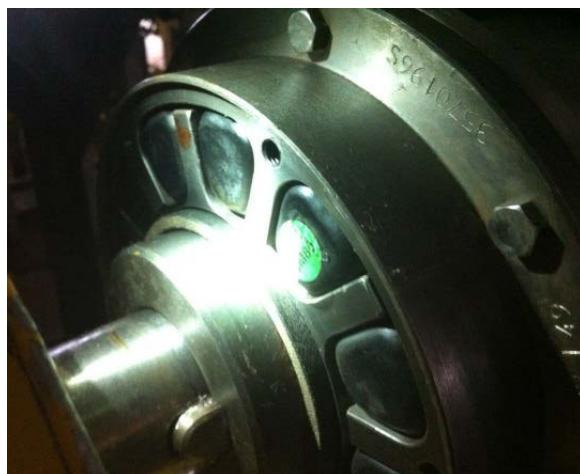
Follow-up field tests were performed on all three units after the new couplings were installed. The coupling with cover plate removed is shown in Figure 11.

Figure 11 – Coupling with Wedge Style Rubber Blocks

Improved reliability of these fan systems was achieved by installing couplings with rubber blocks, which added damping and detuned the first TNF. This type of coupling is commonly used in large fan systems at power plants. When specifying a coupling with rubber elements in VFD service, consider oversizing the coupling (use greater service factor) to ensure that the rubber blocks do not prematurely crack or overheat. Periodic inspection and replacement of rubber blocks are recommended per the coupling manufacturer. In addition, the end user has specified that any new VFD motor / fan systems be designed with 18-pulse VFDs for smoother output.
