EXPERIENCES WITH NONSYNCHRONOUS FORCED
VIBRATION IN CENTRIFUGAL COMPRESSORS

D. R. Smith
J. C. Wachel
Engineering Dynamics Incorporated
San Antonio, Texas 78232

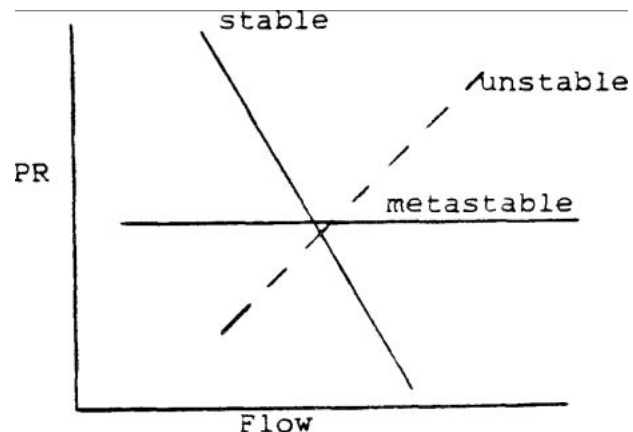
FIGURE 7
Plot of Measured Pressure Ratio Versus Flow

the compressor running speed and the total flow were logged every minute on the process computer in the control room. The test conditions were plotted on a performance map (Figure 7). As shown, the measured test conditions plotted on the performance map did not agree with the predicted curves displayed on the process computer. The source of the discrepancy was not known; however, it could have been caused by an instrumentation error or the actual performance curve was different from the curves stored in the computer.

Although the measured performance data was different than the predicted performance curve, the data did show that the subsynchronous vibration and pulsation amplitudes were greater at operating conditions closer to the calculated surge line shown on the performance map. The surge line shown on the performance map is the surge line for the combined low and high pressure compressors. Although the compressors did not appear to be operating near the system surge line, the high pressure compressor was probably operating near surge or stage stall conditions for one or more of the final stage impellers.

As shown on Figure 7, the plot of the measured pressure ratio versus flow was much flatter than the predicted curves. This would indicate that the compressor was operating near the metastable region.

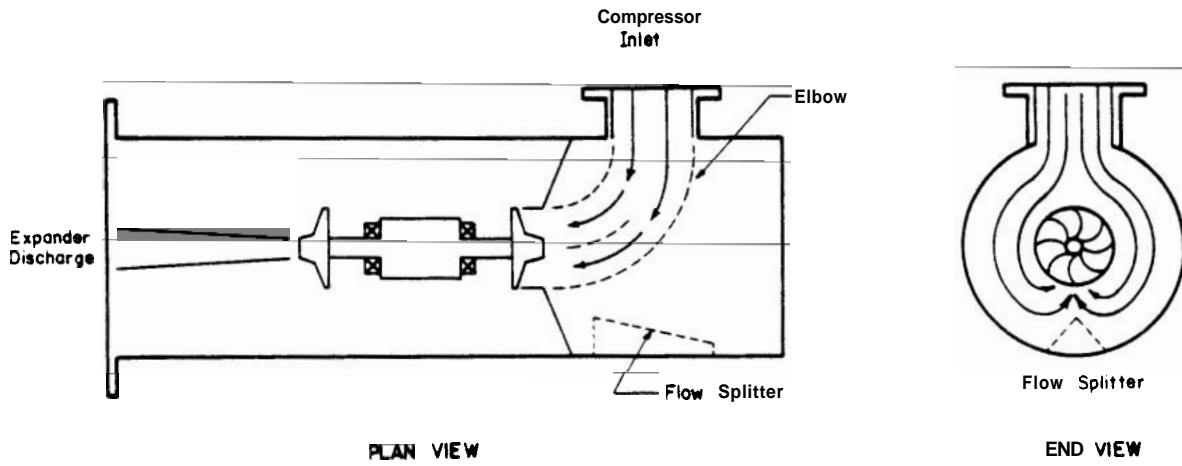
FIGURE 1
Cutaway Drawing of Turboexpander/Compressor Illustrating
Inlet Modifications

As shown in Figure 1, the suction piping was perpendicular to the compressor

shaft and the gas flow had to make a sharp 90 degree turn to enter the compressor impeller. There were no inlet guide vanes or turning vanes in the compressor inlet chamber. It was felt that the problems were caused by turbulence occurring at the inlet of the compressor impeller. In an effort to improve the flow into the compressor, a flow splitter was fabricated on-site and installed in the inlet chamber directly in line with the suction inlet. After the flow splitter was installed, the subsynchronous vibrations, pulsations and speed modulations were significantly reduced and the performance was improved (Figure 2). Similar flow splitters have been used on induced draft fans to prevent inlet vortices which create rotating stall conditions (Ref 5).

Based upon the data obtained with the flow splitter, a compressor inlet modification was designed to further improve the compressor inlet flow conditions. The modification used an elbow inside the compressor inlet chamber to direct the flow into the impeller. A vertical flow splitter was added to ensure that the flow was properly distributed over the flow area of the elbow. Tests showed that the inlet modification greatly improved the inlet flow conditions, reduced the subsynchronous shaft vibrations and pulsations, lowered the speed modulations, virtually eliminated the low frequency piping and case vibrations and improved the compressor performance (Table 1). It is interesting to note that the rotor vibration amplitudes at the running speed (13000 rpm) were not affected by the flow instabilities. This unit has operated successfully for several years since the inlet was modified.

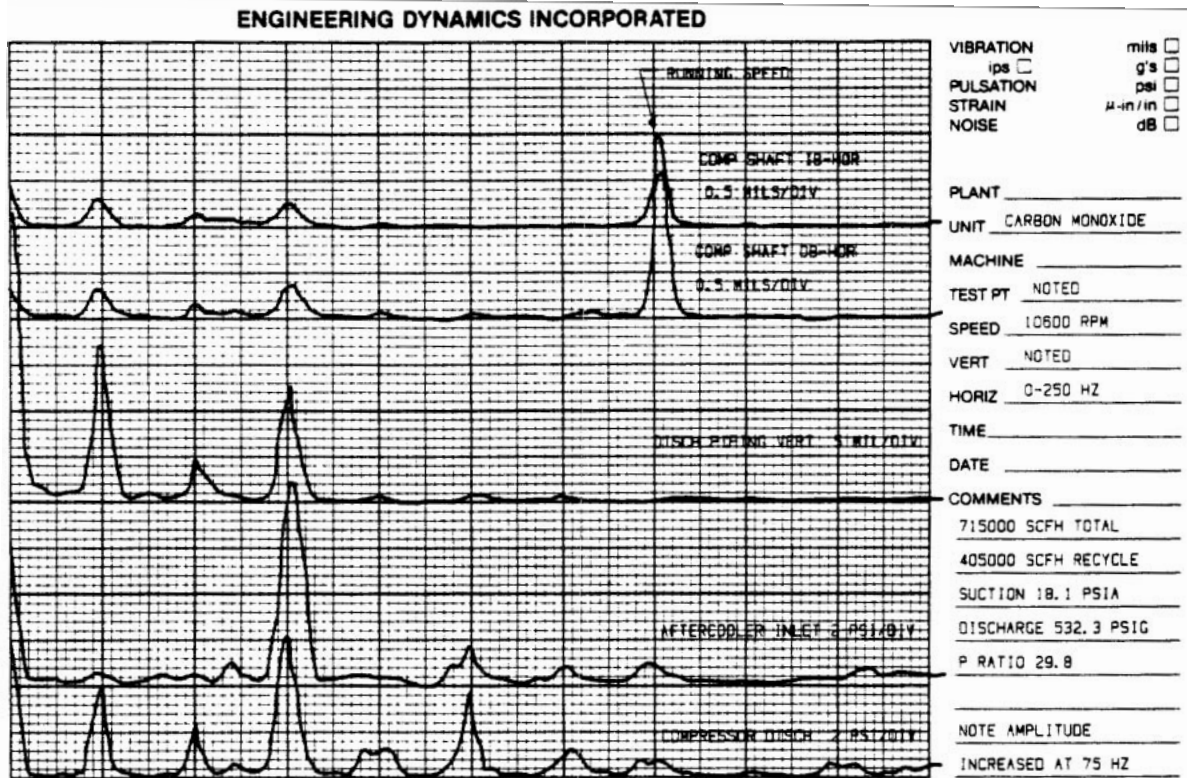
FIGURE 3

Frequency analyses of the compressor discharge pulsations, aftercooler inlet pulsations, discharge piping vibrations and compressor shaft vibrations are plotted for comparisons in Figure 3. It was found that pulsation and vibration amplitudes could be significantly changed by running the compressor at different operating conditions (Figure 4). The operating condition with minimum pulsation and vibration amplitudes was the condition with maximum flow rate and minimum pressure ratio. The piping vibrations and pressure pulsations were primarily at subsynchronous frequencies near 25 Hz and 75 Hz. The amplitude of the frequency components were beating, as can be seen from the time cascade spectral plots given in Figures 5–6.

NOTE AMPLITUDE
INCREASED AT 75 HZ

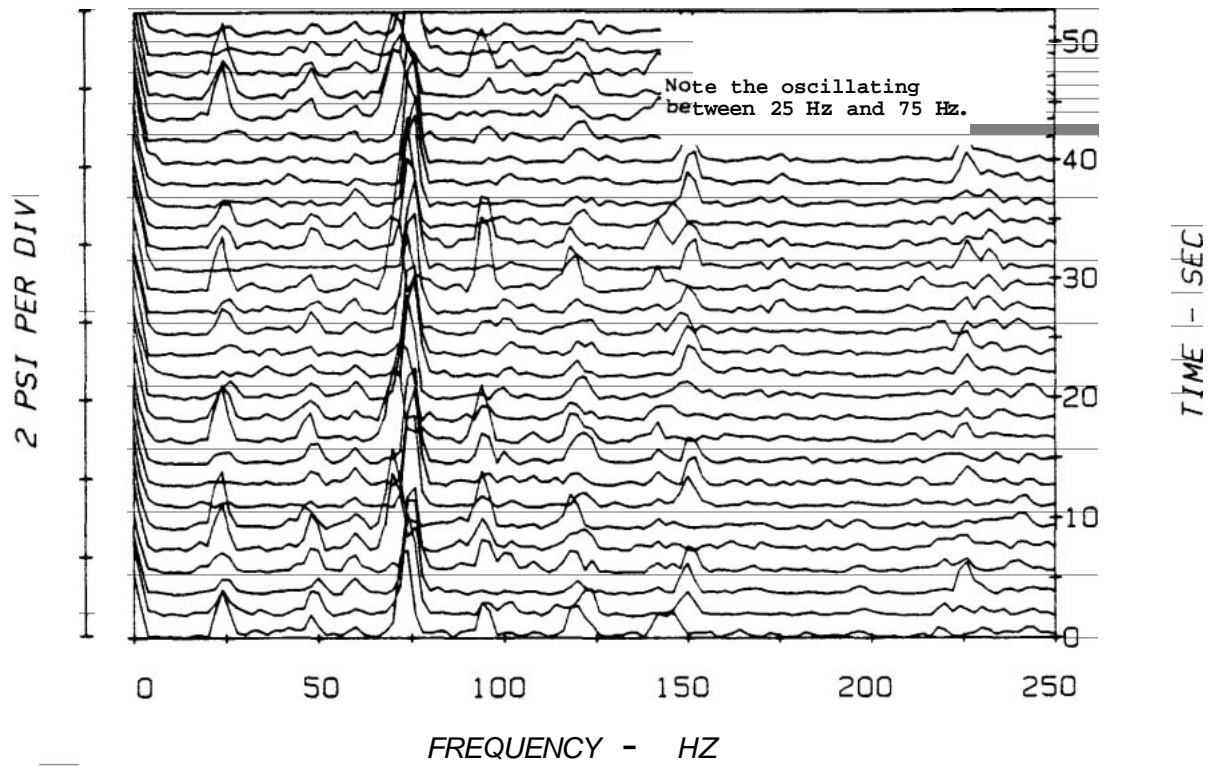
FIGURE 5
Compressor Discharge Pulsations Plotted Versus Time

Note the oscillating between 25 Hz and 75 Hz.

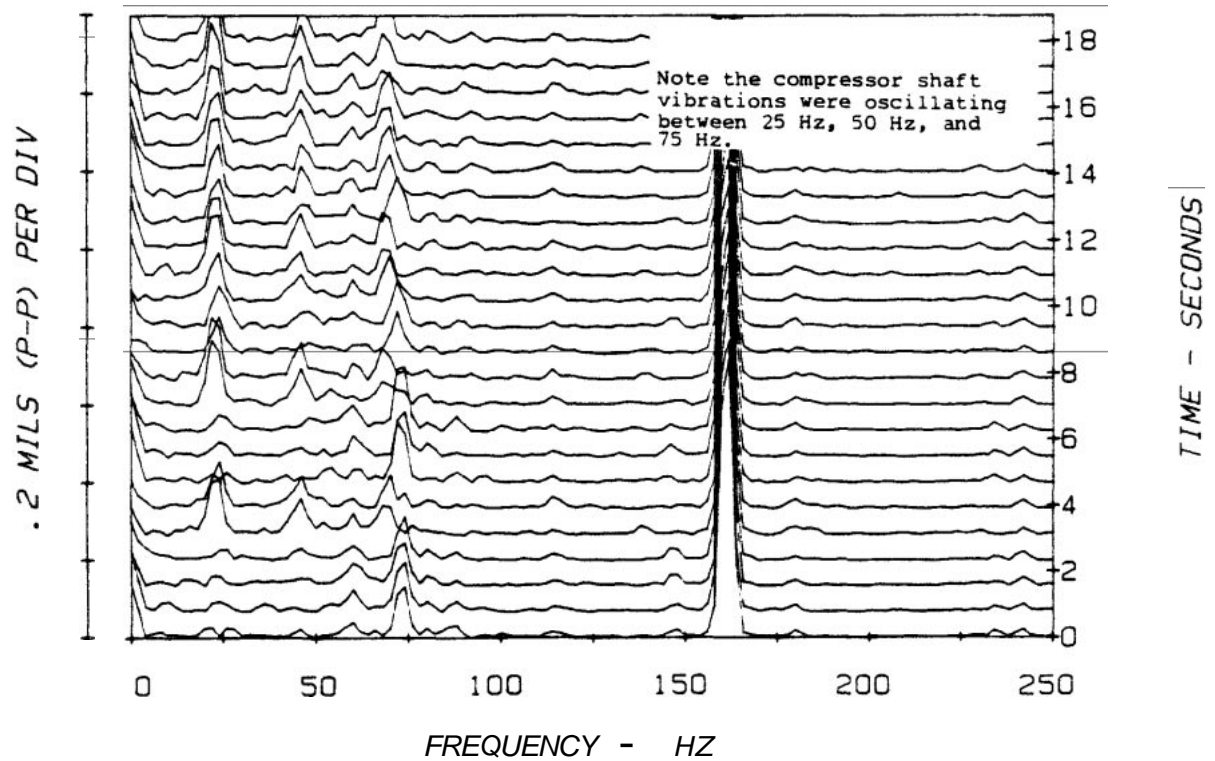
FIGURE 6
Compressor Shaft Vibrations Plotted Versus Time

Note the compressor shaft vibrations were oscillating between 25 Hz, 50 Hz, and 75 Hz.

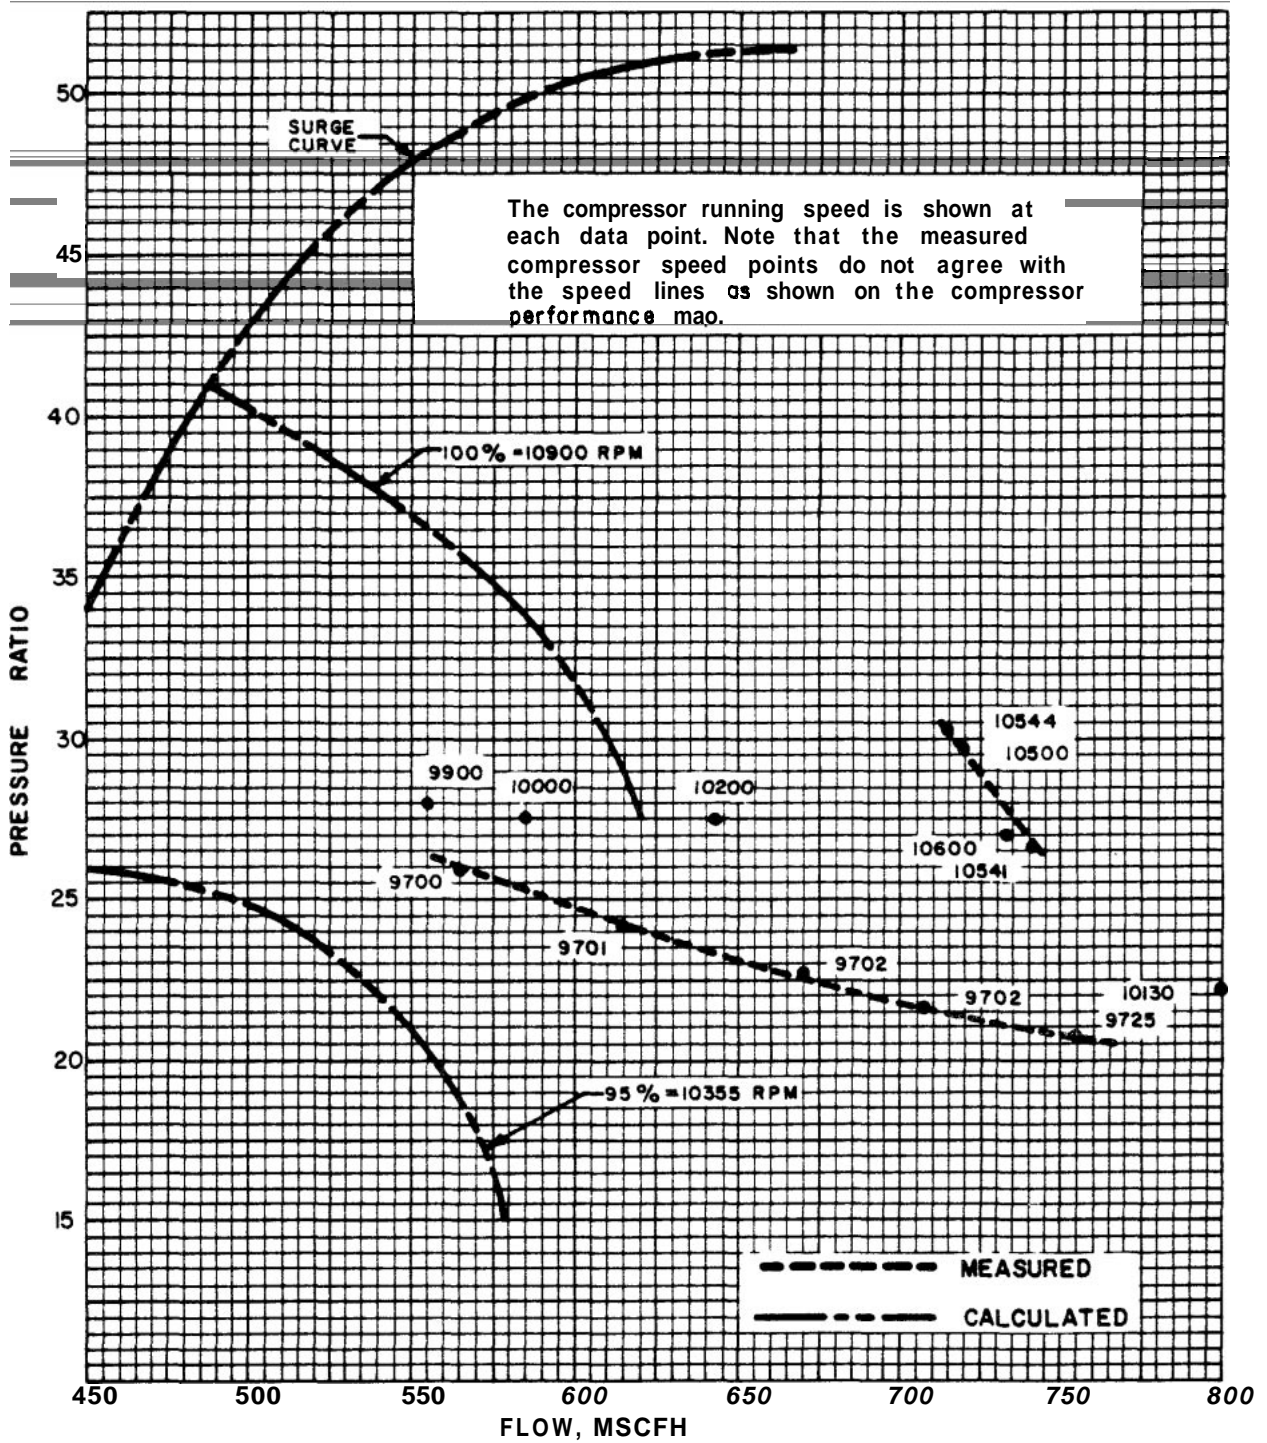
The compressor running speed is shown at each data point. Note that the measured compressor speed points do not agree with the speed lines as shown on the compressor performance map.
