TURBINE AND COMPRESSOR VIBRATIONS  
ENCOUNTERED AT STARTUP OF A METHANOL PLANT

J.C. Wachel  
Manager of Engineering  
Engineering Dynamics Inc.  
San Antonio, TX

Adapted from Paper 52B presented at

American Institute of Chemical Engineers  
Ammonia and Related Plants Safety Symposium  
Minneapolis, Minnesota

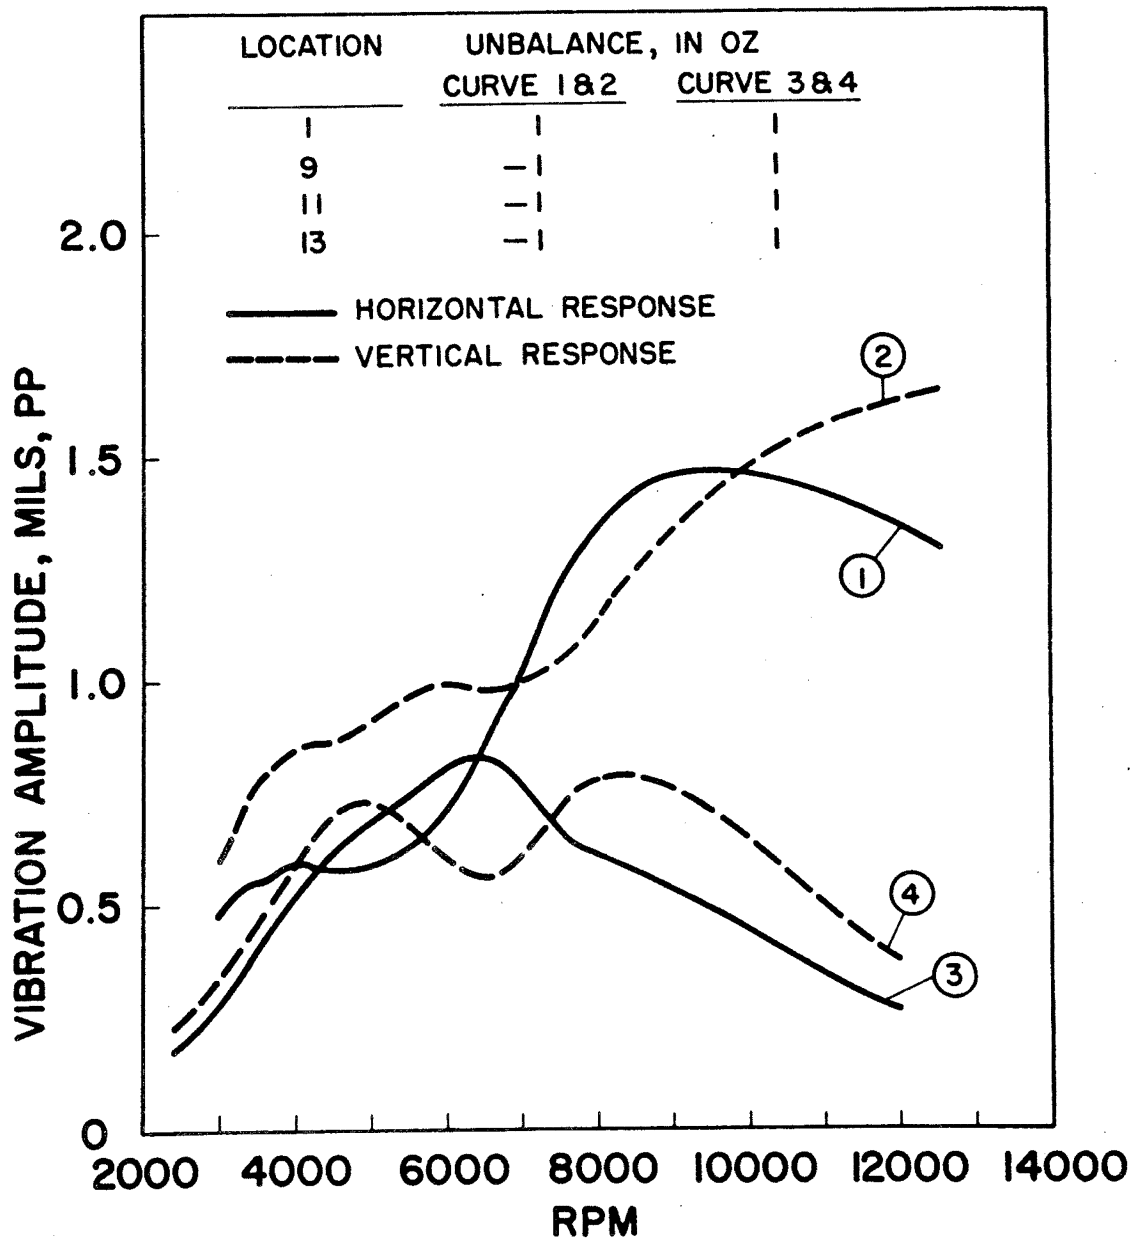
FIG. 1 PREDICTED VIBRATION RESPONSE OF TURBINE ROTOR

vibration response of a unit can be correctly interpreted is to have accurate information on critical speeds and amplitude response. Figure 1 shows two calculated responses for the turbine rotor at the outboard bearing with only a phase change in the unbalance. This data shows that the rotor response could change considerably depending on the location of the unbalance. Vibration measurements made on the test stand indicated that the first critical was near 6900 rpm.
