Failure analysis of an MVR (mechanical vapor recompressor) Impeller

ABSTRACT

This article describes the root cause failure analysis of a mechanical vapor recompressor (MVR) impeller used in a dairy processing plant. An impeller blade was thrown during commissioning after approximately 150 h of service. Visual examination of the blade's fracture surface indicated that the crack growth mechanism was fatigue and this was confirmed by scanning electron microscope (SEM) examinations. A detailed investigation was commissioned to determine the source of the oscillatory stresses that must have been present to cause fatigue. A vibration analysis indicated large torsional oscillatory stresses, leading to fatigue, were induced by excitation of the 1st and 2nd torsional vibration modes of the MVR impeller and motor system. The excitation was induced by the control system for the motor variable speed drive (VSD).

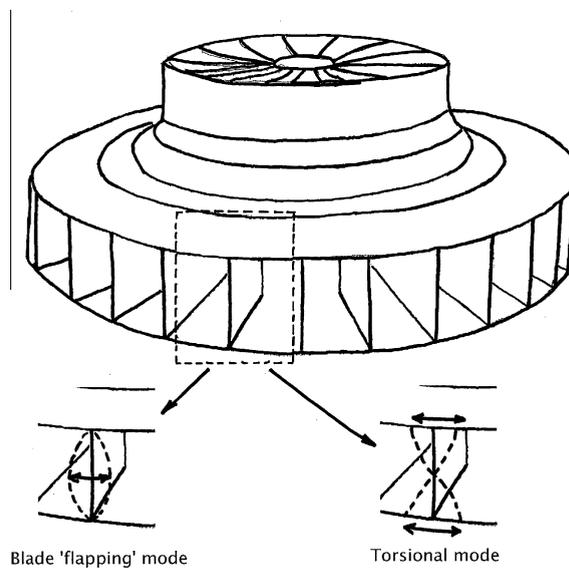
Fig. 8. Possible vibration modes.

In seeking a source of stress, two vibration modes were conceptually identified: a blade ‘flapping’ mode and a torsional mode (see Fig. 8). Thus, the first step was to calculate and measure the natural frequencies for structural modes of vibration of the blades, and the torsional frequency for the impeller (front ring relative to back plate). In addition, an impulse response procedure was used to confirm the calculated values. Initial calculations indicated the three lowest “flapping” modes were 438, 567 and 1037 Hz. These compared well with the measured modes of 422, 586 and 1055 Hz respectively. The torsional mode for the whole impeller was calculated approximately as 71 Hz. The impulse response tests using accelerometers glued to the blade surfaces indicated 94 Hz. Note that the impact tests were performed on a damaged impeller with cracked blades, lying with its back plate on the ground. It is likely these issues will have affected the results.
