Motor / ID Fan System for Main Crude Unit at Refinery

By Troy Feese, P.E.
Engineering Dynamics Incorporated, San Antonio, Texas, USA
www.engdyn.com

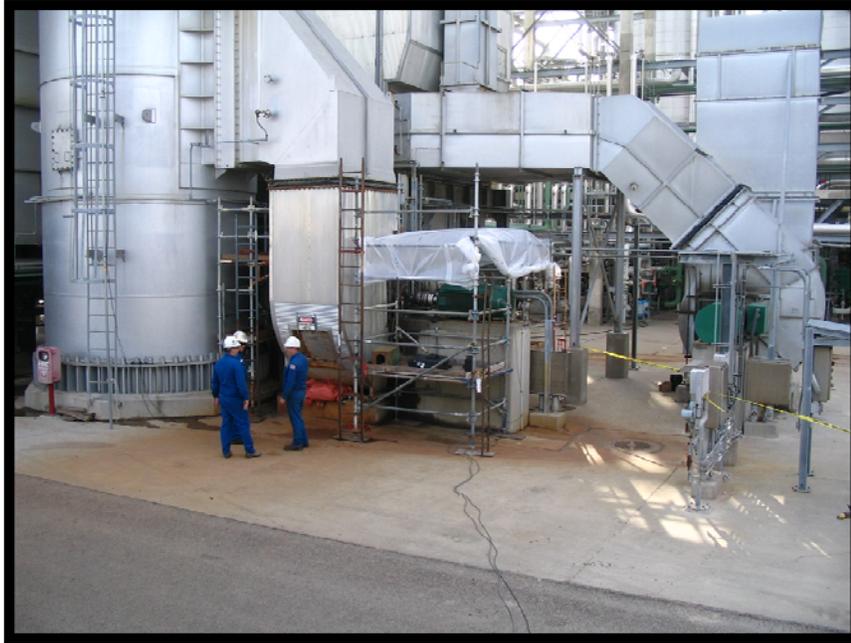
The failure of the original flexible disc coupling consisted of a crack in the spacer, which appeared to originate at a bolt hole. Initially, plant maintenance was blamed for possibly over tightening the coupling bolts. The 45 degree angle of the crack in the coupling spacer is a typical indication of high torsional vibration.

EDI performed a torsional analysis of the system and selected an alternate coupling with standard rubber blocks in compression to detune the TNF away from the 1x electrical frequency of the VFD. The new coupling was installed and the equipment has been working satisfactorily ever since. This case history shows the importance of performing a torsional analysis on a new system or when a system is modified. The TorqueTrak 10K strain gage telemetry system from Binsfeld Engineering was very valuable in collecting data and determining the cause of the original flexible disc coupling failure.
