Special Considerations for Electric Motors Driving Reciprocating Compressors

Troy Feese, P.E. - Senior Staff Engineer
Engineering Dynamics Incorporated – San Antonio, TX
and
William (BJ) Schnitzler, P.E. - Electrical Engineer Supervisor
Western Midstream*

Abstract

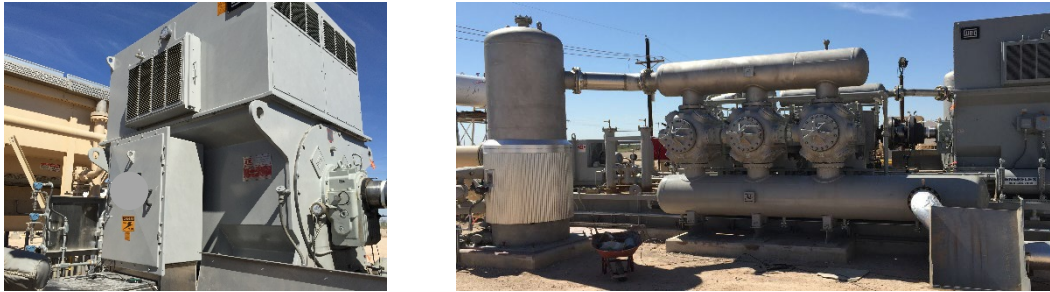
Figure 1. a) Motor, b) Compressor

This first case study shows the importance of the motor being properly anchored. The induction motor was rated for 5,600 HP at 894 RPM and was driving a 6-throw, 3-stage compressor in CO₂ service. The motor is “soft started,” and then transferred to constant speed. A soft start refers to the reduced motor acceleration and inrush current compared to an across-the-line start. Figure 1 shows photos of the unit.

A baseline vibration check was requested on the motor after being put back into service following bearing repairs. During loaded operation of the compressor, the control panel indicated a vibration alarm on the motor. The vibration primarily occurred at 1× running speed, which can be related to imbalance [8] of the motor rotor, coupling, or shaking forces from the compressor.

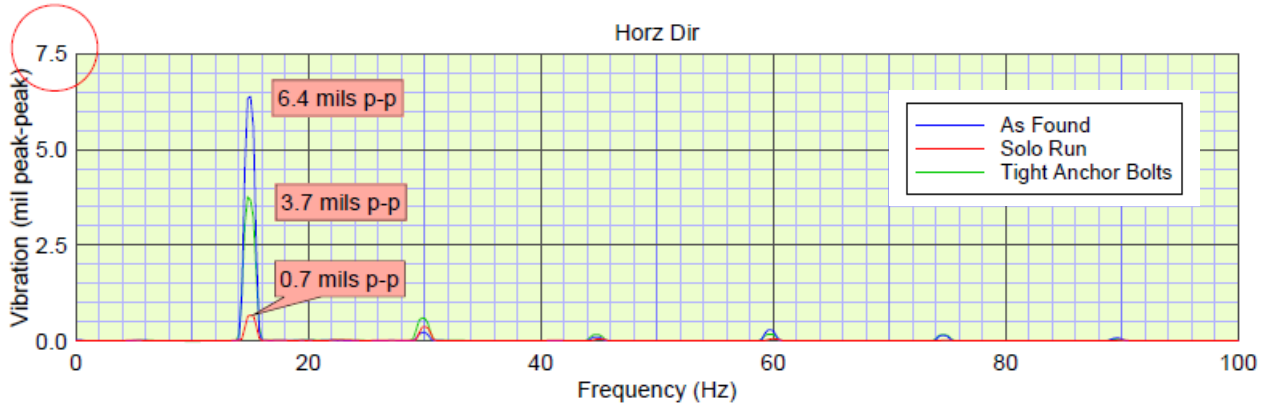
Figure 5. Comparison Vibration Plot

Thicker washers were fabricated in the field and the torque was increased on the anchor bolts. After these modifications, the indicated vibration on the control panel was reduced to approximately 0.16 – 0.18 ips, and the motor was no longer in alarm condition. Comparison vibration plots measured at the motor centerline are shown in Figure 5.

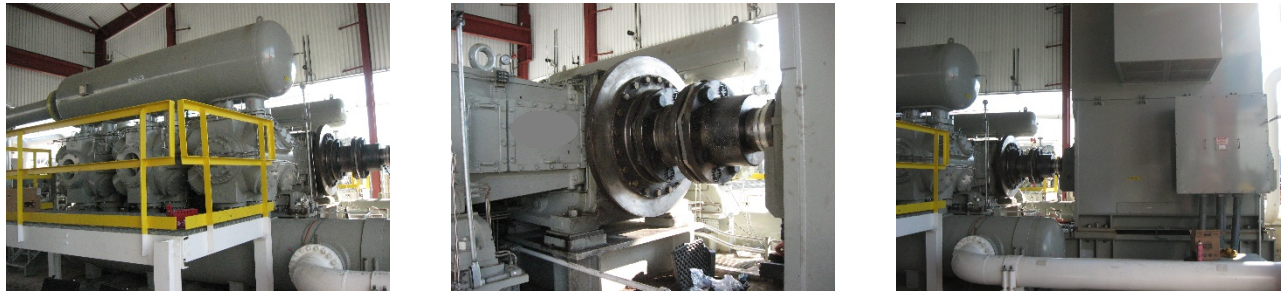
Figure 7. a) Compressor, b) Coupling, c) Motor

Coupling disc pack failures occurred on the induction motors of two identical residue compressor units at a gas plant. The failures occurred within approximately 4000 hours of operation.

The motor rating was 9,300 HP at 717 RPM. The coupling used a keyless hub on the motor side and there was a flywheel adaptor on the compressor side. The reciprocating compressor was a 6-throw unit in 2-stage service. Photographs of one of the units are shown in Figure 7.

In summary, no torsional problems were found. Instead, high axial vibration of the coupling and motor rotor was observed and was believed to be causing the disc pack failures. The axial vibration was highest at certain compressor load steps. The motor had a single cooling fan mounted on the shaft, which could create a thrust force that interacts with the magnetic centering force and axial stiffness of the coupling. Axial alignment and installation procedures may have also been contributing factors.

- Since the couplings in both units were subjected rough operating conditions, inspections of the disc packs were recommended.
- It was recommended to verify alignment on both units. Previous experience of the compressor manufacturer showed that improving axial alignment solved the axial vibration problem.

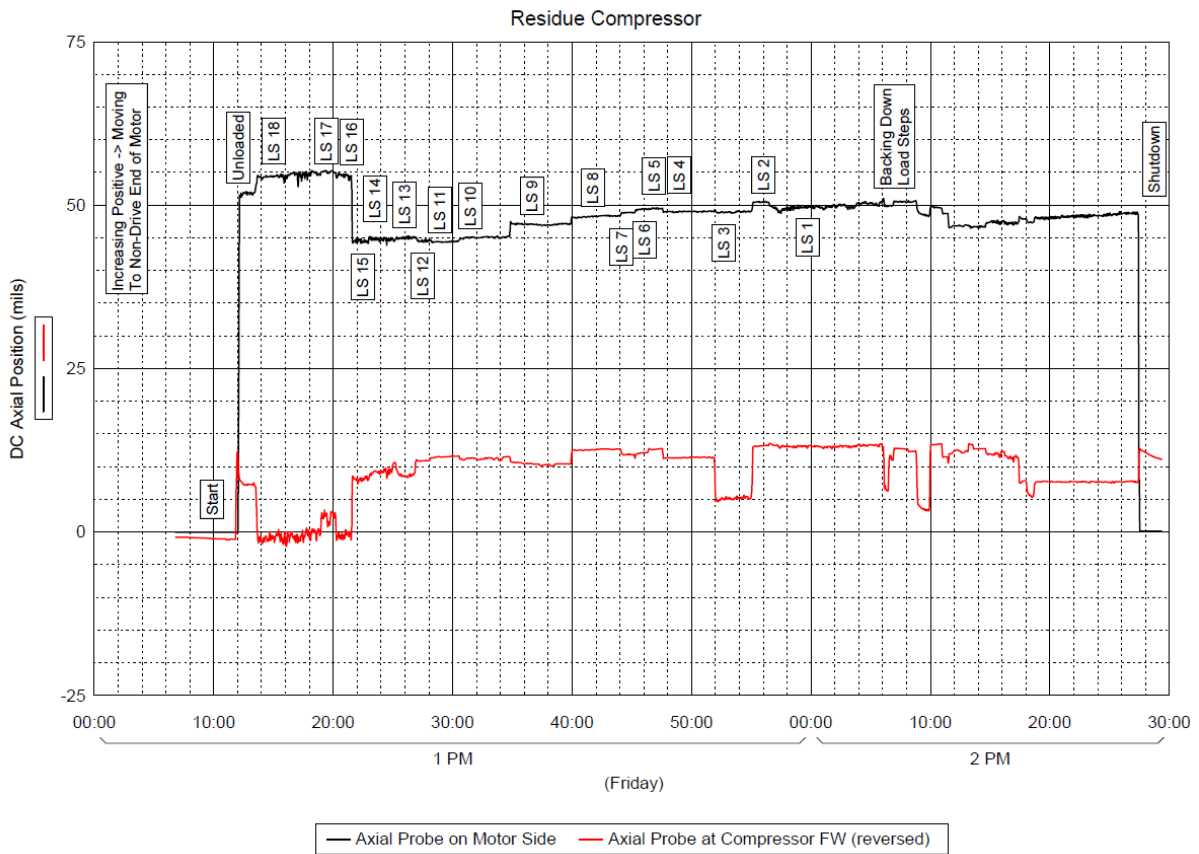
Figure 9. Trend Plot

The axial position of the motor and compressor shafts were plotted, as shown in Figure 9. There was a large change in axial position for the motor during startup. There was another sudden shift in axial position between load steps 16 and 15.

There was significant axial motion of the motor for load steps 2 and 1. However, these were considered relatively good load steps for the first unit. Axial motion occurred at 2.5 Hz during load step 2 operation. At load step 1, additional low frequencies appeared: 4.88, 7.25, and 9.63 Hz. It is interesting to note that the spacing of the low frequencies was 1/5th of the 1x running speed of 12 Hz.

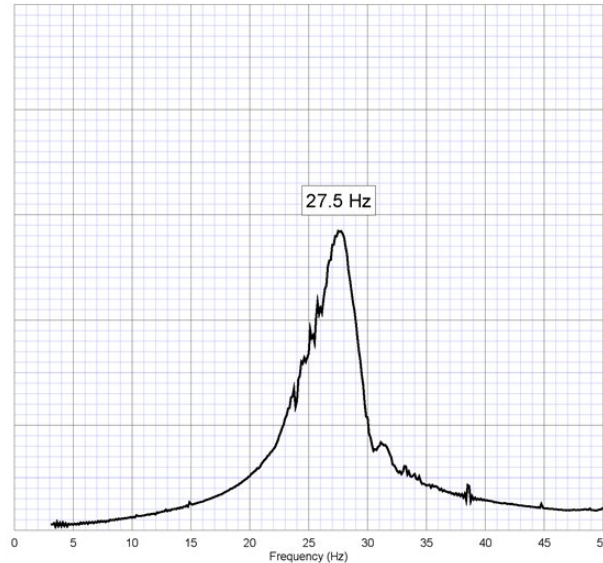
Figure 10. Impact Test

With the unit down, an impact test was performed on the center spacer piece of the coupling. An impact test involves using an instrumented hammer with load cell and accelerometer to measure the response. A natural frequency is identified by a peak in amplitude along with a phase shift. For this case, with the unit at rest, the axial natural frequency was found to be approximately 27.5 Hz (1650 CPM) as shown in Figure 10.

According to the coupling manufacturer, the spacer weighed 694 lbs. The manufacturer's calculated axial natural frequency for this coupling was 800 CPM (with zero axial deflection) to 1300 CPM (with maximum axial deflection of 0.1 inch). This corresponds to approximately 13 - 22 Hz, which was lower than measured with the impact test but well above the predominant frequencies of axial vibration observed. However, if the disc packs were deflected more than maximum allowable of 0.1 inch, this could account for the higher measured natural frequency in the field compared with theoretical predictions.

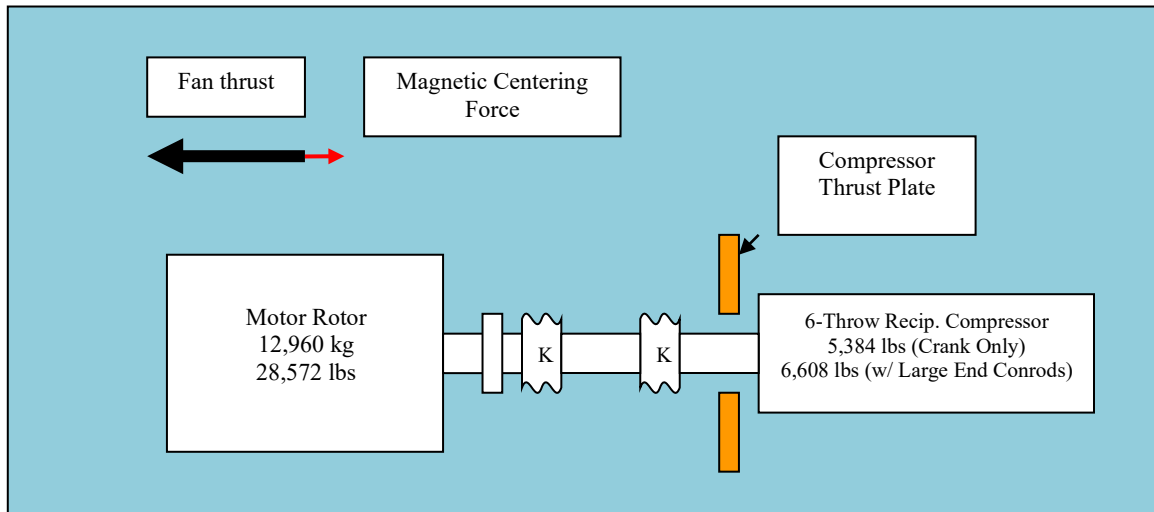
Figure 11. System Diagram

In addition to the axial natural frequency of the coupling spacer, there is also an axial natural frequency of the motor versus compressor with the controlling stiffness being the coupling. As shown in Figure 11, there are several forces acting on the system. There was only one cooling fan on the motor shaft and it may have caused a thrust toward the non-drive end of the motor. There is also a magnetic centering force in the motor between the stator and rotor.

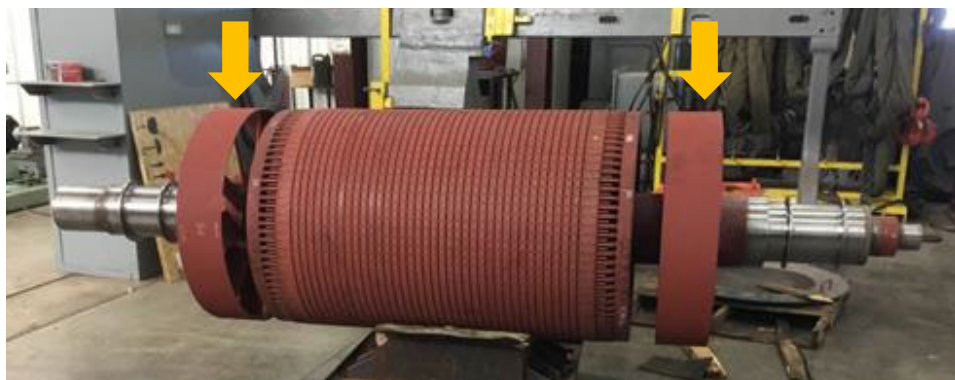
Figure 17. Motor Rotor with Internal Fans

Figure 17 shows the motor rotor with two internal fans (NDE and DE) sitting on the shop floor.

Some of these motors experienced failures of the internal cooling fans after commissioning. For example, the first two failures were detected when the cracked fan shroud contacted the winding causing a differential trip. This trip had a repeatable behavior (tripping at a certain point during the starting sequence). The plant found the differential protection reliable and likely prevented major damage from occurring.

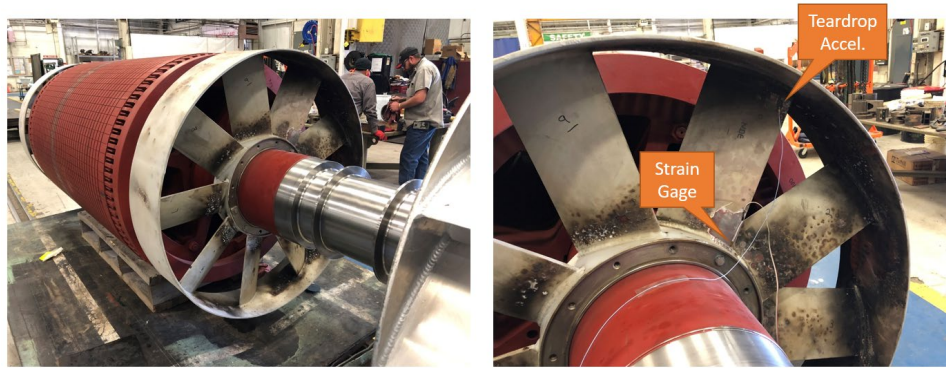
Figure 19. Close-Up of Internal Fan NDE with Instrumentation

Impact tests were recommended to determine the natural frequencies and mode shapes of the existing motor fans. The data could also be used to help normalize the finite element analysis (FEA) that the motor manufacturer was performing.

Impact response spectra were obtained using an instrumented hammer, a response accelerometer, and a strain gage. The impact tests were performed in the motor repair shop with the rotor removed.

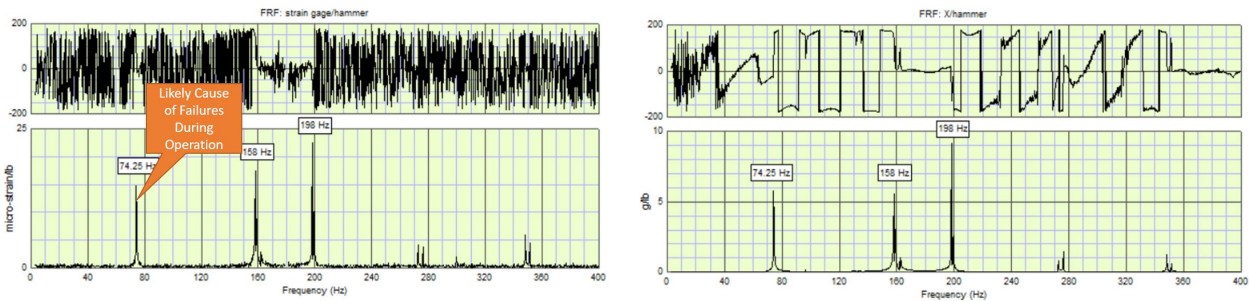
Figure 20. Impact Test Results

Frequency response functions (FRF) were plotted. A natural frequency is identified by a peak in response amplitude and a phase shift.

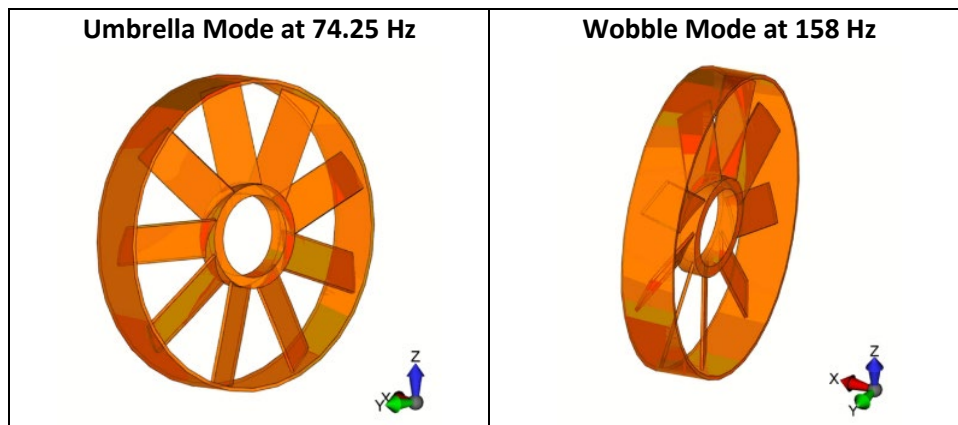
Figure 21. Fan Mode Shapes

Two typical fan modes were identified by the impact data and mode shape software [20]. The first mode is like an umbrella folding with the fan blades flexing and the center hub fixed. Maximum stress would be near where the cracks formed. The second mode has the outer ring wobbling about the center hub with the fan blades flexing. Reference [21] gives more details about modal testing of a motor fan.

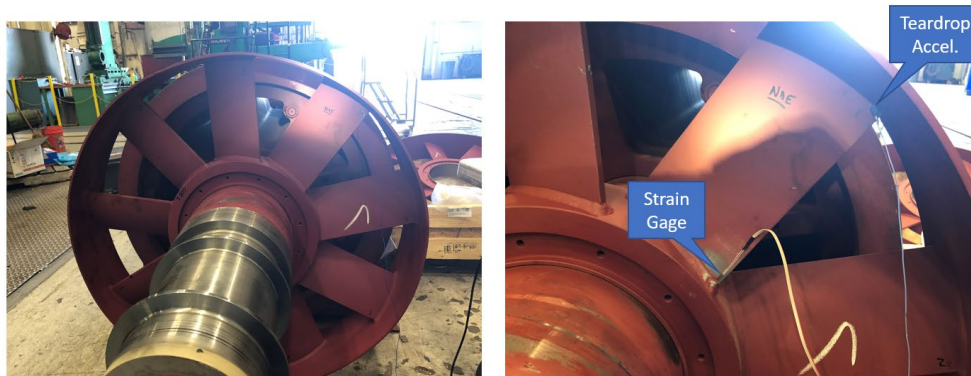
Figure 22. Close-Up of Internal Fan NDE with Instrumentation

The impact tests were repeated at the motor repair shop for the new fans. Both the NDE and DE fans were impact tested. The natural frequency results are summarized in Table 2.

- Interference Fit (Fan Hub to Shaft) Reduced to 0.005"
- Increased Outside Diameter of Fan Hubs. This resulted in shorter fan blades since the outer ring diameter remained the same.
- Thicker Fan Blades (3/8" versus 1/4").
- Improved Weld Quality (which should reduce SCF).

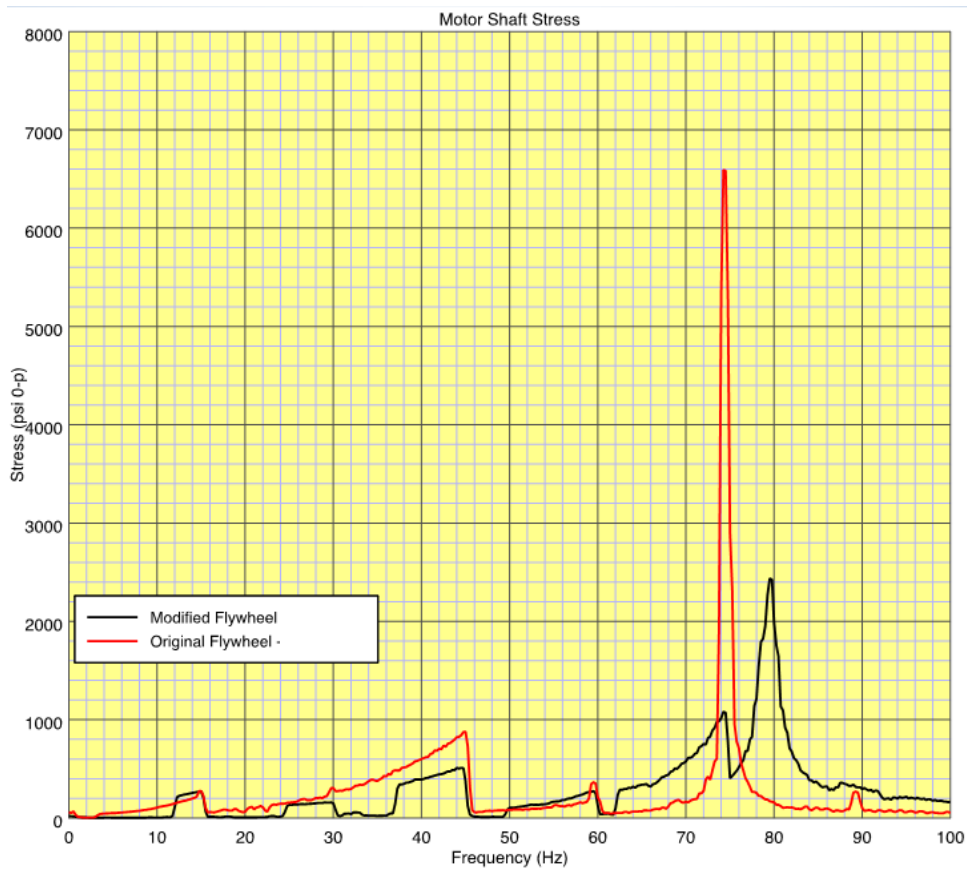
Figure 25. Comparison of Torsional Response

The TVA was normalized to match the field data. This involved adjusting the mass-elastic model to match the test data TNF. A parametric study was then performed on the computer to determine the optimal flywheel size. Follow-up field measurements with the modified flywheel confirmed good separation margin and acceptable alternating torque and stresses.

Figure 25 shows a comparison of the “before” and “after” torsional response measured in the motor shaft. A big improvement was made with the modified flywheel.

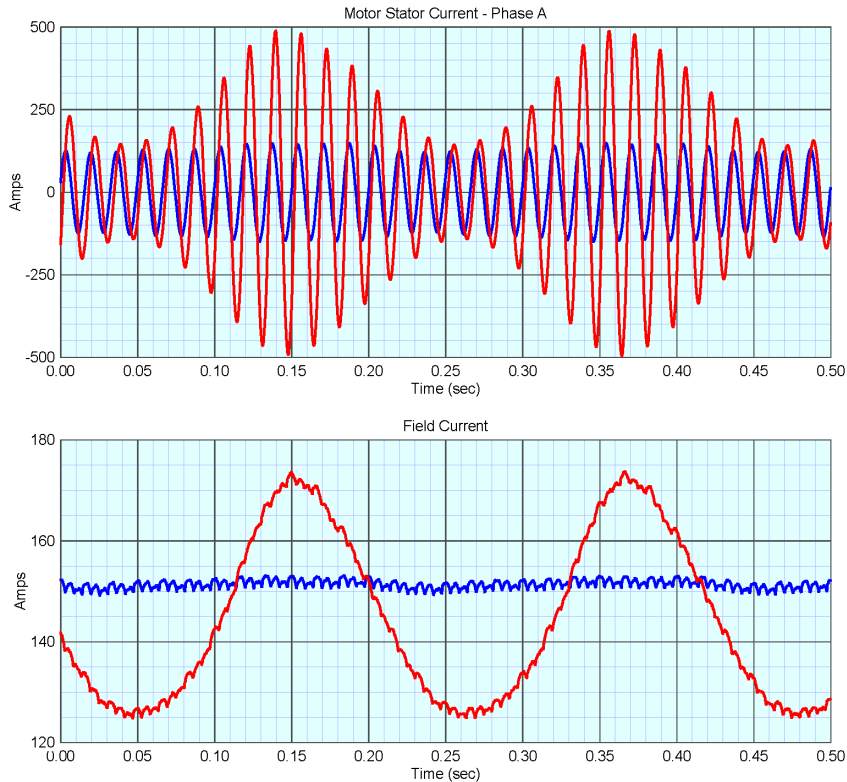
Figure 27. Measured Stator and Field Currents [24]

The machinery had been in service for over 20 years, but after an upgrade of the switch gear, high current pulsation was detected causing the motor to trip. To avoid unexpected shutdowns, the averaging time for the current was extended. The synchronous motor (rated 4,000 HP at 277 RPM) used slip rings for static field excitation. The reciprocating compressor had a single load step (fixed clearance), all cylinders were double-acting, and atmospheric air was being compressed to 6,000 psi final discharge pressure.

Torsional oscillation correlated with the electrical measurements (stator voltage, stator current, field voltage, and field current). As shown in Figure 27, when the compressor was unloaded (blue traces), the current pulsation was low; however, when the compressor was loaded (red traces) the current pulsation increased. The percent current pulsation was found to be 92% of FLA, which exceeded the 66% limit.

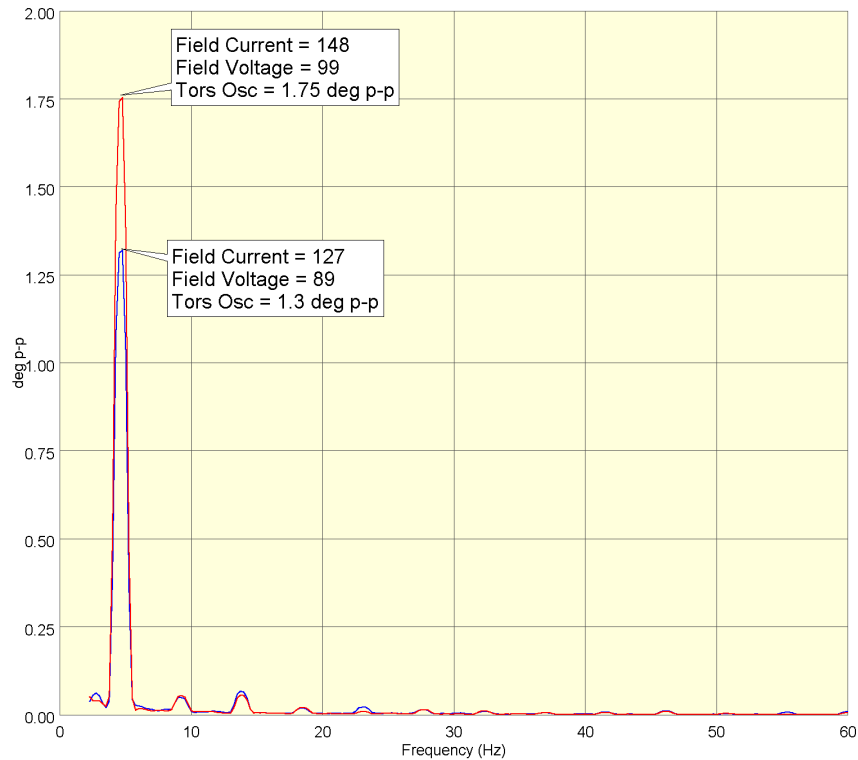
Figure 28. Angular Oscillation of Motor with Reduced Excitation [24]

The angular oscillation of the motor rotor could be decreased by reducing the field excitation. Figure 28 shows the 1× harmonic decreasing from 1.75 to 1.3 deg p-p as the effective torsional spring to ground (EM) was reduced with a weaker field.

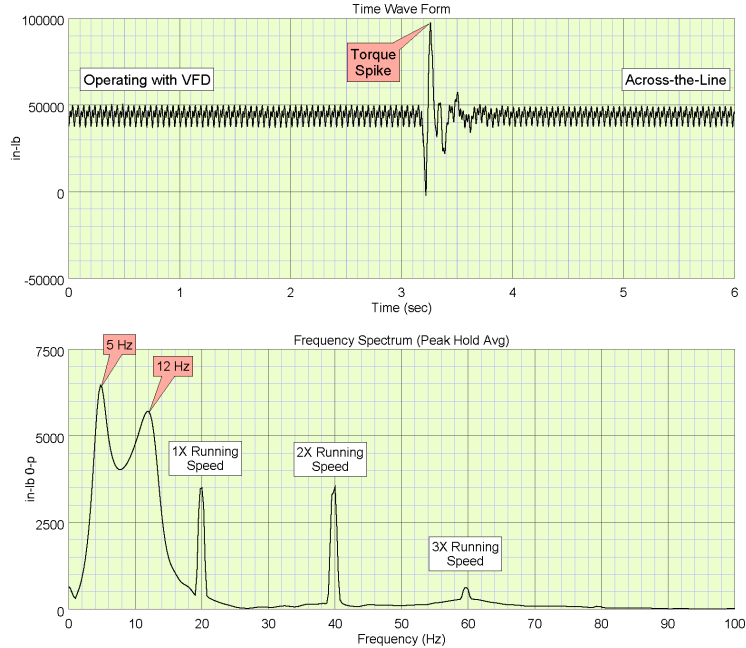
A torque spike was captured when the motor was switched from the VFD to across-the-line operation. As shown in Figure 30, the highest torque spike was approximately 100,000 in-lb (twice the full load torque), which is still lower than the allowable peak torque for the rubber coupling. During the electrical switching event, non-synchronous response peaks were evident at 5 Hz and 12 Hz by using peak hold averaging. However, the 5 Hz frequency was not observed during startup with the VFD.

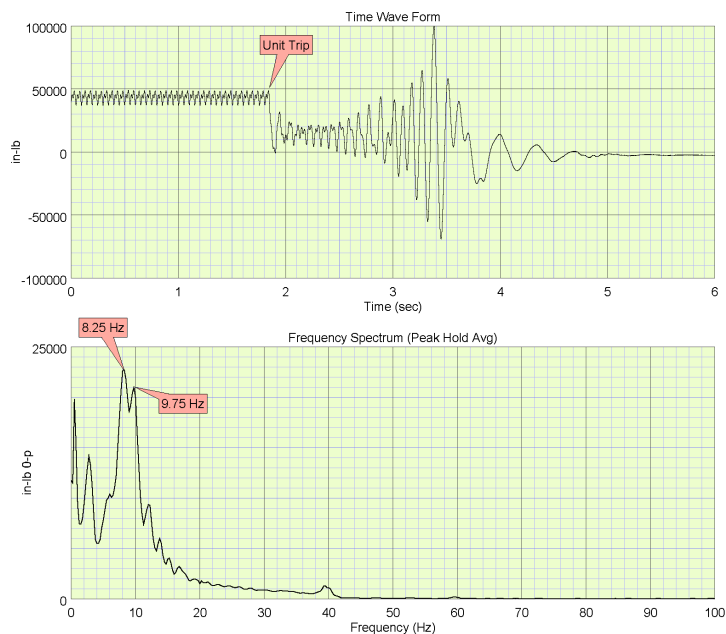
The motor was operating across-the-line (no VFD) just before a loaded shutdown of the compressor. The unit was stopped by cutting off electrical power to the motor, which quickly dissipated any EM stiffening effects. Load torque from the compressor stopped rotation in a few seconds. The response frequencies ranged from 8 – 10 Hz during the shutdown event (see Figure 31).

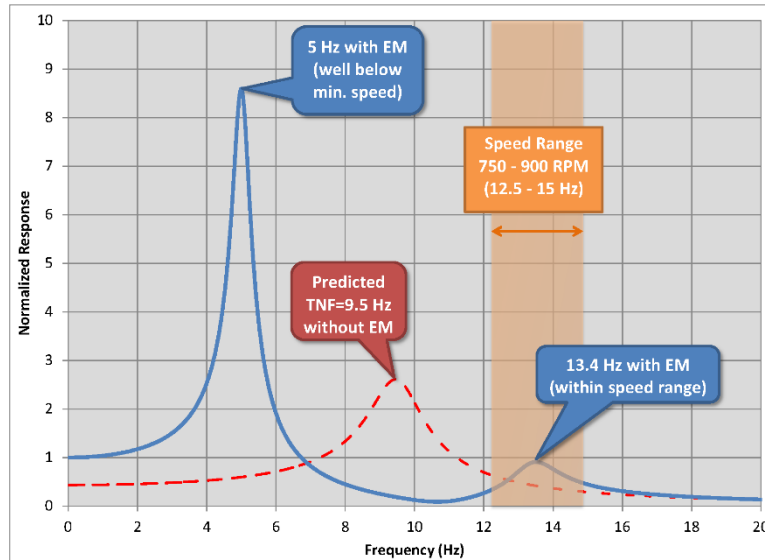
Figure 32. Comparison of Calculated Normalized Dynamic Torque in Coupling – With and Without EM [31]

Neglecting the EM effect, the predicted TNF of 9.5 Hz would be below the minimum operating speed (see Figure 32). With the EM stiffness included, the TNF increases by 40% to 13.4 Hz and is within the speed range. The first torsional mode shape involves maximum twisting through the coupling with the motor and compressor having out-of-phase angular oscillation. If the alternating torque exceeds the coupling rating, the rubber elements could be damaged from overheating.

With EM included, another TNF appears at 5 Hz. The mode shape associated with the TNF at 5 Hz has the entire motor-coupling-compressor system twisting across the EM spring to ground. Without the EM stiffness to ground, this would have been considered the zero mode for the entire system and typically not shown in the TVA report.

Since the TNF of 13.4 Hz fell within the operating speed range, it did not meet the API recommended separation margin. The TNF at 5 Hz had a higher peak response but was well below the minimum operating speed and not of concern. The TNF at 5 Hz likely would not have been noticed except for the switching from VFD to across-the-line that caused a small torque spike.

- Increase the minimum operating speed to avoid possible damage to the rubber elements in the coupling. This was accomplished by reprogramming the VFD in the field.
- Continuous operation of the compressor with single-acting cylinders or failed valves should be avoided since that would significantly increase exciting torque at 1× running speed and could result in premature wear of the rubber elements in the coupling.
