Vibration Issues with Engine Driven Reciprocating Compressor Systems

Engine driven reciprocating compressors are commonly used for gas pipeline systems. These units need to be reliable over a range of operating conditions and speeds. This paper presents three case studies detailing issues that were encountered on otherwise standard packages consisting of a 16-cylinder engine driving a six-throw reciprocating compressor in natural gas service.

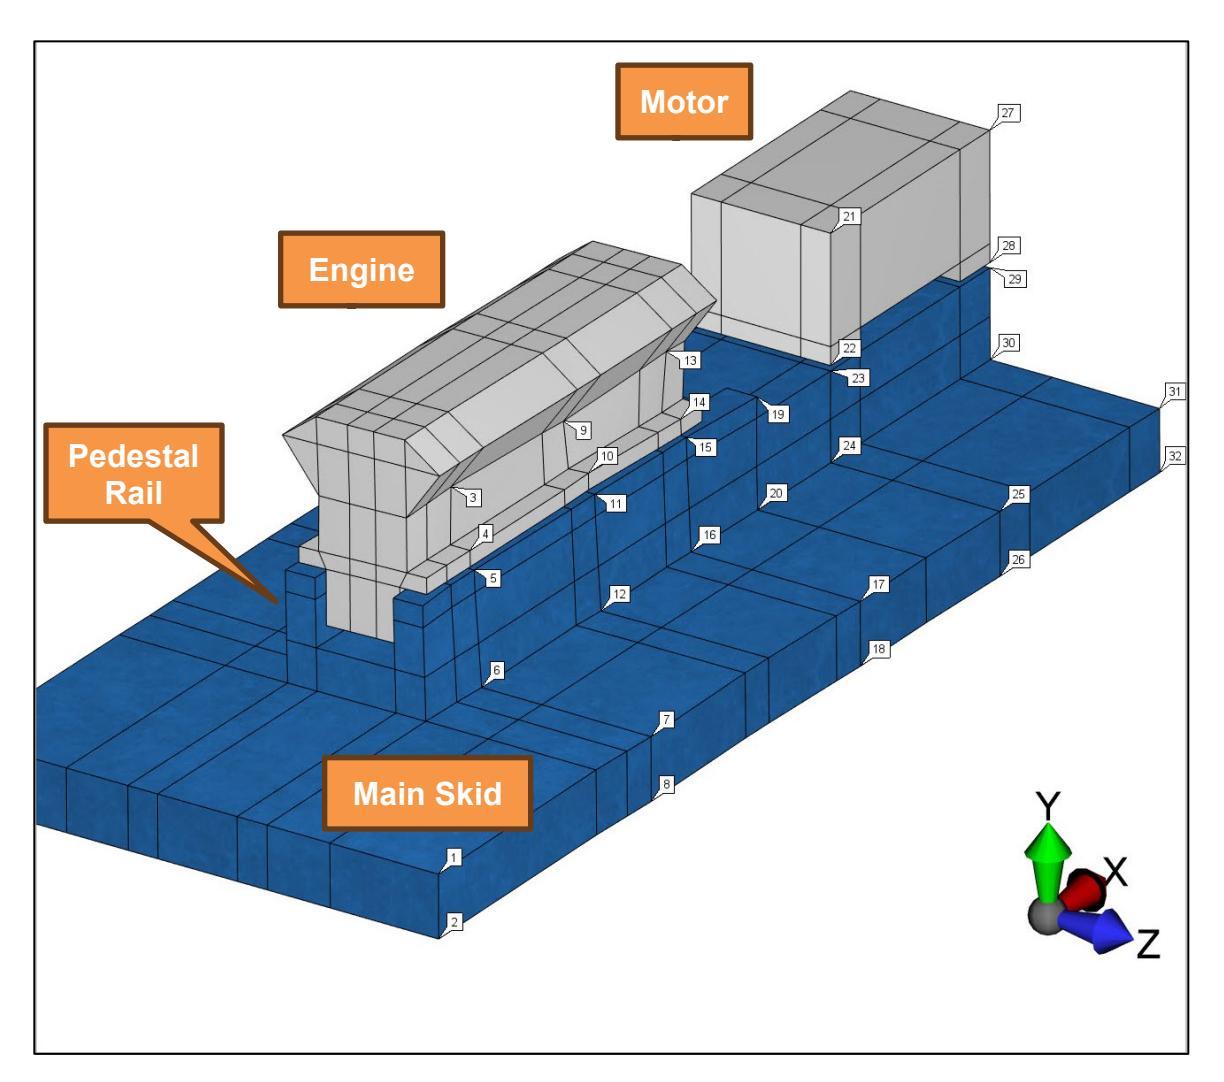
Figure 3. Operating Deflection Shape Test Locations

An operating deflection shape (ODS) test was performed on each unit while operating at constant speeds near the previously identified resonances so that the mode shapes of the natural frequencies would be measured. ODS is a method of visualizing vibration mode shape at a specific frequency. A geometric representation (model) was created from physical measurements as shown in Figure 3.

A roving tri-axial accelerometer was used to measure vibration in the horizontal (X), vertical (Y), and stretch (Z) directions at various locations on the engine, motor, pedestal and skid. The data were phase-referenced to a stationary accelerometer located on the engine frame so that it was also measuring the engine firing half-order. Animations were then generated to visualize the motion and help identify any areas of structural flexibility or looseness.
