HIGH VIBRATION OF INTEGRALLY GEARED COMPRESSOR DUE TO VARIABLE FREQUENCY DRIVE

Tim Robertson¹ and Troy Feese, P.E.²

Abstract

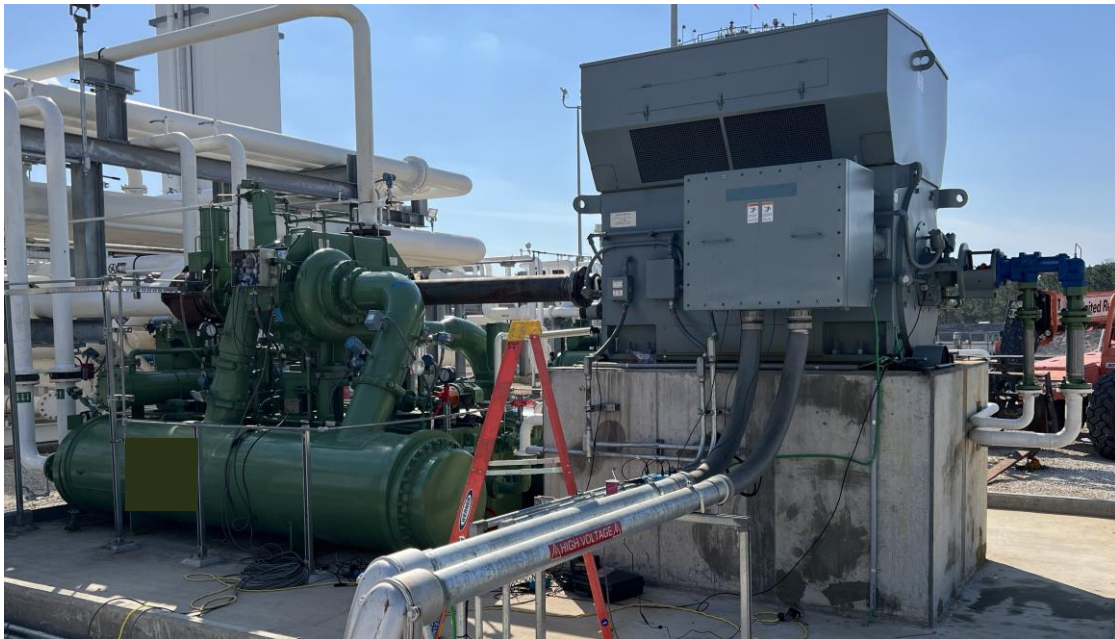
Both units at the plant are similar and consist of three stages of compression for nitrogen service. The first and second stages are on the low-speed (LS) pinion shaft and the third stage is on the high-speed (HS) pinion shaft. The pinion shafts are driven by a bull gear. A two-pole induction motor (rated 4690 HP at 3583 RPM) drives the compressor through a long disc coupling. The motor is rated for full load current of 534 amps at 4160 volts. Unit 2 is shown in Figure 1.

Figure 1 – VFD Motor, Coupling, and Compressor for Unit 2

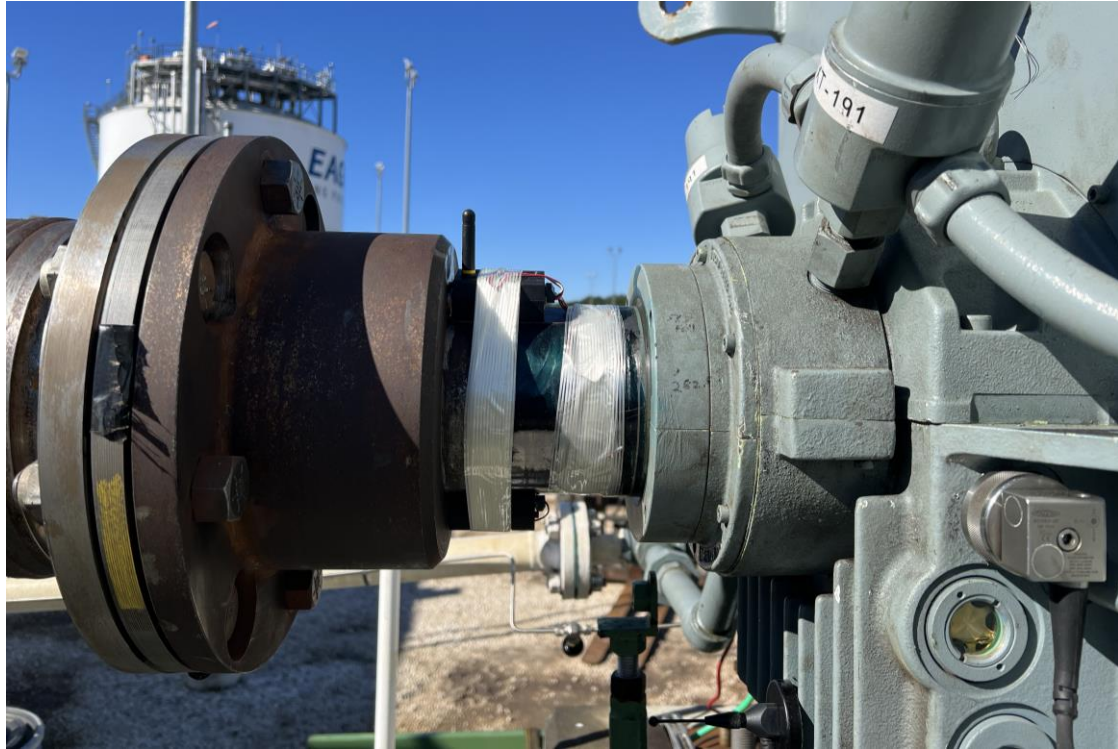
Field tests were performed to determine the cause(s) of the vibration. A battery-powered strain gage telemetry system was installed on the motor shaft extension to measure transmitted and alternating torque as shown in Figure 3.

Figure 3 – Strain Gage Telemetry System on Motor Shaft
